# **Andy Carr**

**Director | Carriageway Consulting Limited**

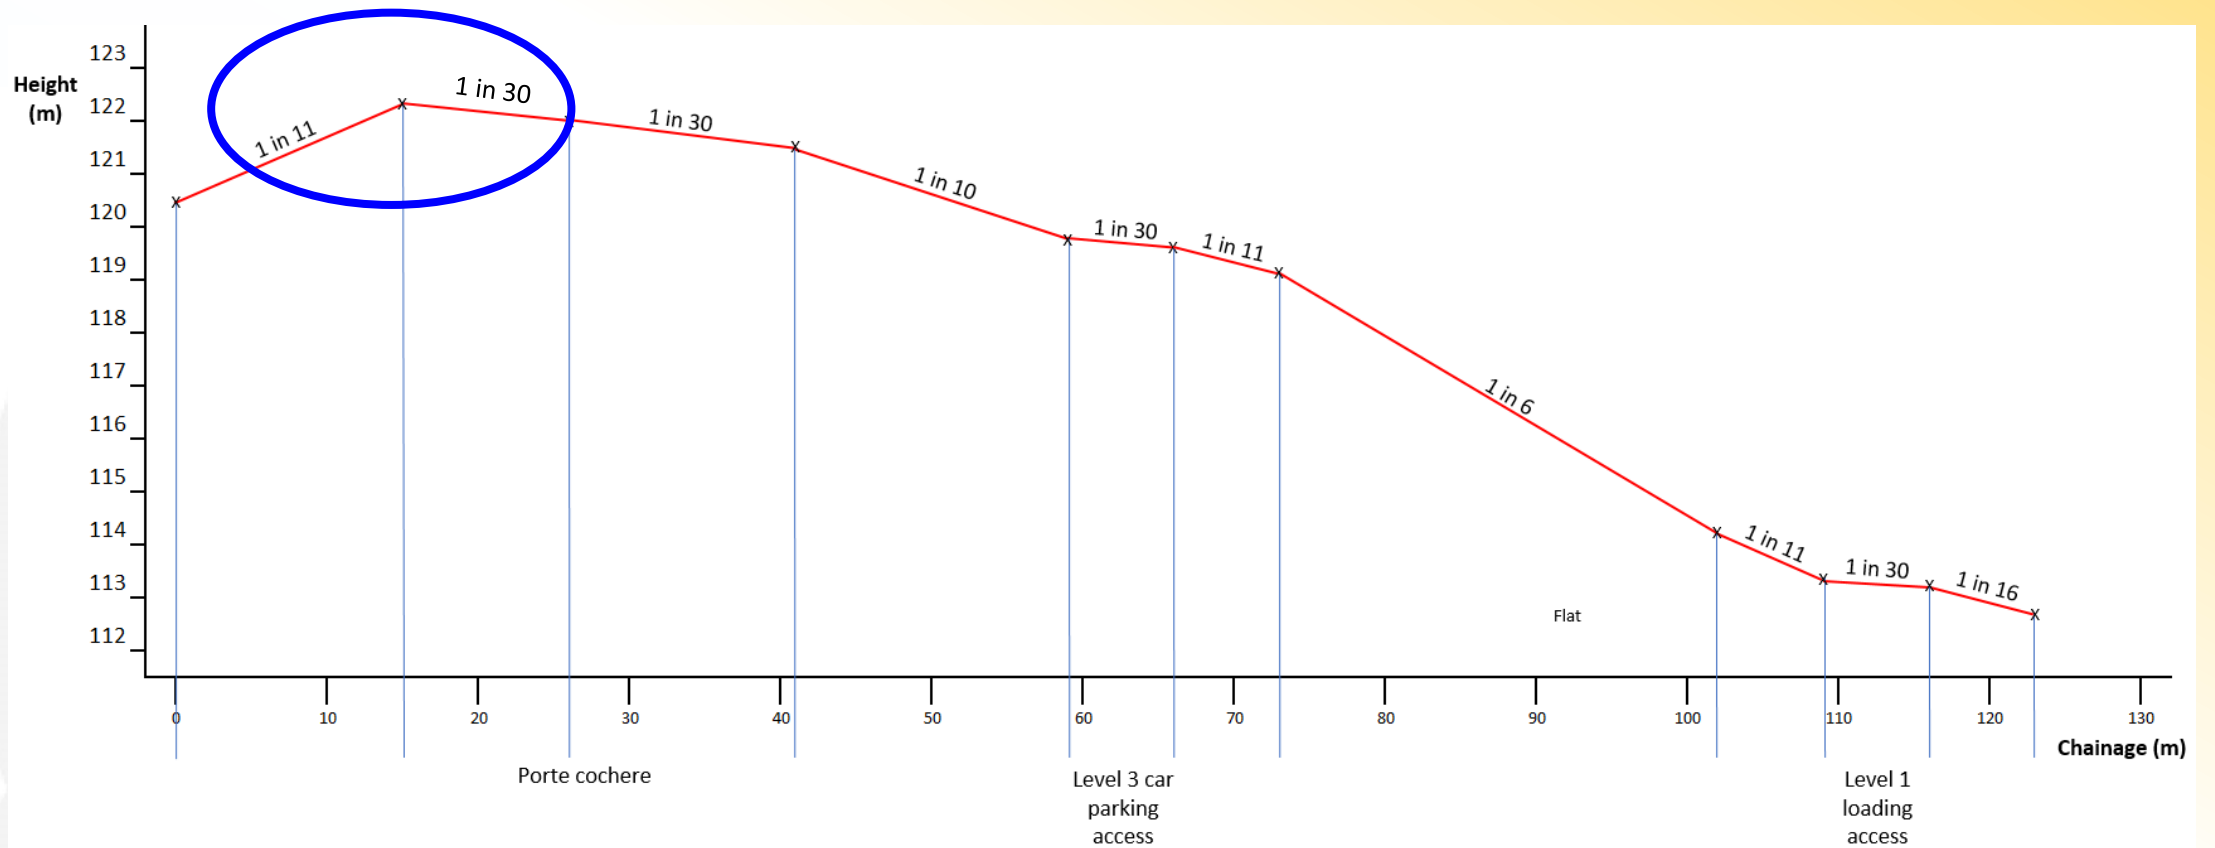
# Summit Grade

Applicant's plan shows 1 in 11 uphill, changes to 1 in 30 downhill

So total change in angle is 7.1 degrees, which equates to an overall change of gradient of 1 in 8.05

Problem: The maximum change of grade for a coach is 1 in 10.4 and for a service vehicle is 1 in 16 – otherwise they scrape or get jammed

So porte cochere remains unusable by coaches and service vehicles

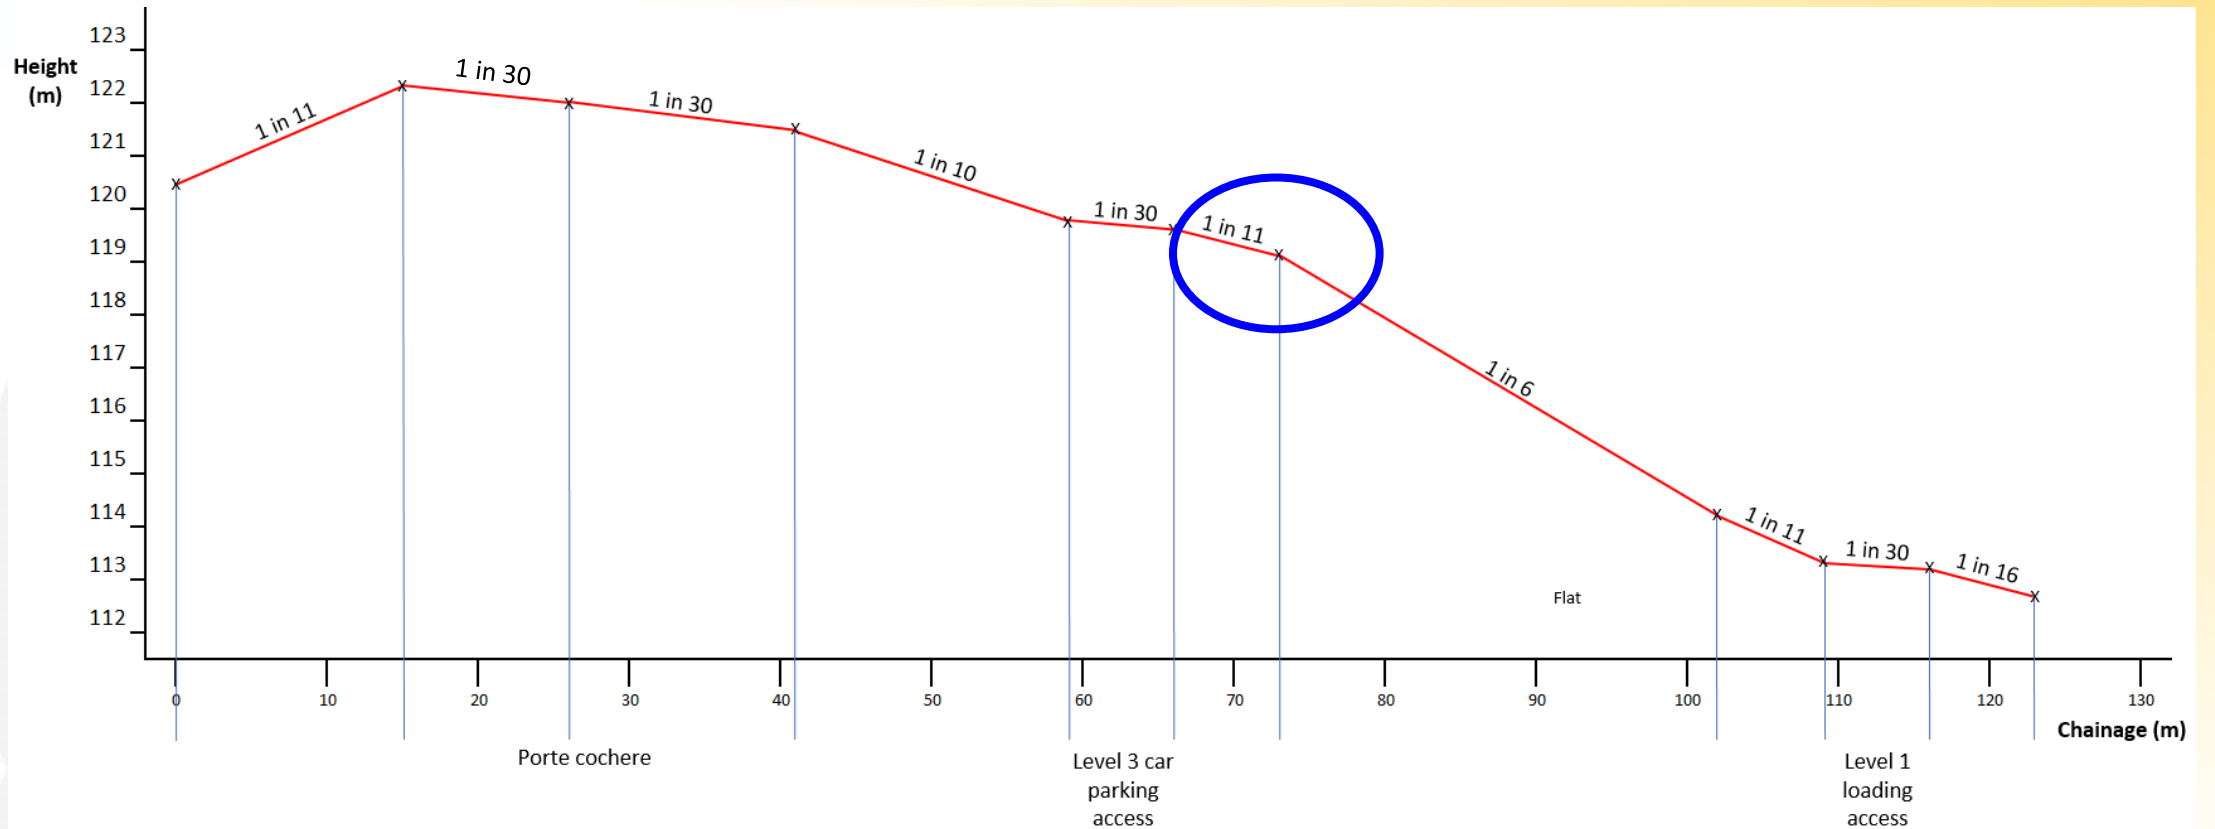
# Second Summit Grade

Applicant's plan shows 1 in 11 downhill, changes to 1 in 6 downhill

So total change in angle is 4.3 degrees, which equates to an overall change of grade of 1 in 13.4

Problem: The maximum change of grade for a service vehicle is 1 in 16 – otherwise they scrape or get jammed

So service vehicles are unable to get to the loading bay

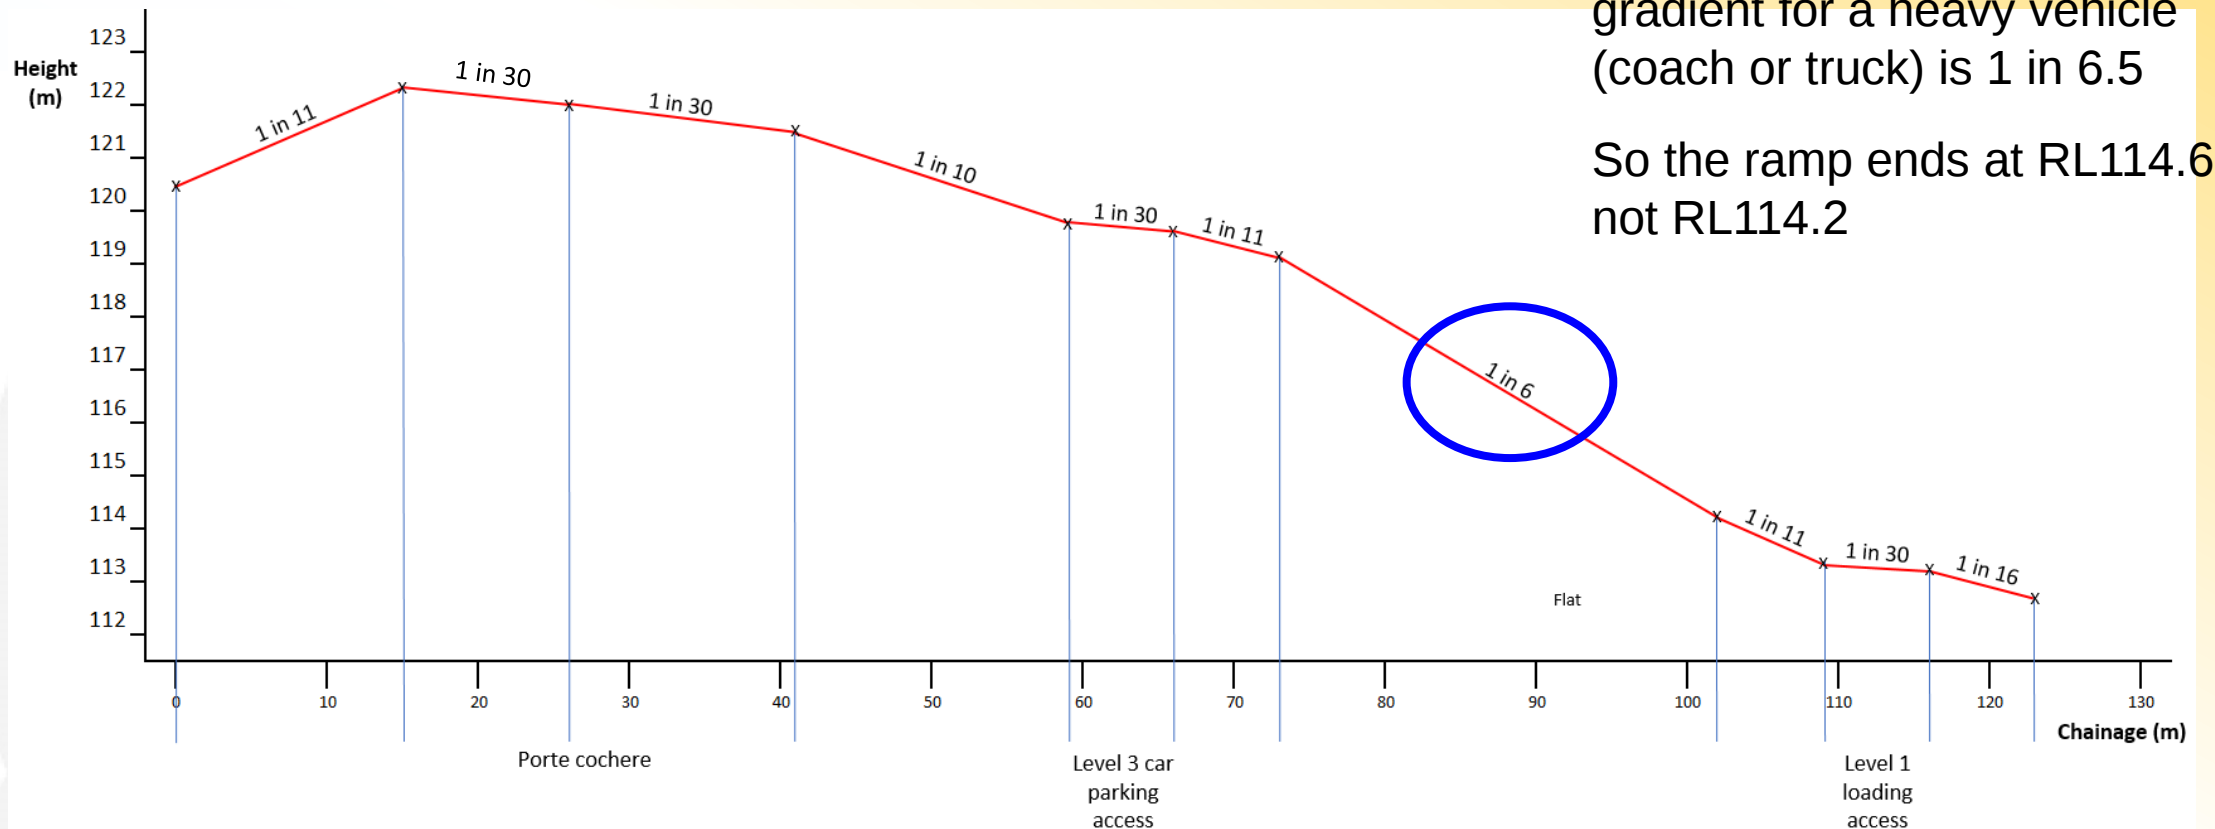
# Steep Gradient

Change in level from 114.2m to 113.4m (0.8m) over a distance of 7m

Equates to a gradient of 1 in 8.8 **not** 1 in 11 as shown

So total change in angle is 4.6 degrees, which equates to an overall change of grade of 1 in 12.5

Problem: The maximum change of grade for a service vehicle is 1 in 16 – otherwise they scrape or get jammed

So service vehicles are unable to get to the loading bay
