Prepared for Lion NZ Ltd  
Prepared by Beca Limited

## Location and Extent

**Asbestos Demolition Survey of**

Lion NZ Limited requested Beca to inspect and prepare a structural condition report for the building at 180 Rattray St, Dunedin, with respect to the current condition of the structure and any specific hazards or structural weaknesses presented by the current condition of the structure. This report has been prepared in response to this request.

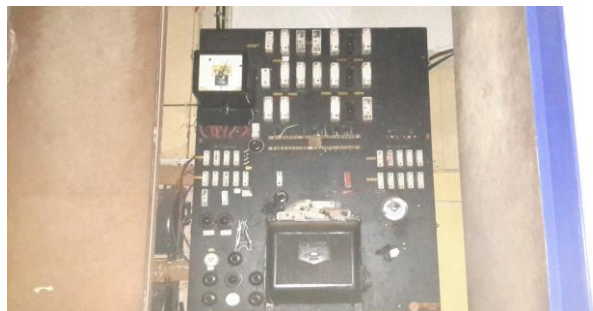
Room/Area: Floor 0, Room A (Ground Floor Internal Areas)

Description: Fuse flash guards to electrics (Woven textile) - 18-047155-01sp

Recommendations: Remove by licensed contractor prior to demolition works

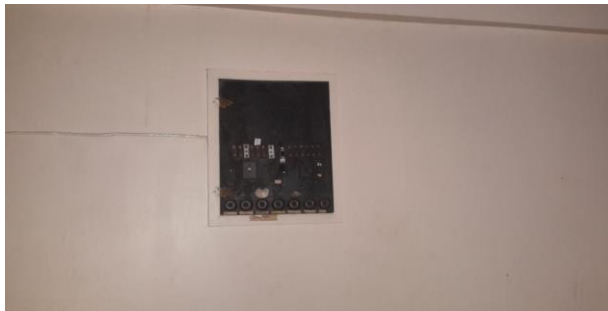
Room/Area: Floor 1, Room B (First Floor Internal Areas)

Description: Fuse backing board to electrics (Composite) - As 18-047155-01

Recommendations: No further action required

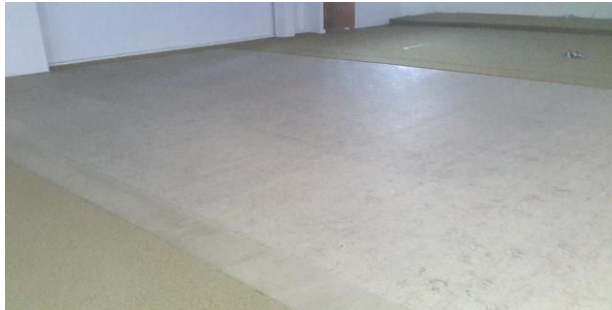
| | Room/Area: Floor 1, Room B (First Floor Internal Areas) |
| | Description: Coveting to wooden floor (Vinyl) - As 18-047155-02 |

| | Recommendations: Remove by licensed contractor prior to demolition works |

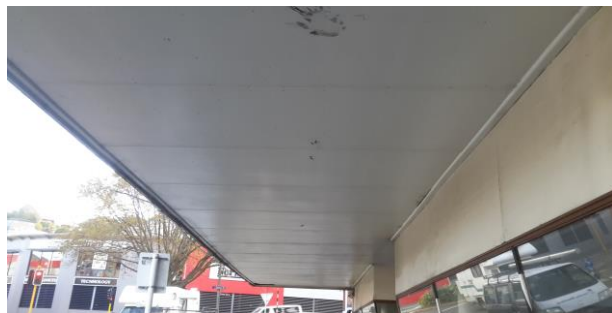
Room/Area: Floor 0, Room C (Externals)

Description: Front canopy (Fibre cement) - 18-047155-06

Recommendations: No further action required

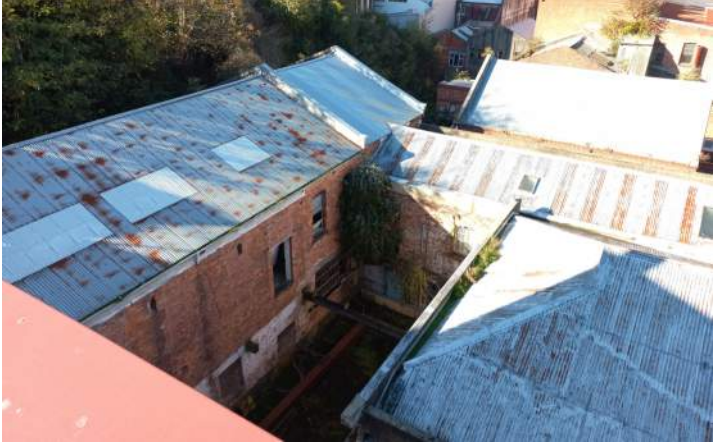
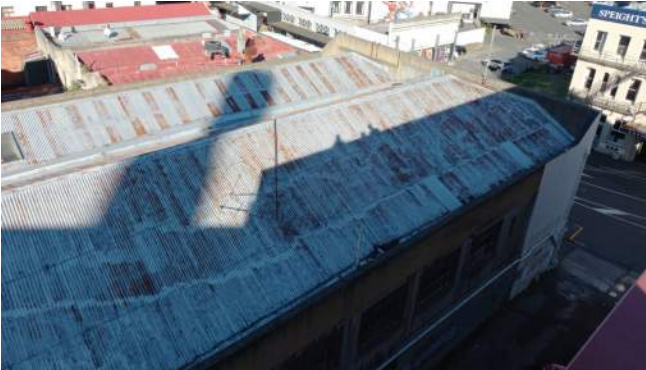
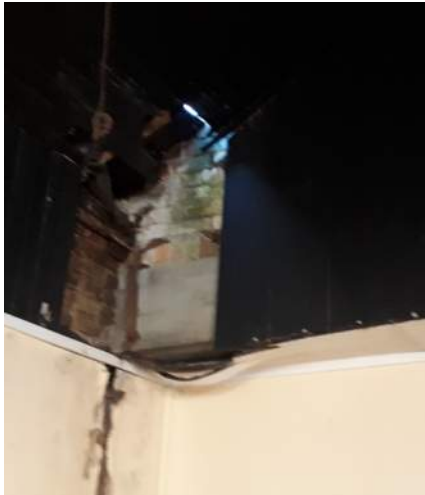
| Observation | Image |
|---|---|
| <p><b>Roofing</b></p> <p>Poor condition, several holes in roof resulting in water ingress to the roof space in area 2, and partially in area 1. The roofing is sagging and warped in several locations.</p> <p>The internal gutter between area 1 and area 2 is a likely source of water ingress. Damage to the roofing can be seen Figure 5, with subsequent damage to the roof structure and softening of the brick mortar which was observed to be crumbling in several locations.</p> | <p>Figure 3 – Roof of area 3 at rear of site</p> <p>Figure 4 - Roof of area 1 and 2 at front of site</p> <p>Figure 5: Example of water ingress through hole in the roofing at internal gutter between area 1 and 2</p> |

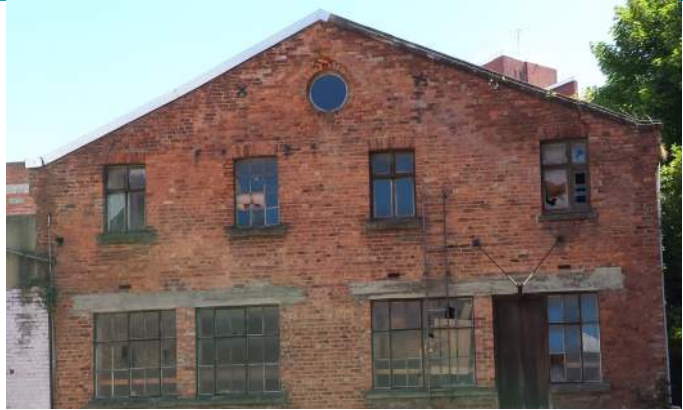
Figure 14 – Gable end wall (photo from 2013)

Observations on the outside of the gable end wall made in 2013 show several locations with loose and displaced bricks. Figure 15 and Figure 16 show horizontal and vertical displacement in the corners of the gable end wall. This is consistent with the cracking pattern observed internally in Figure 10 and Figure 11.

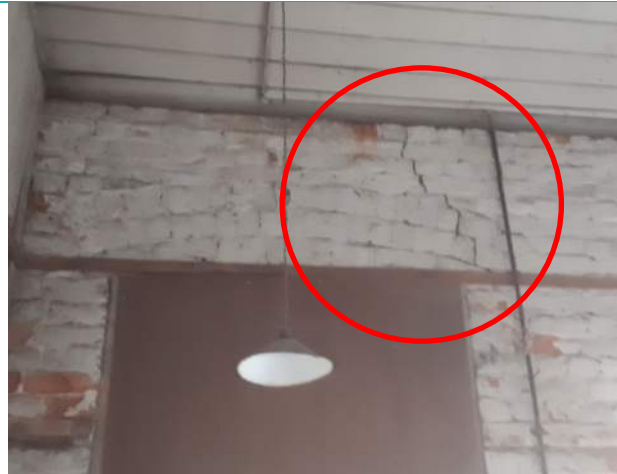
Figure 20

Cracks through brick lintels observed in the area 3, example shown in Figure 20.

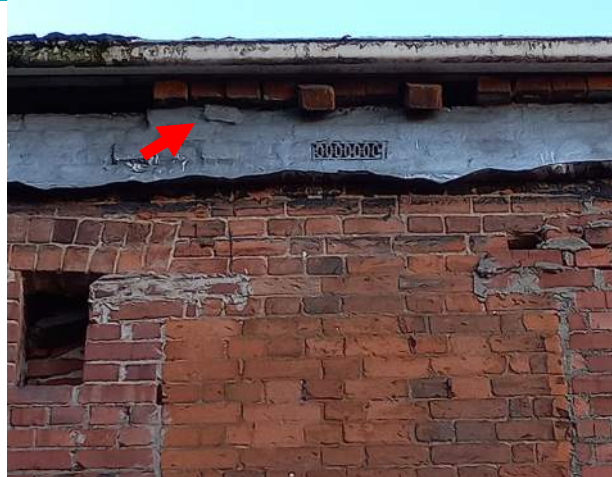
Figure 32 shows displaced bricks and bricks that are loose and look likely to fall out.
