# Dunedin City Council

## **DCC Landslide Monitoring Report**

### **Puketeraki Landslide**

23 February 2026

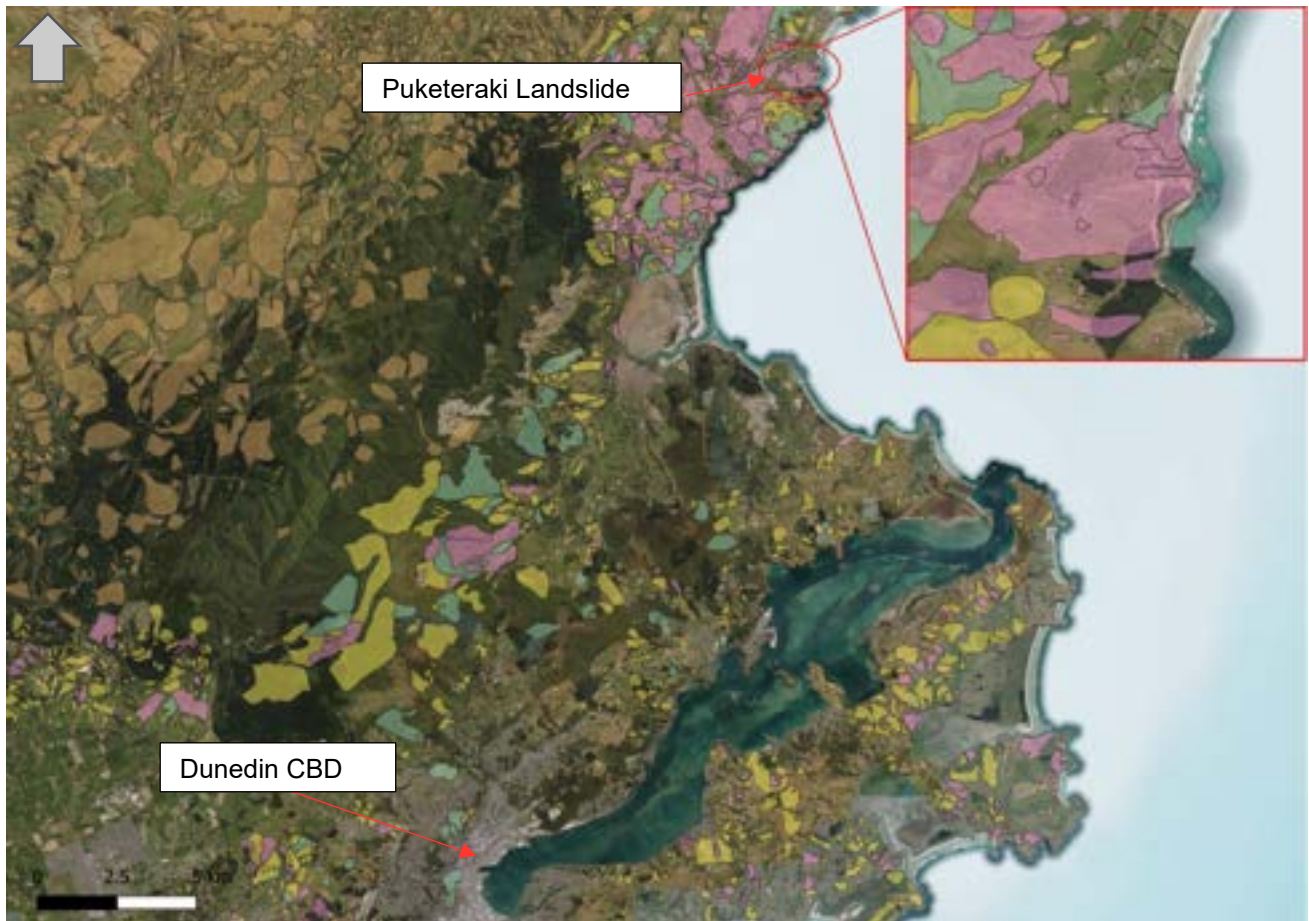
Figure 1 : Location of the Puketeraki Landslide, with reference to Dunedin CBD.

The Puketeraki Landslide ('the site') is located near Karitane, approximately 25 km north of Dunedin Central Business District (CBD). The site is in a rural area surrounded by farmland and hillsides, with the Main South Line located at the toe of the landslide. The approximate extent of the landslide is annotated in Figure 1.

The landslide is ~1.5 km in length and is ~800 m wide within the "definite" landslide probability (pink) as assigned by the Otago Regional Council's natural hazards database<sup>1</sup>.

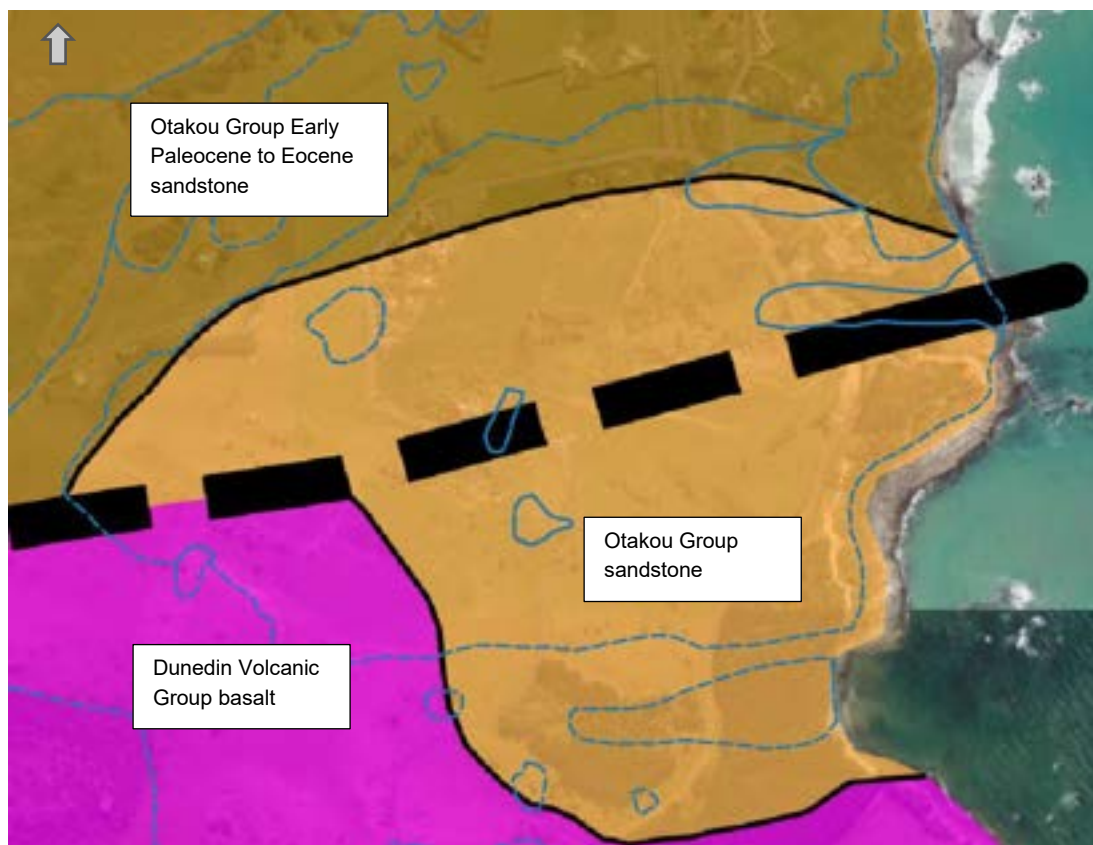
Figure 2: Geology as indicated by GNS with the outline of definite landslides in blue dashed lines. The thick black line indicates an inferred fault trace

The published Geology Map (1:250,000 Map)<sup>2</sup> (Figure 2) indicates that the landslide is largely located in Undifferentiated Otakou Group sandstone, which is comprised of “Blue-grey siltstone sandstone and carbonaceous mudstone in shallowing-up sequence (north of Waihemo Fault Zone); outer shelf sandstone and impure limestone further south”.

No active faults are noted within 50 km of the site. The GNS Geology Web Map indicates a potential fault trace that passes through the site, however there is no information regarding this fault expression in Figure 2. Given the distances of active faults from the site, the risk of associated ground movements at the site in the event of a rupture is considered to be 'low'.

A difference in topography was noted in the middle of the site, where large vertical deformation had occurred. A height difference of approximately 2-3 m between blocks was noted along the trace of the inferred fault shown in Figure 2 (refer to photograph 15, Appendix B).

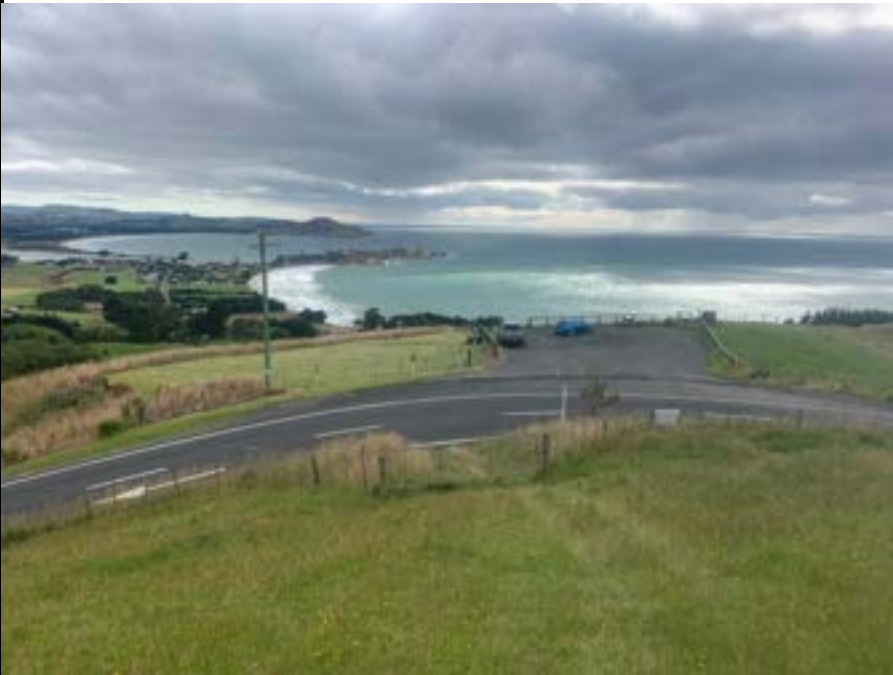
| <b>Photograph No.</b><br><br>1 | <b>Date</b><br><br>27/01/2026 | |

| <b>Description</b><br>View of Puketeraki look out. Image taken facing northeast above Coast Road | | |

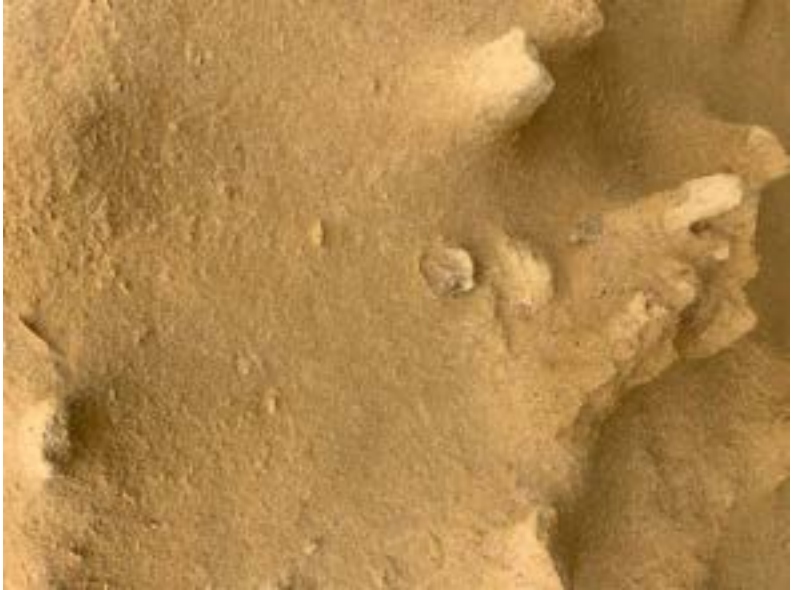
| <b>Photograph No.</b> | <b>Date</b> | |
|---|---|---|
| 13 | 27/01/2026 | |

| <b>Photograph No.</b> | <b>Date</b> | |
|---|---|---|
| <b>Description</b><br>Close up of fossiliferous limestone observed in photograph 11. | | |
