**In the Matter of** Hearing 4 of the Proposed Variation 2 (Additional  
Housing Capacity) of the Second Generation Dunedin  
District Plan – Appeals Version (**2GP**)

**Brief of Evidence of Mark Tapio Walrond  
on behalf of:**

GeoSolve Ref: 220581  
12 August 2022

### Geotechnical Assessment 353 Main South Road, Sunnyvale, Dunedin

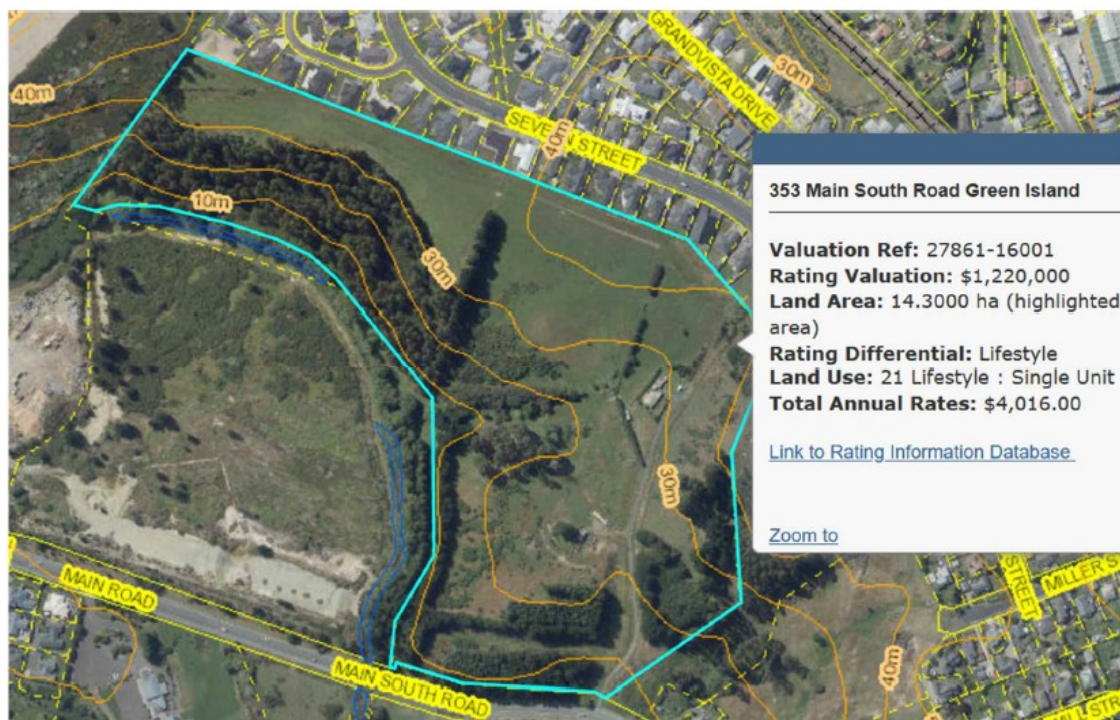
Figure 3 – Site extents and topography

The site topography (Figure 3) can be summarised as an upper area of gently to moderately sloping land (sown in pasture) adjacent to the existing residential developments on the south side of Severn St. To the south of this are relatively steep slopes of approximately 20 degrees that define the incised valley margins of Abbotts Creek. These slopes have been sown in gum trees. The south-eastern extents of the site also comprises mostly gently to moderately sloping land.

A large gully drains south-westwards from Severn St to Abbotts Creek and its axis lies just to the west of the existing dwelling on site. Several other minor drainage swales exist. A pond has been established within the gully.

The site has been used for farming and forestry in recent times. We understand that the site was previously owned by a brick manufacturer and there has been localised excavation over parts of the site. Some residual fill is locally present on site as a result of these activities.

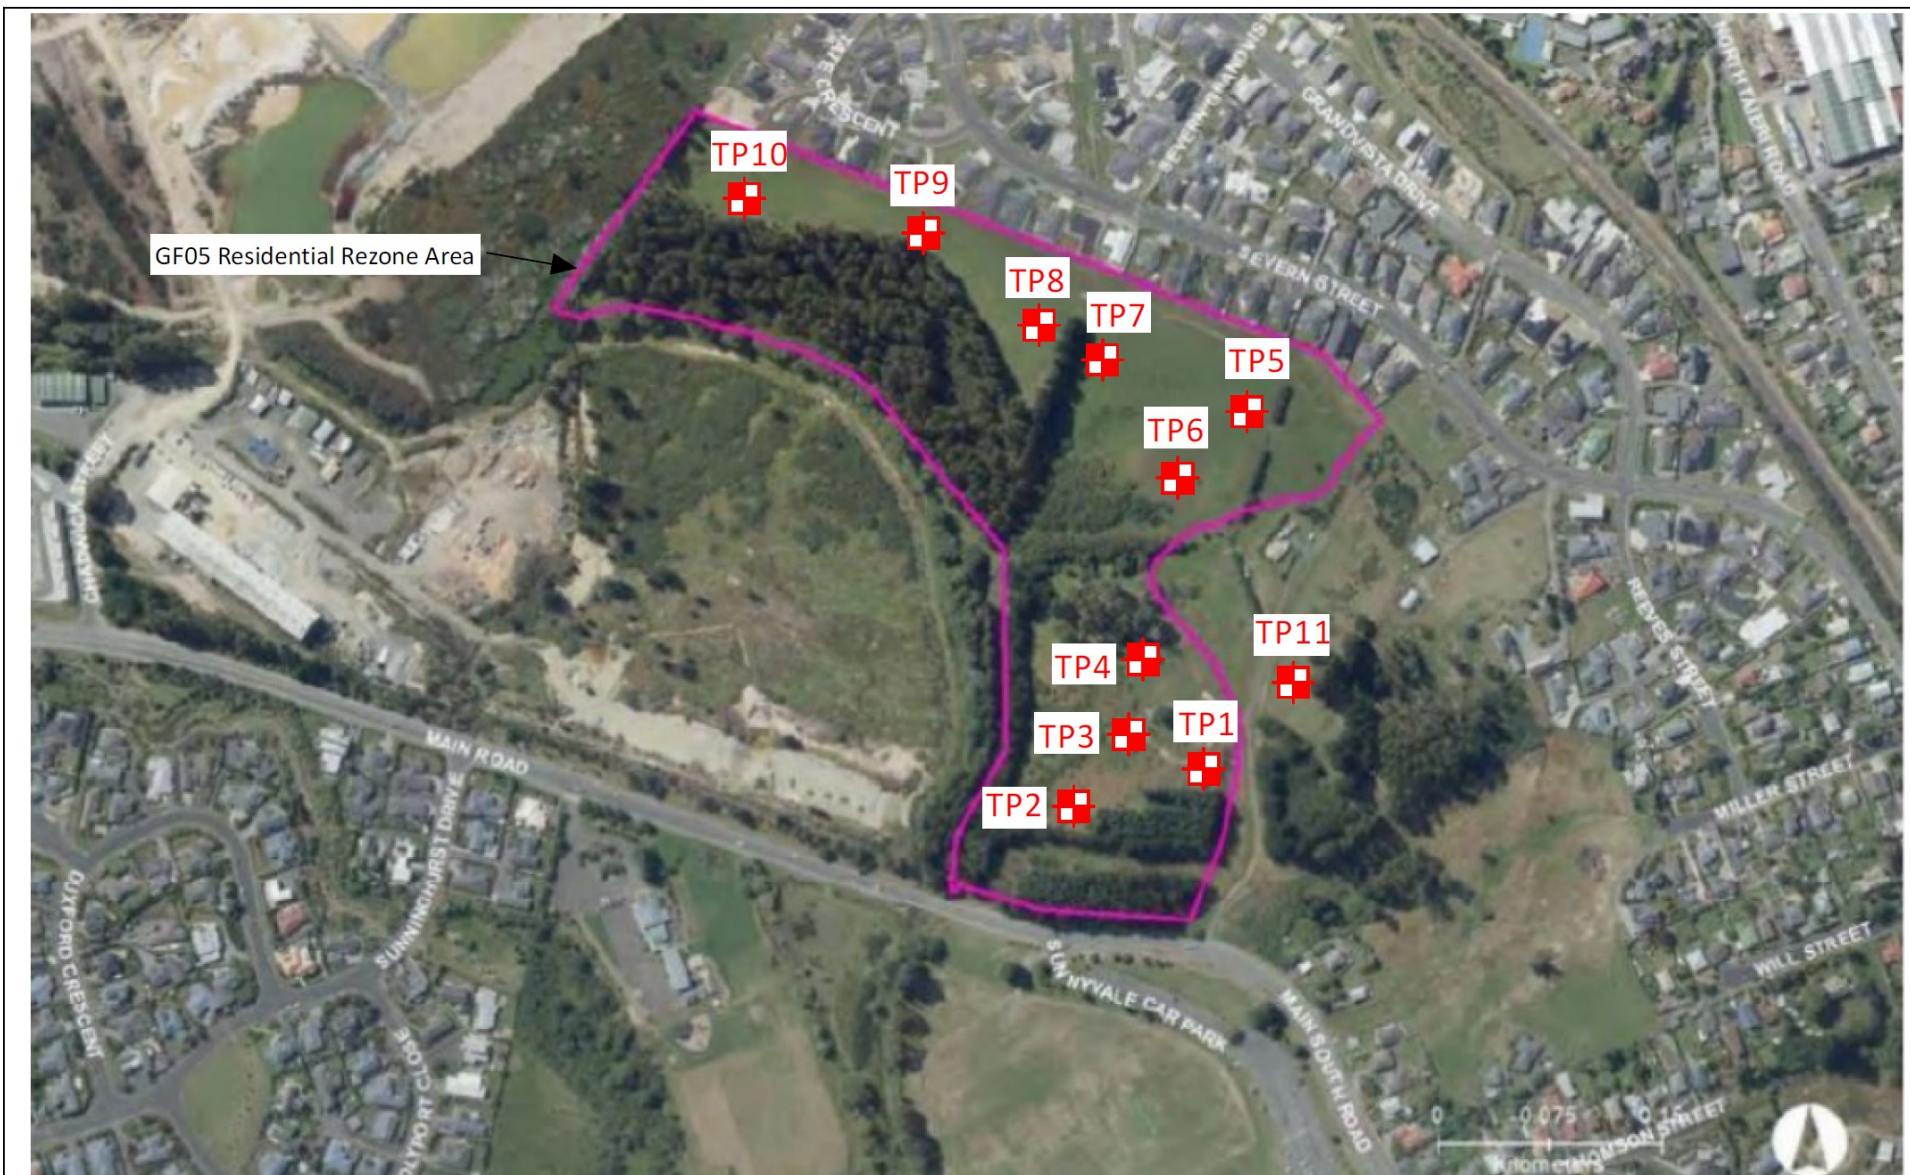
FIG No:  
Figure 1 - Site Plan

Our recent test pitting comprised 11 test pits taken to a depth of 3.2 m to assess the near surface soils and groundwater conditions. In summary the soils are mostly colluvium or ancient landslide debris overlying Abbotsford Formation bedrock which was visually observed in 2 test pits at depths of between 0.5 m (TP2) and 2.7 m (TP6).

No groundwater was observed for most of the site, apart from the test pit in the GF05a area (TP11).

Only localised uncontrolled fill was observed (up to 1 m in TP3 and 9 – likely associated with forestry and brick works). Some obvious stockpiles of fill are also located near the north-east corner of the site.

The test pit locations are shown in Figure 1 (appended) and Figure 5 below (with respect to the mapped landslide extents). We have retained a photographic record of the test pitting on file.
