## BEFORE THE COMMISSIONERS APPOINTED BY THE DUNEDIN CITY COUNCIL

**AND** Variation 2 to the Dunedin

BETWEEN GTJM PROPERTY

## BRIEF OF EVIDENCE OF JAMES MOLLOY DATED 5 AUGUST 2022

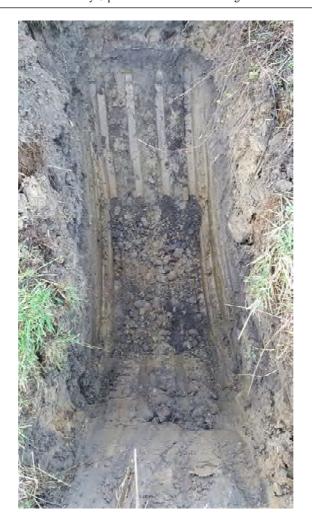
le: 336 Portobel :: 202106304 2021	lo Rd Logged By: Regan Lord	Client: GTJM Property Ltd Weather: Sunny & clear Excavator: 7T excavator (Hyundai 70cr-9)
Water @	Depth	Soils Description	TRIAL PIT No. TP01
Ory	0.0m—0.7m	Mottled grey and dark brown silty CLAY with minor c tion (Fill)	coarse gravel and cobbles. Soft and in damp condi-
	0.5m		
	0.7m—0.9m	Dark brown SILT. Soft and in damp condition. (Origin	al topsoil)
	0.9m—1.4m 1.0m	Mottled grey and orange brown silty CLAY. Soft beco- damp condition.	ming firm with moderate plasticity and in dry to
	1.5m	End of Test Pit at 1.4m	
	-		
	2.0m		
	2.5m		
	<u> </u>		
	3.0m	Note: Hole stable and dry. 3 photos. Backfilled with ar	isings.

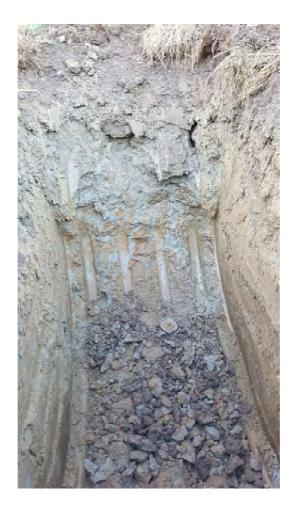
Contract Title: 336 Portobello Rd Contract No.: 202106304 Date: 21/06/2021 Client: GTJM Property Ltd Weather: Sunny & clear Excavator: 7T excavator (Hyundai 70cr-9) Logged By: Regan Lord Soils Description Water @ Depth TRIAL PIT No. TP02 Dark brown topsoil with rootlets. Soft and in damp condition.

Mottled grey and orange brown silty CLAY. Soft becoming firm with moderate to high plasticity and in damp condition. Large infilled cracks to 0.7m. 0.0m—0.25m Slow 0.25m—1.3m steady seepage at 0.5m 0.5m 1.0m End of Test Pit at 1.3m 1.5m 2.0m 2.5m 3.0m Note: Hole stable and dry. 3 photos. Backfilled with arisings.

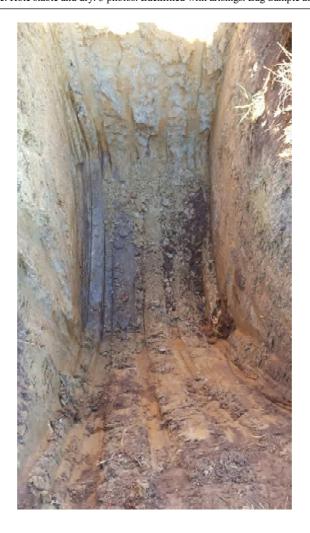
Contract Title: 336 Portobello Contract No.: 202106304 Date: 21/06/2021		lo Rd Logged By: Regan Lord	Client: GTJM Property Ltd Weather: Sunny & clear Excavator: 7T excavator (Hyundai 70cr-9)
Water @	Depth	Soils Description	TRIAL PIT No. TP03
Dry	0.0m—0.3m 0.3m—1.6m	Dark brown topsoil with rootlets. Soft and in damp con Mottled grey and orange brown silty CLAY. Soft becon condition. Large infilled cracks to 0.9m	
	0.5m		
	<u> </u>		
	1.0m		
	├ -		
	1.5m 1.6m—1.75m	Dark brown and grey clayey SILT. Stiff becoming hard	d and in dry to damp condition. (Weathered Tuff)
	<u> </u>	End of Test Pit at 1.75m	
	2.0m		
	_		
	2.5m		
	3.0m	Note: Hole stable and dry. 3 photos. Backfilled with an	isings Dag Sample at 1 0m - 1 5m

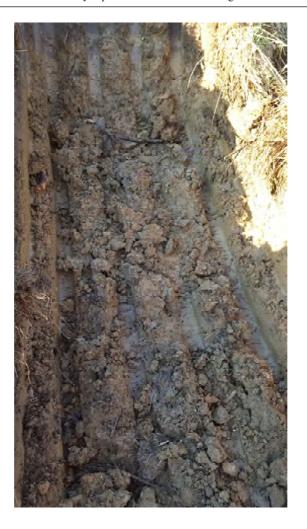
le: 336 Portobel .: 202106304 2021	lo Rd Logged By: Regan Lord	Client: GTJM Property Ltd Weather: Sunny & clear Excavator: 7T excavator (Hyundai 70cr-9)
Water @	Depth	Soils Description	TRIAL PIT No. TP04
Dry	0.0m—0.25m _0.25m—0.4m	Dark brown topsoil with rootlets. Soft and in damp co Mottled grey and orange brown silty CLAY. Soft with	ondition. h moderate plasticity and in damp condition.
	0.5m	End of Test Pit at 0.4m	
	<u> </u>		
	1.0m		
	-		
	—— 1.5m		
	_		
	2.0m		
	_		
	2.5m		
	3.0m		
	3.0111	Note: Hole stable and dry. 2 photos. Backfilled with a	arisings.

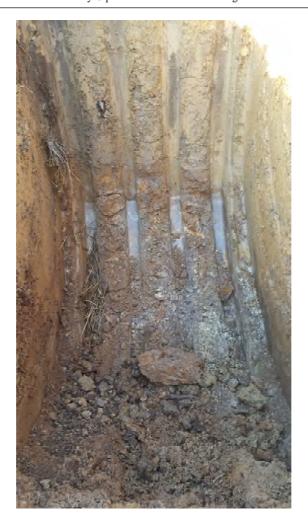
le: 336 Portobel :: 202106304 2021	llo Rd Logged By: Regan Lord	Client: GTJM Property Ltd Weather: Sunny & clear Excavator: 7T excavator (Hyundai 70cr-9)			
Water @	Depth	Soils Description	TRIAL PIT No. TP05			
Dry	0.0m—0.3m _0.3m—1.2m	Dark brown topsoil with rootlets. Soft and in damp con Mottled grey and orange brown silty CLAY. Soft becon condition.				
	0.5m					
	-					
	1.0m					
	_1.2m—1.4m	Dark brown and grey clayey SILT. Stiff becoming hard and in dry to damp condition. (Weathered Tuff)				
	1.5m	End of Test Pit at 1.4m				
	2.0m					
	<u> </u>					
	2.5m					
	<u> </u>					
	3.0m	Note: Hole stable and dry. 3 photos. Backfilled with ari	isinos

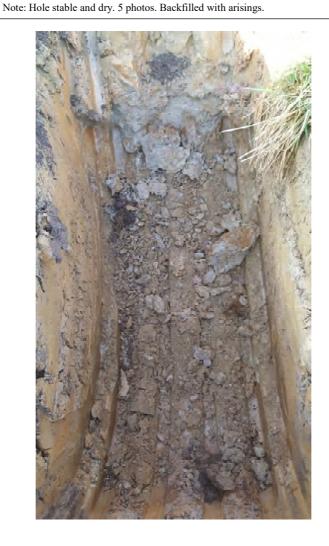
Client: GTJM Property Ltd Weather: Sunny & clear Excavator: 7T excavator (Hyundai 70cr-9) Contract Title: 336 Portobello Rd Contract No.: 202106304 Date: 21/06/2021 Logged By: Regan Lord Soils Description Water @ Depth TRIAL PIT No. TP06 Dark brown topsoil with rootlets. Soft and in damp condition. Mottled grey and orange brown silty CLAY. Soft with high plasticity and in damp to wet condition. Large infilled cracks to 0.7m. 0.0m—0.25m Slight seepage at 0.4m 0.25m—1.05m 0.5m 1.0m 1.05m—1.3m Dark orange brown silty CLAY. Firm to stiff with moderate plasticity and damp condition. End of Test Pit at 1.3m 1.5m 2.0m 2.5m 3.0m

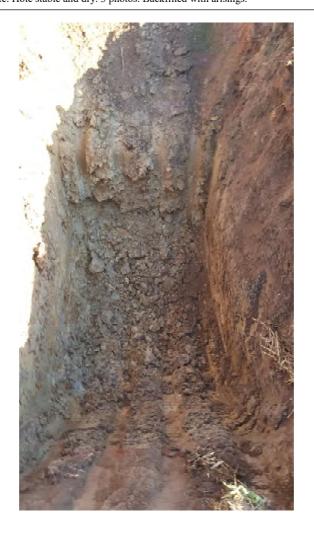
e: 336 Portobel : 202106304 2021	lo Rd Logged By: Regan Lord	Client: GTJM Property Ltd Weather: Sunny & clear Excavator: 7T excavator (Hyundai 70cr-9)
Water @	Depth	Soils Description	TRIAL PIT No. TP07
Dry	0.0m—0.3m 0.3m—0.9m	Dark brown topsoil with rootlets. Soft and in damp con Mottled grey and orange brown silty CLAY. Soft becon damp condition.	dition.  ning firm with moderate to high plasticity and in
	0.5m		
	0.9m—1.25m 1.0m	Dark brown and grey clayey SILT. Stiff becoming hard	and in dry to damp condition. (Weathered Tuff)
	<u> </u>	End of Test Pit at 1.25m	
	1.5m		
	<u> </u>		
	2.0m		
	<u> </u>		
	2.5m		
	<u> </u>		
	3.0m	Note: Hole stable and dry. 3 photos. Backfilled with ari	sinos

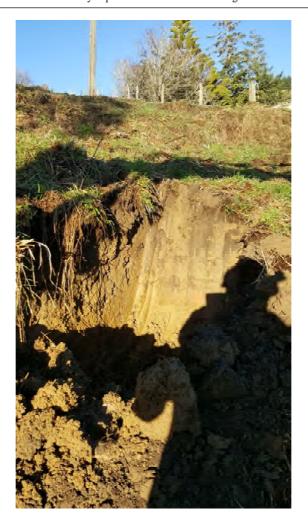
le: 336 Portobel :: 202106304 2021	lo Rd Logged By: Regan Lord	Client: GTJM Property Ltd Weather: Sunny & clear Excavator: 7T excavator (Hyundai 70cr-9)
Water @	Depth	Soils Description	TRIAL PIT No. TP08
Ory	0.0m—0.25m _0.25m—0.8m	Dark brown topsoil with rootlets. Soft and in damp con Mottled grey and orange brown silty CLAY. Soft with	ndition. moderate to high plasticity and in damp condition.
	0.5m		
	-	End of Test Pit at 0.8m	
	1.0m		
	<u> </u>		
	—— 1.5m		
	2.0m		
	<u> </u>		
	2.5m		
	<u> </u>		
	3.0m	Note: Hole stable and dry. 2 photos. Backfilled with an	isings.

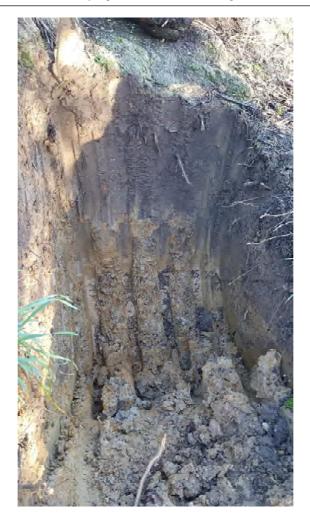
Contract Titl Contract No. Date: 21/06/2		llo Rd Logged By: Regan Lord	Client: GTJM Property Ltd Weather: Sunny & clear Excavator: 7T excavator (Hyundai 70cr-9)
Water @	Depth	Soils Description	TRIAL PIT No. TP09
Dry	0.0m—0.3m	Dark brown clayey SILT with minor coarse gravel. Sof	ft and in damp condition. (Fill)
	0.3m—0.5m 0.5m—1.0m 0.5m	Dark brown SILT Soft and in damp condition. (Origina Mottled grey and orange brown silty CLAY. Soft with	al topsoil) moderate plasticity and in damp condition.
	1.0m	End of Test Pit at 1.0m	
	1.5m		
	2.0m		
	2.5m		
	3.0m	Note: Hole stable and dry. 1 photo. Backfilled with aris	sings.

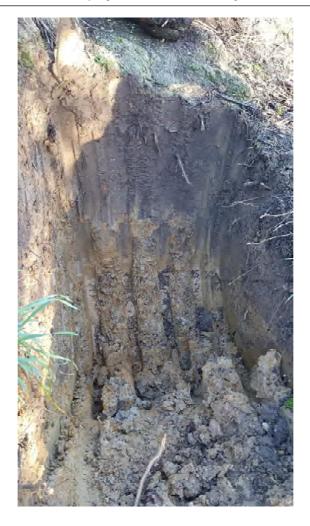
Contract Title: 336 Portobell Contract No.: 202106304 Date: 21/06/2021		llo Rd Logged By: Regan Lord	Client: GTJM Property Ltd Weather: Sunny & clear Excavator: 7T excavator (Hyundai 70cr-9)
Water @	Depth	Soils Description	TRIAL PIT No. TP10
Dry	0.0m—0.4m	Dark brown clayey SILT with roots throughout. Soft a	and in damp condition. (Fill)
	0.4m—0.6m 0.5m	Dark brown SILT Soft and in damp condition. (Origin	nal topsoil)
	0.6m—1.4m	Mottled grey and orange brown silty CLAY. Soft with	n moderate plasticity and in damp condition.
	1.0m		
	<u> </u>		
	1.5m	End of Test Pit at 1.4m	
	2.0m		
	-		
	2.5m		
	<u> </u>		
	3.0m	Note: Hole stable and dry. 3 photos. Backfilled with a	risings.

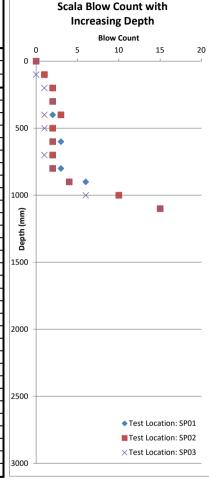
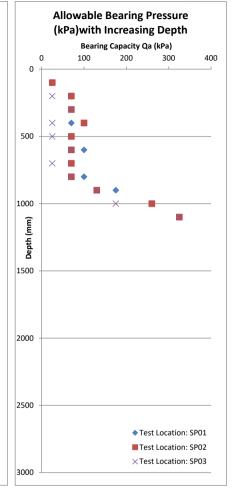
#### **Scala Penetrometer Test Results**

Test Lo	cation:	SP01		Test Lo	cation:	SP02		Test Lo	cation:	SP03		Test Lo	cation:		
Depth	No.	Equiv.	$Q_a$												
(mm)	Blows	CBR%	(kPa)												
0	0	0	#N/A	0	0	0	#N/A	0	0	0	#N/A	0			#N/A
100	1	2	25	100	1	2	25	100	0	0	#N/A	100			#N/A
200	2	4	70	200	2	4	70	200	1	2	25	200			#N/A
300	2	4	70	300	2	4	70	300	2	4	70	300			#N/A
400	2	4	70	400	3	6	100	400	1	2	25	400			#N/A
500	2	4	70	500	2	4	70	500	1	2	25	500			#N/A
600	3	6	100	600	2	4	70	600	2	4	70	600			#N/A
700	2	4	70	700	2	4	70	700	1	2	25	700			#N/A
800	3	6	100	800	2	4	70	800	2	4	70	800			#N/A
900	6	13	175	900	4	8	130	900	4	8	130	900			#N/A
1000	10	23	260	1000	10	23	260	1000	6	13	175	1000			#N/A
1100	15	36	325	1100	15	36	325	1100	15	36	325	1100			#N/A
1200			#N/A												
1300			#N/A												
1400			#N/A												
1500			#N/A												
1600			#N/A												
1700			#N/A												
1800			#N/A												
1900			#N/A												
2000			#N/A
