# CONDITION REPORT

SAMMY'S ENTERTAINMENT VENUE,  
65 CRAWFORD STREET, DUNEDIN.

- Report commissioned by:** Feldspar – David Booth
- Report and site inspection undertaken by:** Grant Parker MSc Arch MNZIBS  
Registered Building Surveyor

- Date of Inspection:** Monday 26<sup>th</sup> September 2016 @ 9:00 am & 3:00 pm
- Other persons present:** The Current Owner, Agent, Fire Engineer and Valuer

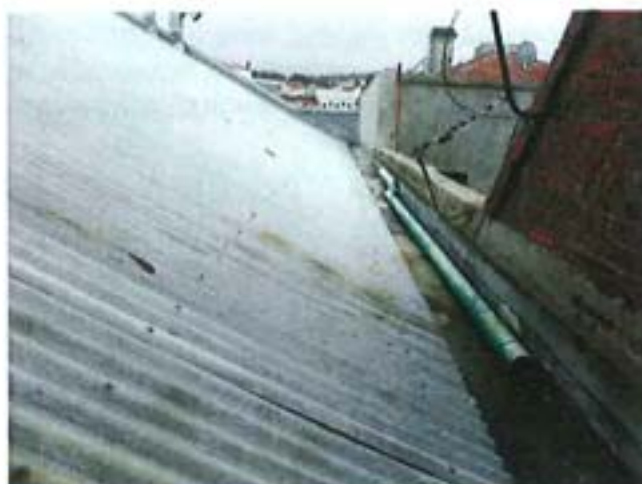
Photograph 2

- 4.2 The western roof has been covered with short-run corrugated sheet metal roofing, with associated ridge and apron flashings and appeared in reasonable to average condition when viewed from the hatch. Some sheets are indented with some lifted end and side laps and there are areas of red rust corrosion, which require monitoring to ensure that these sheets remain weathertight.

- 4.5 The gutter is lined with metal, which is buckled with areas of corrosion and ponding water which, suggest that it is not laid to adequate falls. There is a build-up of debris at the parapet which will require periodic clearing. The redundant downpipe within the gutter should be removed.

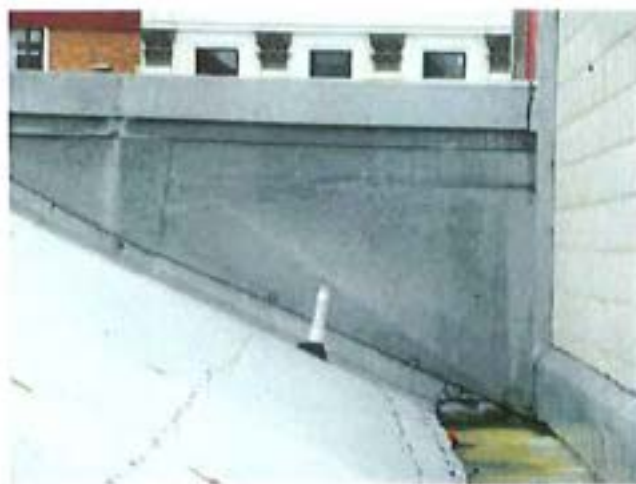
Photograph 3

- 4.6 The upstand flashings with the neighbouring property are not considered to be robust and appear to be reliant on sealants for their weathertightness. These areas will require monitoring with consideration given to installing more robust apron flashings to reduce the risk of moisture penetration along this junction.

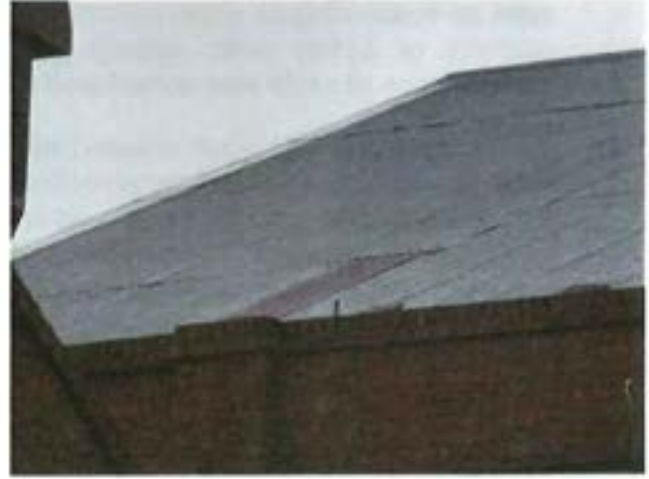
Photograph 5

- 4.7 The eastern roof has been covered with short-run corrugated sheet metal roofing, with associated ridge and apron flashings and appeared in reasonable to average condition when viewed from ground levels. The roof covering appears to be of older origin and secured with lead head nails. There are some lifted end laps between sheets and heads to the fixings, with some corrosion, which require monitoring to ensure that they remain weathertight.

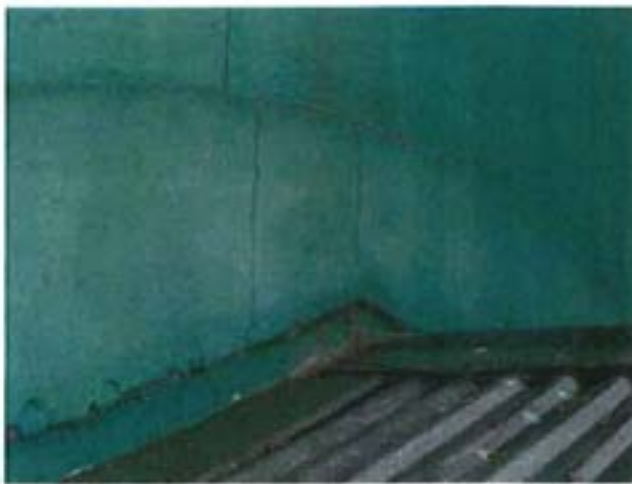
Photograph 9

- 4.8 The roof above the western entrance has been covered with painted, long-run corrugated sheet metal, with associated ridge and barge flashings and appeared in reasonable to average condition. There are paint spatters to the roof covering and the actual paint coting is deteriorating and would benefit from re-decoration.

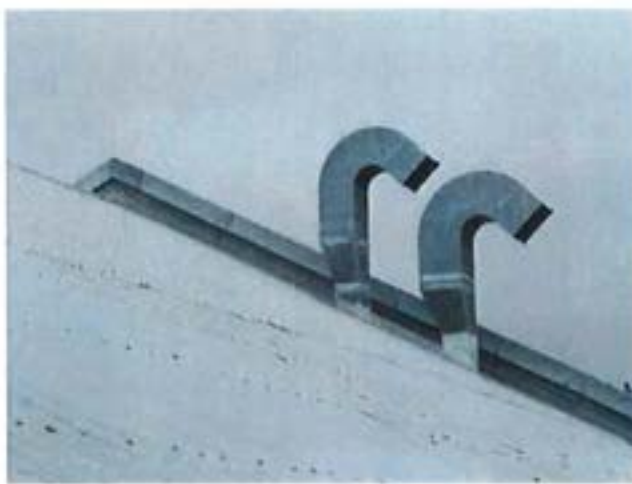
Photograph 13

- 4.9 The roof penetrations that were able to be viewed appeared to be remain adequately flashed, although the flues and metal flashings are corroding, in particular to the top edges behind the penetrations. All roof penetrations are considered to be weak points and will require ongoing monitoring.

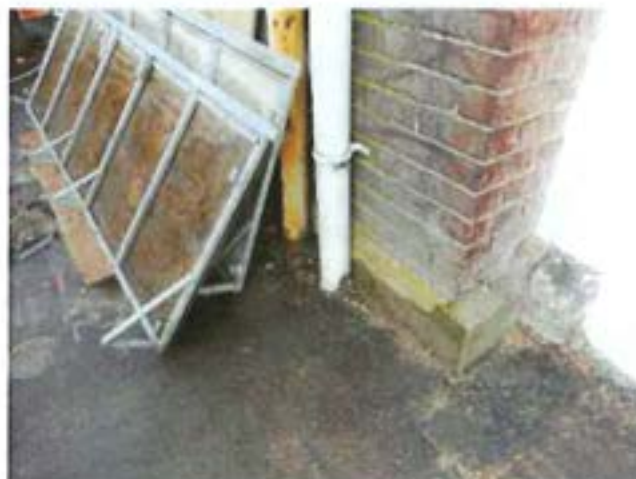
Photograph 15

- 4.10 Rainwater downpipes to the east are uPVC and are not adequately secured as the older metal brackets are re-used in places and these require replacement. The original metal pipe remains to the southern side at low level and would benefit from replacement. These downpipes discharge direct to the below ground drainage.

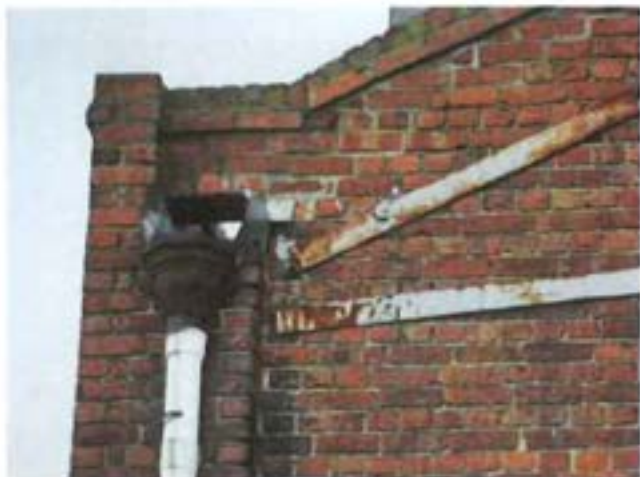
Photograph 16

- 4.12 The rainwater runoff from the roofs is directed to the western elevation through scupper outlets to metal hoppers externally. The hoppers are believed to be original and are corroded however the downpipes have been replaced with uPVC pipe. The metal flashing to both the scupper outlets appears poor when viewed from ground levels and requires further investigation. There are no obvious overflows installed, and these gutters, scupper outlets and hoppers will require regular monitoring to ensure that any leaf litter or debris is cleared and thus reduce the potential for blockage.

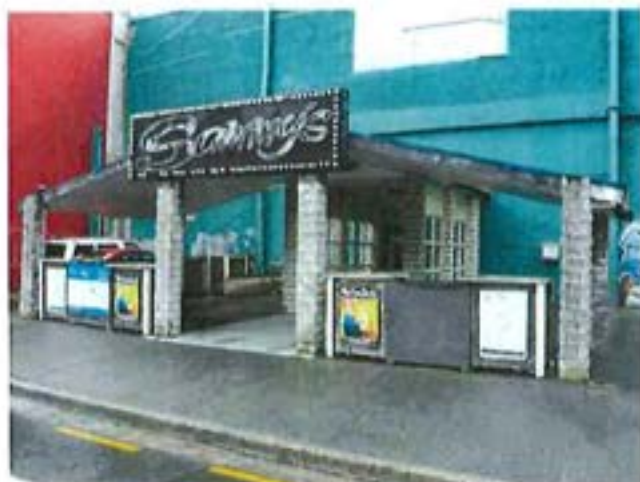
Photograph 20

5.2 As the concrete brick veneer is installed with no ground clearance, there is mould growth occurring as these bricks are porous and will soak up and hold moisture.

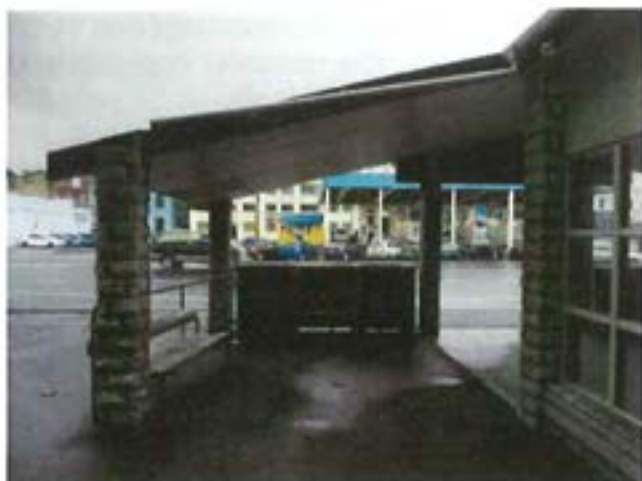
Photograph 22

5.3 Additionally, the gullies for the rainwater require clearing. In some areas the mortar joints have cracked, with some bricks either spalled or missing. Where the barge boards penetrate through the masonry columns there is also concentrated water run-off which has resulted in staining below.

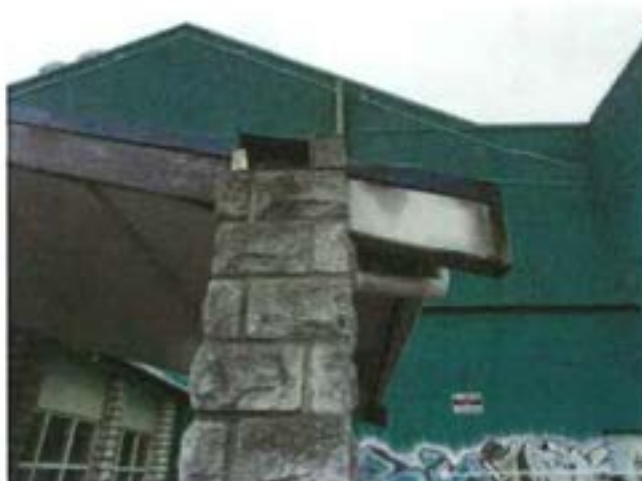
Photograph 25

5.4 There is corrosion noted to the exposed steel columns where bricks are missing. The columns are likely to have suffered as a result of moisture over time and require further investigation to ensure that there are no significant defects occurring as a result.

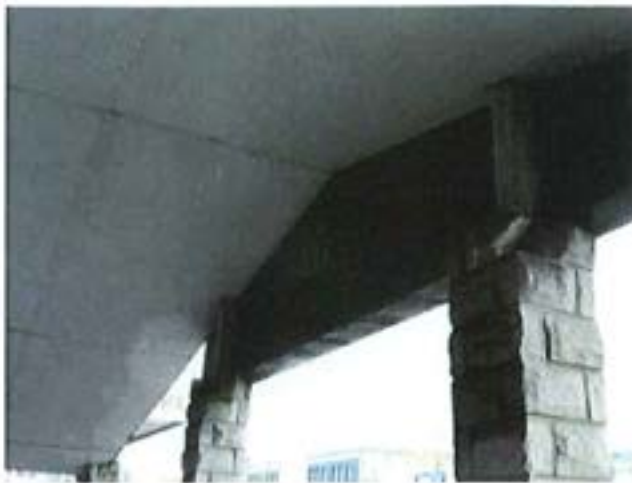
Photograph 28

- 5.5 The signage to the entrance is in poor condition, likely as a result of aging and deferred maintenance, with a number of lightbulbs missing. The painted timber fascia boards appeared in poor condition and decorative order. The fascias behind the spouting have not been re-decorated and there is paint failure to these hidden areas. Consideration should be given to removing the spouting when re-decorating the fascias. There may be some areas of decayed timber that require replacement.
- 5.6 The entrance corridor at the main door has infill timber windows with Georgian wired glazing and fibre cement cladding above, which is in reasonable to average condition and decorative order; the timber requires re-decoration.

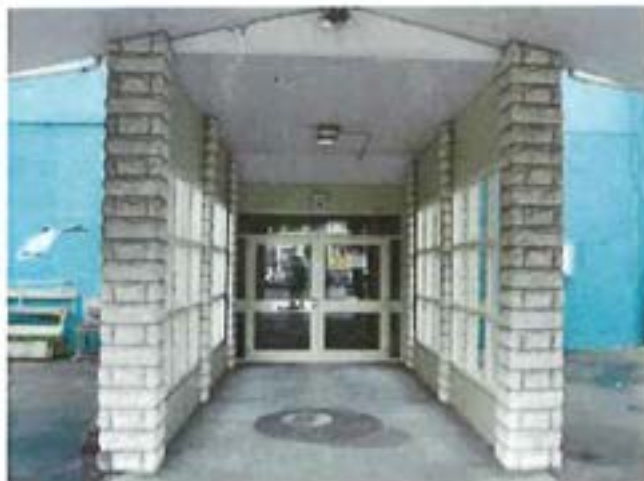
Photograph 31

- 5.7 The main entrance doors to the western elevation are sheltered from the elements and remain in reasonable condition. The timber doors are fully glazed with top and bottom clear single glazed panels along with side and top lights, with Georgian wired glazing. The door security consists of a mortise lock and handle along with a rim night latch.

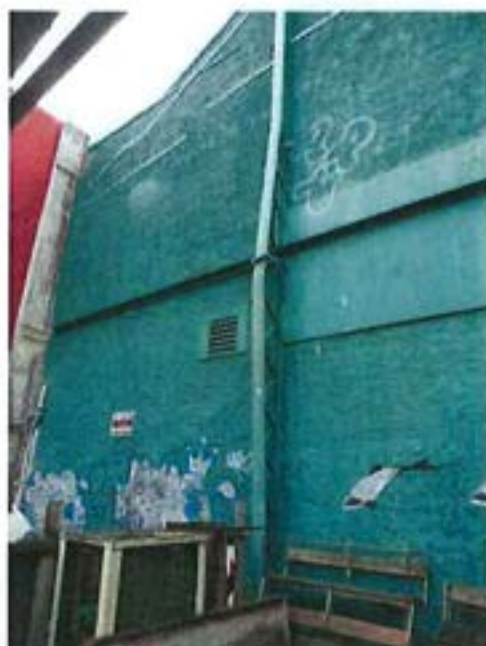
Photograph 34

- 5.10 The walls were visually inspected and it was established that whilst the walls appeared to remain true to line, level and plumb, that there are areas of random cracking to the solid plaster to the western elevation. Where the original openings to the western elevation have been plastered these have also cracked, likely as a result of the change of substrate. These cracks appear to range in size from hairline to larger cracks with plaster failure noted in some instances.

- 5.11 Where cracks have penetrated the full thickness of the plaster they are at risk of moisture penetration, and further cracking due to loss of adhesion, which could also be accelerated due to frost action. We note that this was a visual inspection and therefore, we did not take any measurements or check the depth of any cracking.

- 5.12 All cracking should be painted with suitable high build acrylic paint that will bridge hairline cracks or alternatively raked out and sealed with a flexible external grade sealant and finished with an appropriate paint coating to minimise and reduce the potential for any further moisture penetration.
- 5.13 The western elevation has been subjected to graffiti, which would benefit from re-decoration. The original signage has been removed from the upper western elevation and would benefit from redecoration to match the existing.

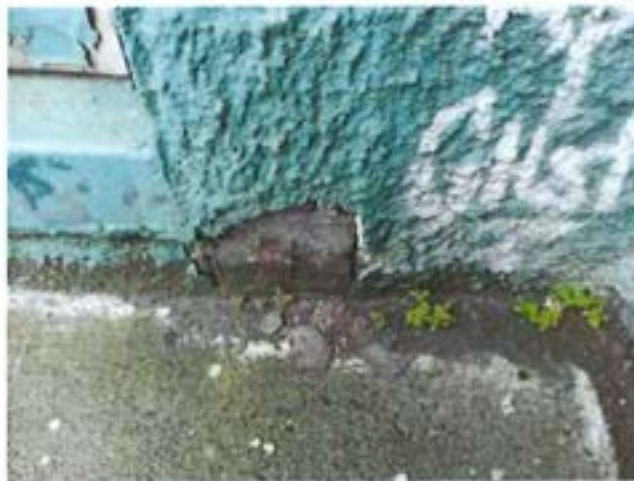
Photograph 37

- 5.14 The original building has older steel ties with circular bosses installed through the wall, assumed to be tied to the roof structure to provide some additional lateral strength.
- 5.15 It appears that the building was subject to further strengthening in the 1980's. External steel angle brackets are bolted to both the eastern and western elevations, along with two steel laced columns bolted to the western elevation. It is recommended that further clarification and advice is obtained in this regard prior to offer of purchase.
- 5.16 It appears that the original steel columns to the western elevation towards the southern end have been exposed at ground level for some as the plaster has deteriorated and failed as a result of moisture. These are severely corroded and delaminating and may require further investigation and comment.

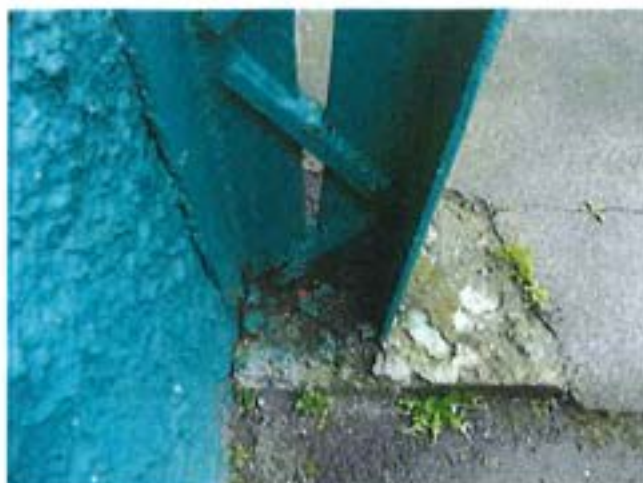
Photograph 42

- 5.19 The external wall to the north has been re-built with painted concrete masonry. As a result, the laced steel columns installed to this wall are now redundant and could be removed.

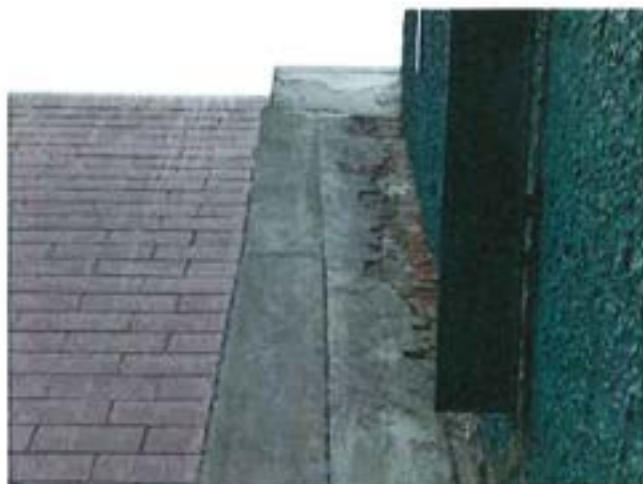
Photograph 44

- 5.20 The northern elevation was viewed from Jetty Street and via the side entrance. The solid brickwork is in bays between brick piers and appears to remain reasonably true to line, level and plumb.
- 5.21 The solid timber entrance doors are in poor condition with damp and mould growth to the bottom edge. These doors have also been subjected to graffiti. The windows above are cracked and the broken glazing should be removed to make this area safe. A lean-to roof has been removed at some time and the flashings remain however, should be removed with the areas of brickwork and / or plaster being made good.

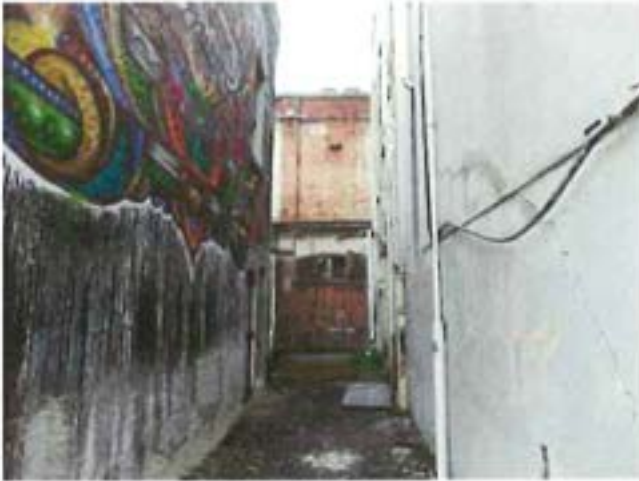
Photograph 46

- 5.22 The mortar pointing has failed or is deteriorating to the high level areas in particular at the parapet and these joints require raking out and re-pointing.
- 5.23 It is recommended that the mortar capping to the parapets on this elevation are removed, the brickwork and mortar pointing will also need to be checked, and a suitable metal parapet and gutter flashing should be installed to reduce the risks associated with moisture penetration to this wall.

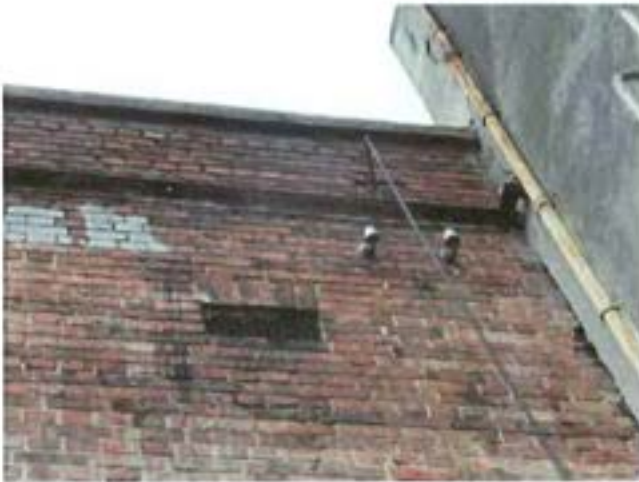
Photograph 48

- 5.24 There is cracking at the internal junction with the neighbouring property likely as a result of differential movement, which requires remedial works and suitably sealing.
- 5.25 The junction roof to wall junction with the neighbouring property to the north was viewed via ladder however views were limited. There is a metal cap flashing installed however this appears older and aged with areas of corrosion. Similarly, the steel angle bracket is corroded and requires further investigation, remedial works and suitably finishing with an anti-corrosion paint.

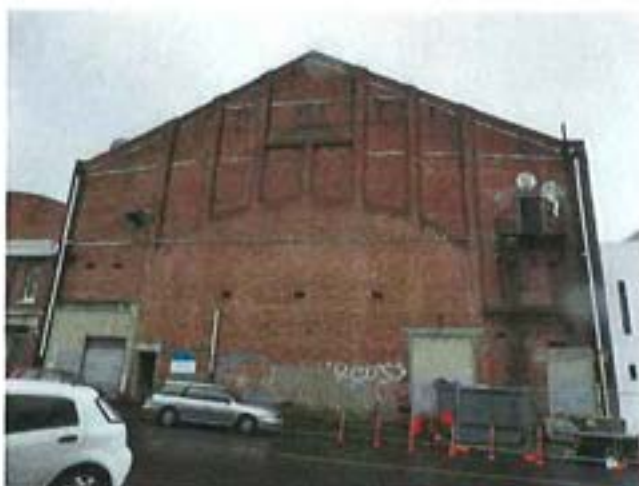
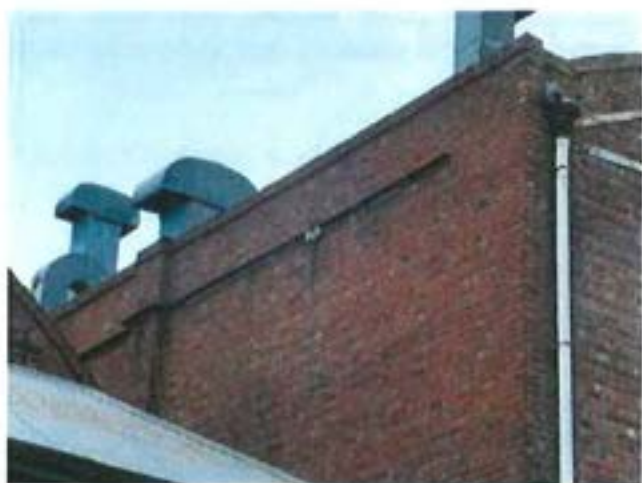
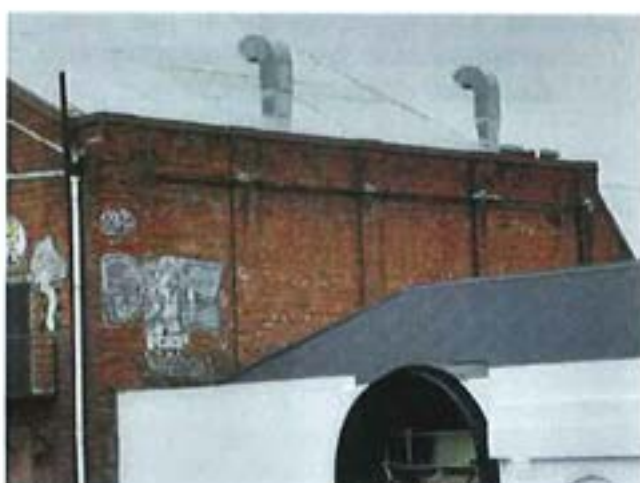
- 5.26 The eastern and upper elevations to the north and south are solid brick, with a decorative brick arch and pilasters to the high level. The wall appears true to line, level and plumb, with no significant movement or cracking noted at the time of inspection.
- 5.27 This elevation has been subject to some structural strengthening with the walls tied back to the roof framing for lateral support. The angle brackets are starting to corrode and would require careful inspection, suitably preparing and re-painting with an anti-corrosion paint system.
- 5.28 There are some areas of staining to the brickwork, in particular below the structural bosses, which would benefit from cleaning. The upper and lower levels have been subject to graffiti which could be removed.

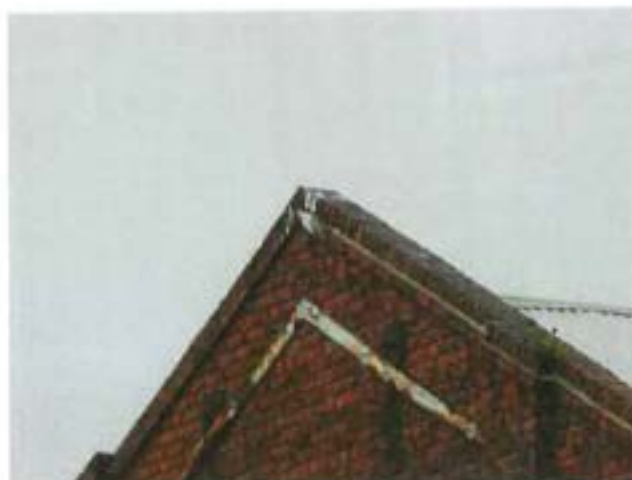
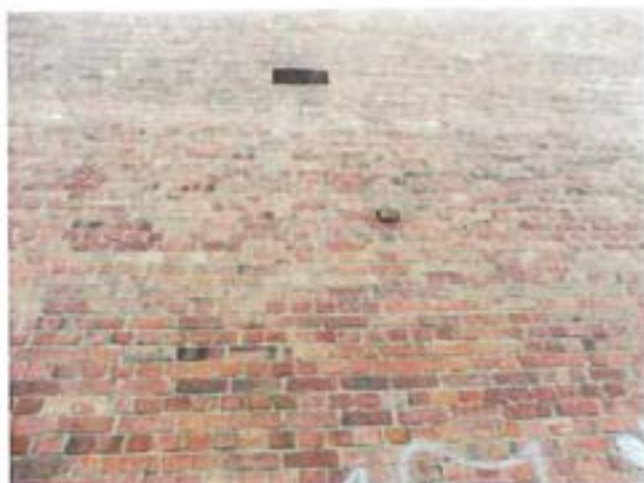
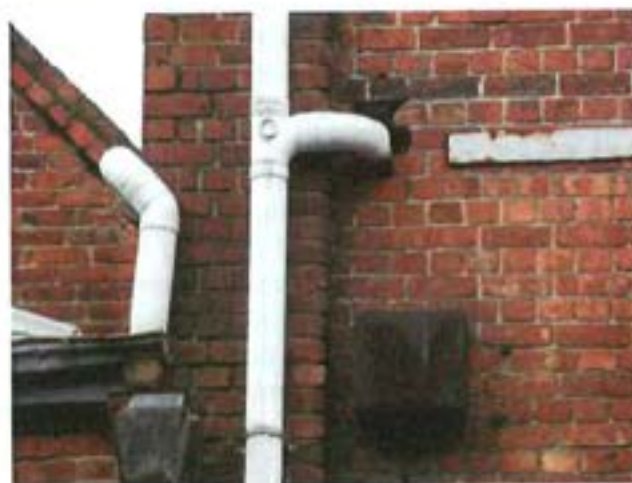
5.29 The parapets to the eastern elevation are constructed with bricks on edge and the mortar is aged and failing and would benefit from a suitable cap flashing being installed. Additionally, the vegetation growth should be removed.

5.30 There is a loose brick centrally on the eastern elevation which should be replaced and pointed. Additionally, the penetration for the rainwater downpipe to the southern side is poor and requires suitably sealing.

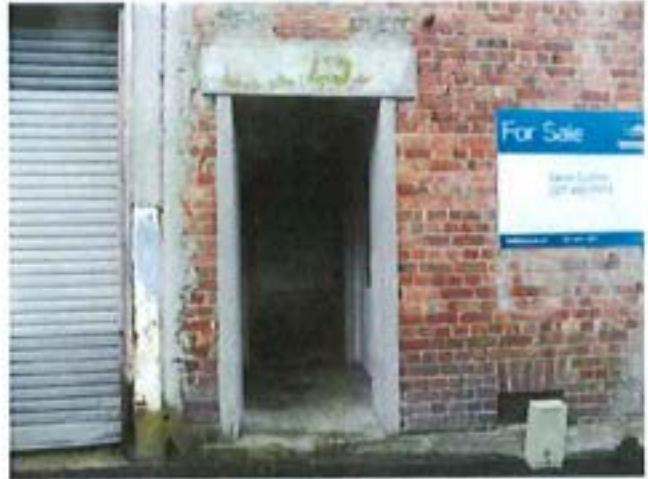
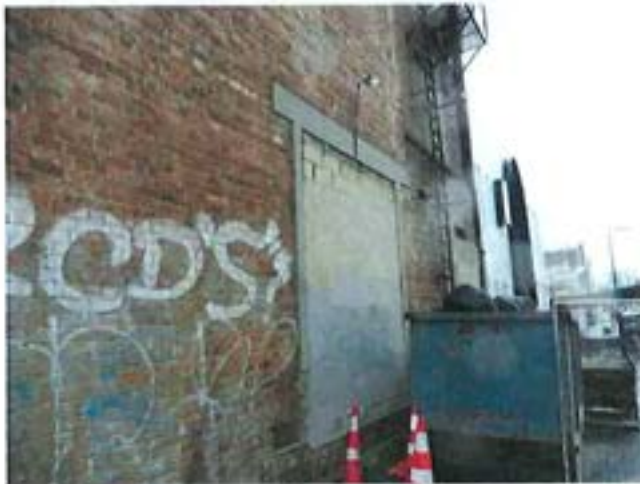
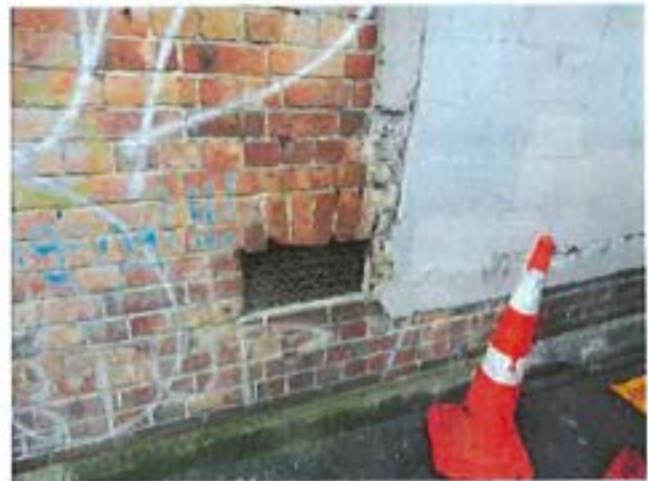
5.31 There are decorative metal ventilation grilles installed to the eastern and western elevations to allow some cross ventilation to the under floor and backstage areas. Being solid the external walls will not be insulated.

5.32 The original openings to the western elevation have been altered over time with unsympathetic concrete masonry infill panels installed. The plaster band surrounds have also been damaged over time.

5.33 The timber framing for the roller shutter door is in poor condition as a result of moisture and is mould stained and decayed.

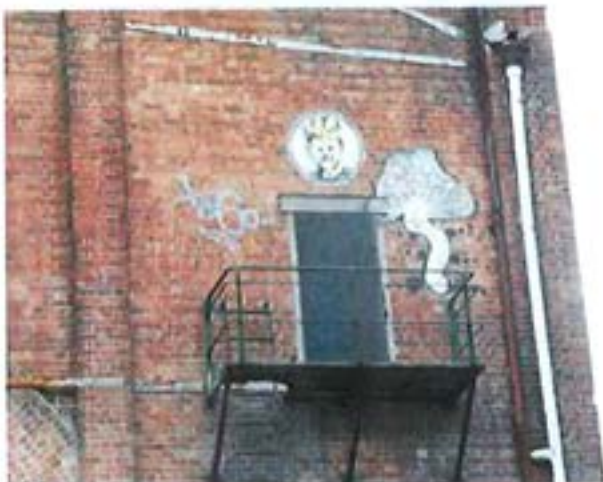
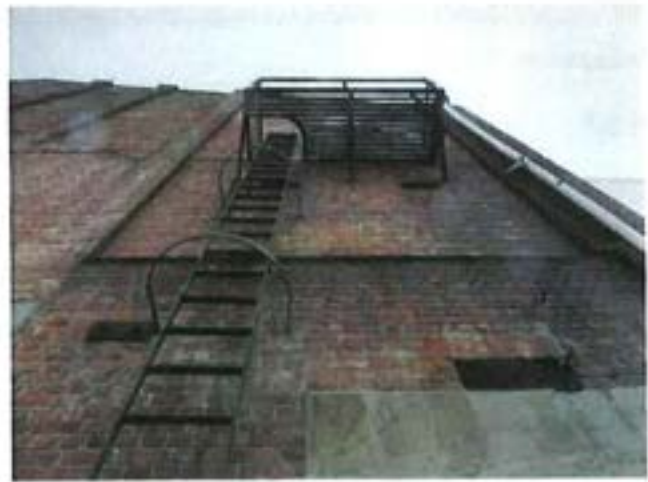
- 5.34 An exterior fire escape has been installed to the eastern elevation. The balcony and ladder was not accessed at the time of inspection however, appeared secure. This metal structure has some corrosion and should be suitably checked to ensure that it remains safe and fit for purpose. This will require ongoing monitoring, in particular at the fixing points through the brickwork.

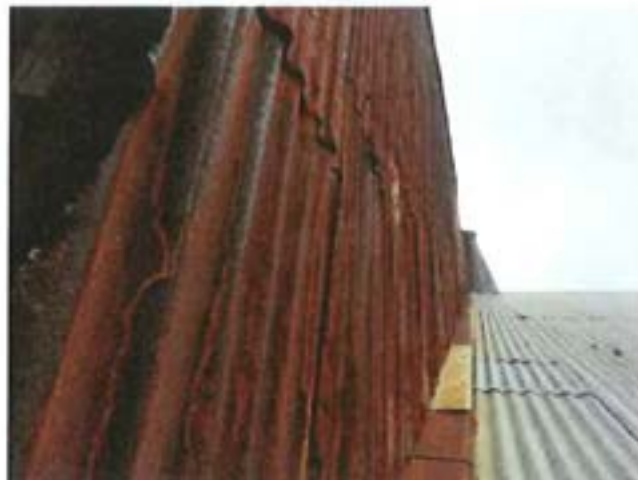
Photograph 65

- 5.35 The upper level wall to the western elevation above the roof is clad with a vertically hung corrugate profile metal sheet cladding, which is in poor condition and require replacement.

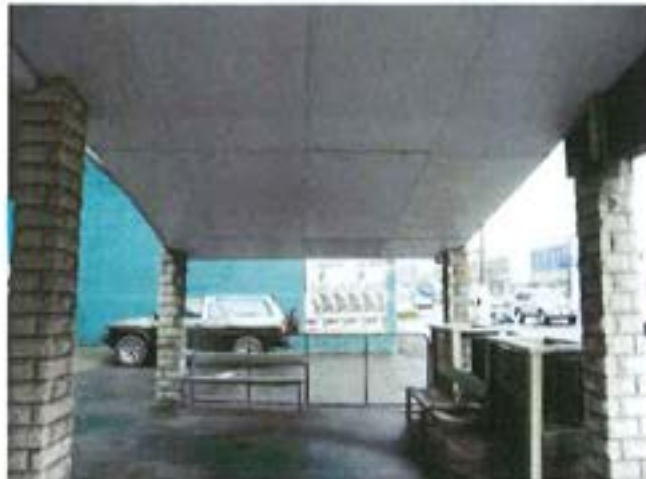
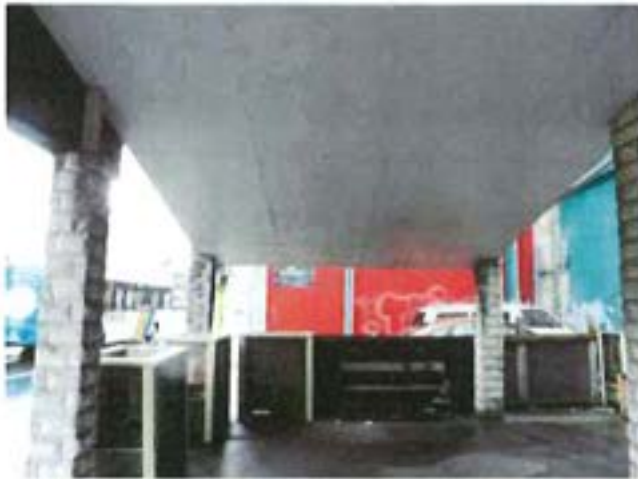
- 5.36 Based on the age of the property, it is possible that the fibre cement soffit boards may contain asbestos. There have been some previous patch repairs undertaken to the front entrance. Internally, there are fibre cement linings within the roof space which are likely to contain asbestos and these have cracked and broken in places.

- 5.37 It can be difficult to tell the difference between fibre cement and older asbestos cement. If there are concerns in this regard, then a sample could be sent for analysis. The only way to find out for sure if a material contains asbestos is to have it tested in an approved laboratory.
- 5.38 It is important to maintain a good waterproof or paint coating on all fibre-cement. Water entering fibre-cement can cause swelling, delamination and eventual failure of the material. If the boards are found to contain asbestos, then extra care should be taken with boards being removed by an experienced contractor.

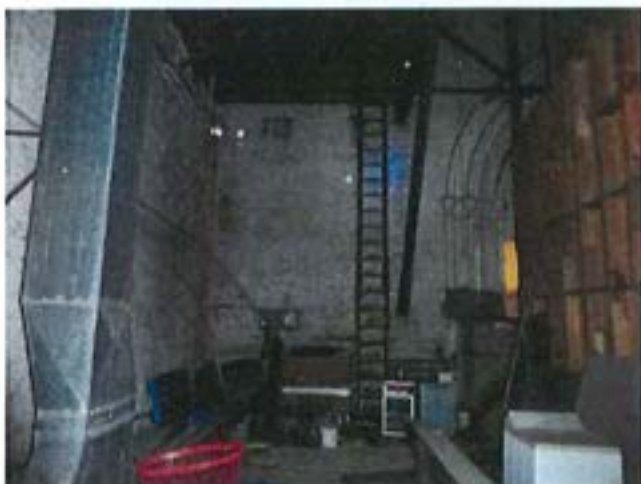
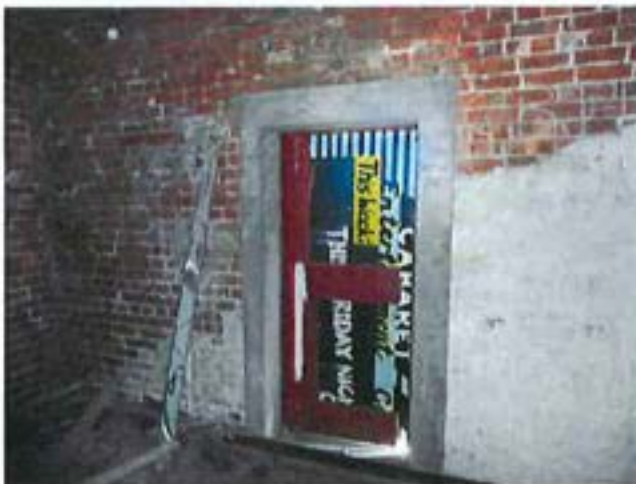
7.2 The upper fire escape door is broken and the opening has been boarded up.

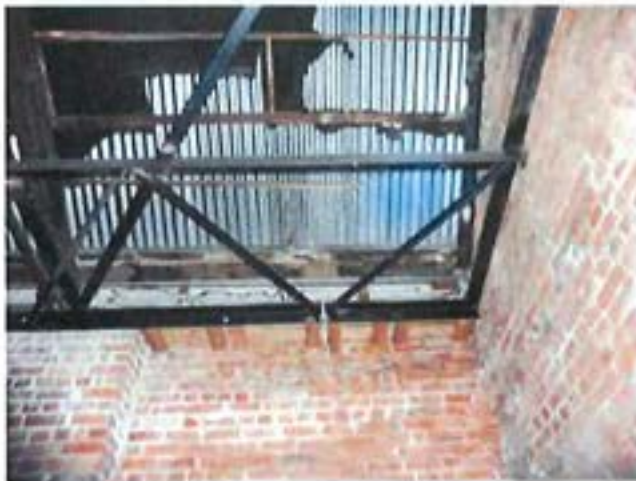
Photograph 81

7.3 The roof is constructed with engineered steel trusses, with timber purlins and a bituminous building paper is installed below, however has failed being ripped and torn.

7.4 The roof structure appears reasonable however, there is some moisture staining to the roofing timbers and to the hidden parapet gutters, which will require further investigation and monitoring. Additional steel bracing has been installed as part of the strengthening process and specialist comment may be required in this regard. Additional timber framing has been installed where ventilation ducting penetrates through the roof covering.

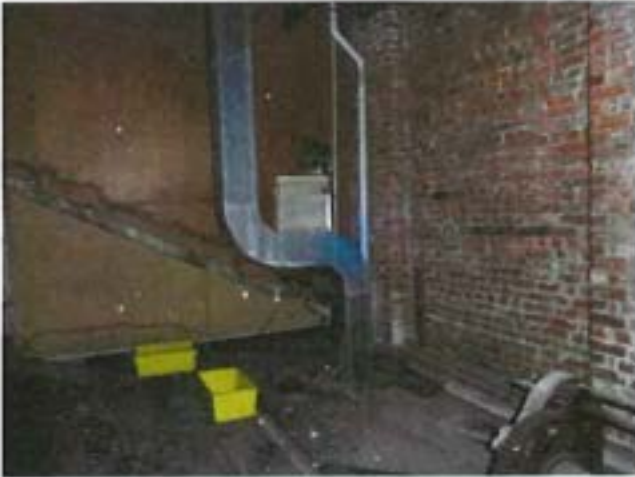
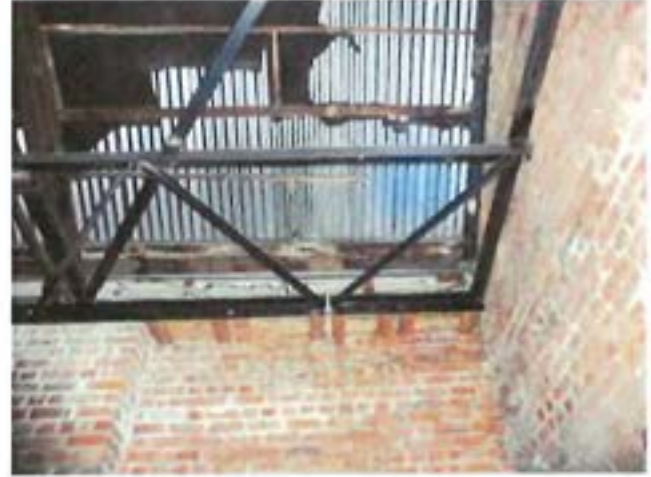
- 7.5 The linings to the rear of the western gable are moisture stained diagonally at the roof junction, which suggest that they are leaking and these require further investigation and remedial works. There are areas of moisture staining and decay to the floor boards on the platform which require remedial works to ensure that access is safe. Additionally, it would be recommended that suitable and robust handrails are installed to the platform access around the auditorium roof.

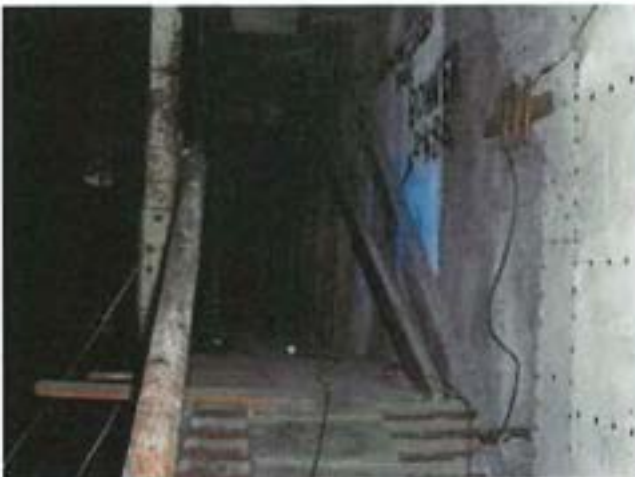
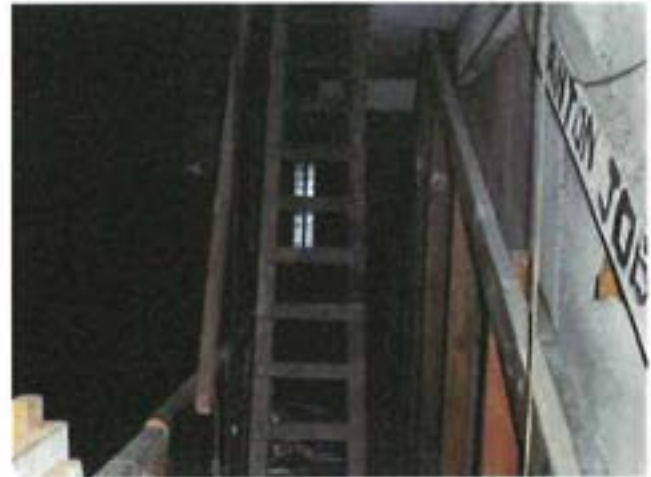
- 7.6 The wall to the west has been clad with a fibre cement sheet material which is likely to contain asbestos and this will require testing.
- 7.7 Access to the upper roof space is via a ramped platform and timber ladder. This requires updating to current best practice to ensure that the risk of working at heights is reduced and access is safe.

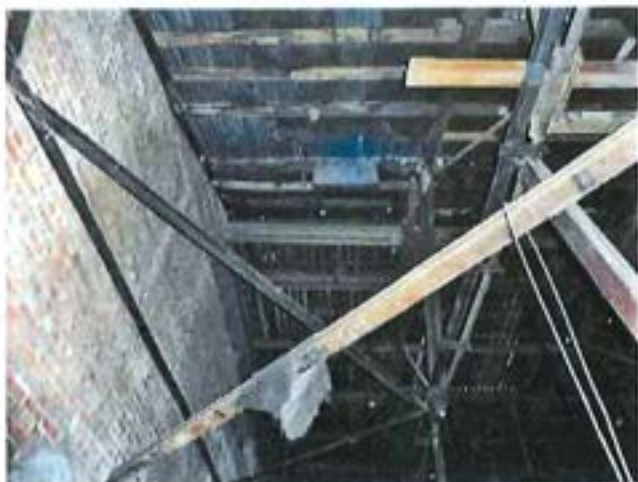
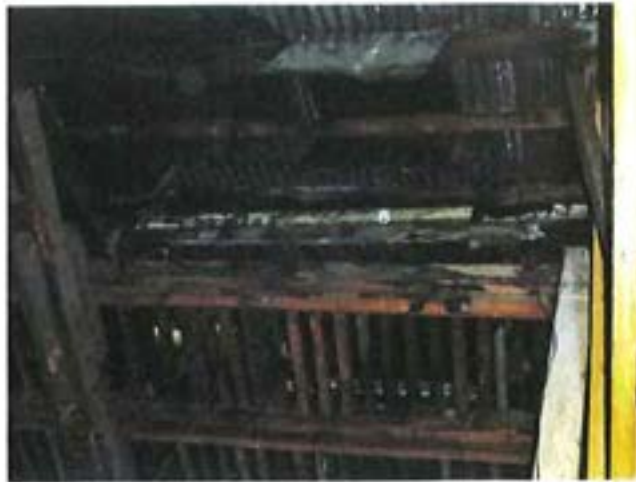
- 7.8 The upper roof timbers could not be adequately viewed as access was not considered to be safe. There are areas of moisture staining and these would require further investigation as there may be areas of deterioration and decay.
- 7.9 Any timbers that are built into the solid external walls will likely have suffered as result of moisture and should be checked to ensure that there is no decay and that they remain structurally sound.

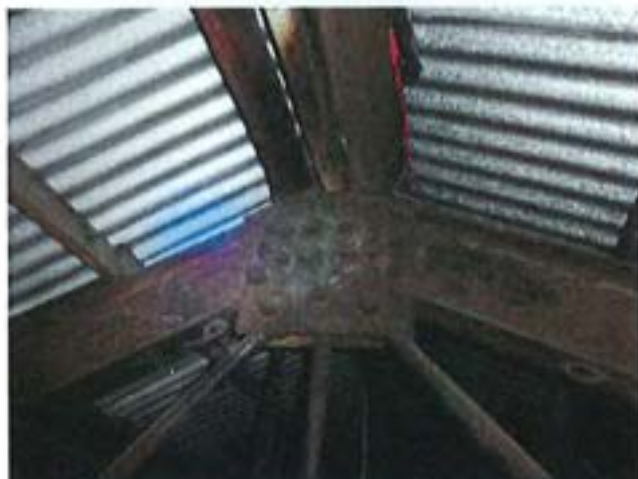
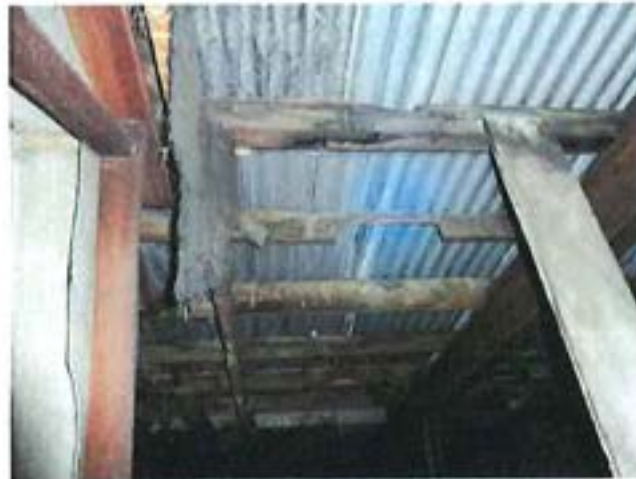
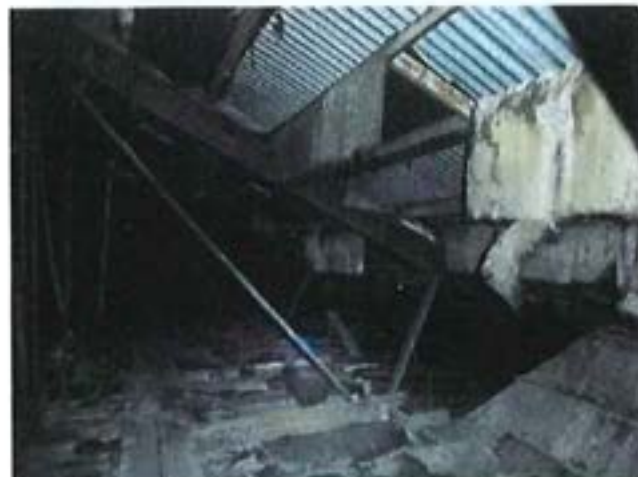
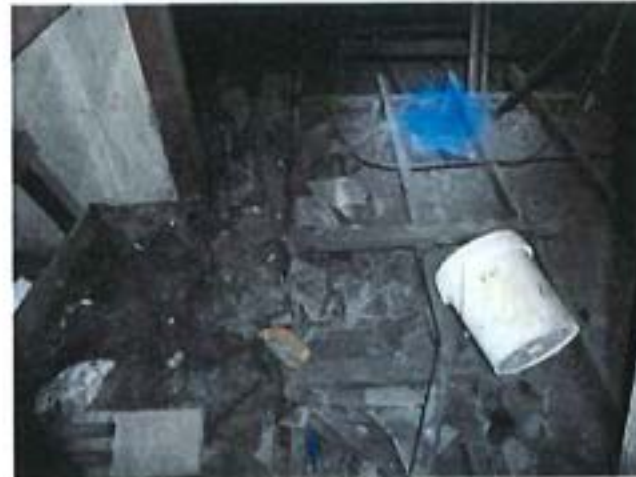
- 7.10 There was limited access into the upper roof space and there was also broken asbestos fibre cement sheets to the entrance. From the limited views it was established that the structure is engineered steel trusses. One of the timber purlins viewed has been cut and should be strengthened and the majority of the timbers appeared moisture stained with failed, ripped and torn building paper.

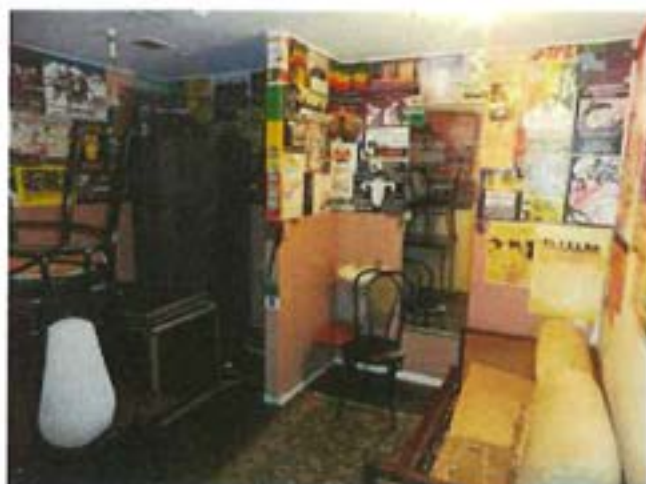
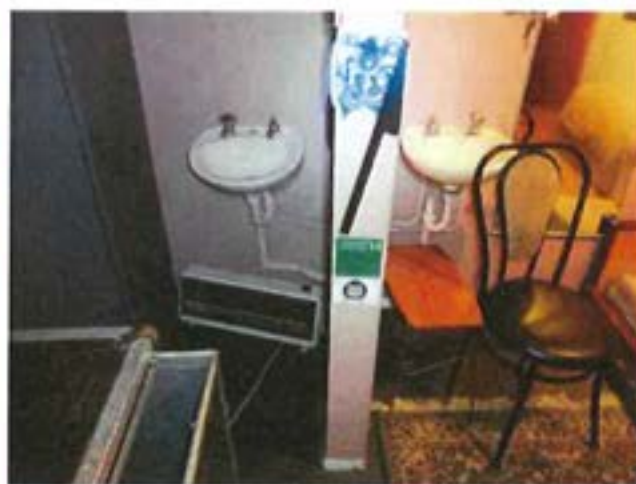
- 8.4 The wash hand basin to the artists changing room requires re-fixing to the wall. The cold tap handles have been removed from both basins. The low level electric heater requires re-fixing to the wall and further investigation to see if it's safe and operable.

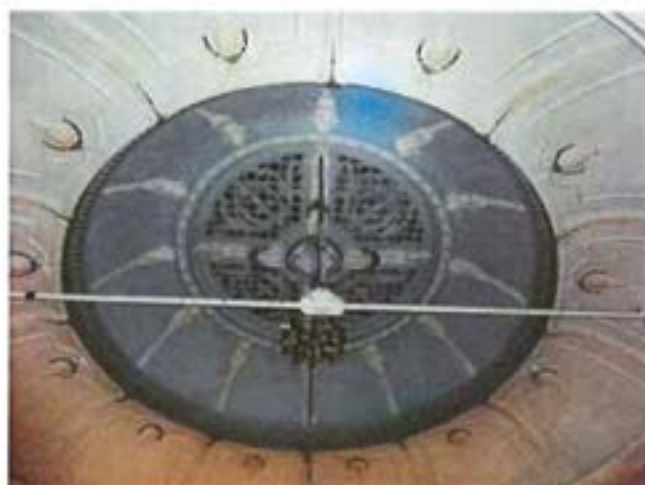
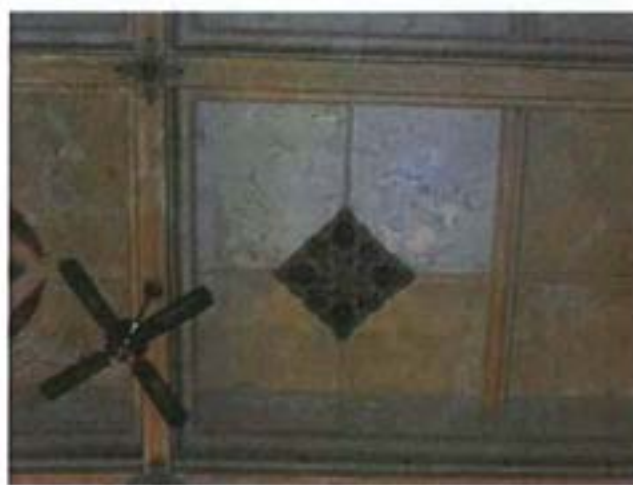
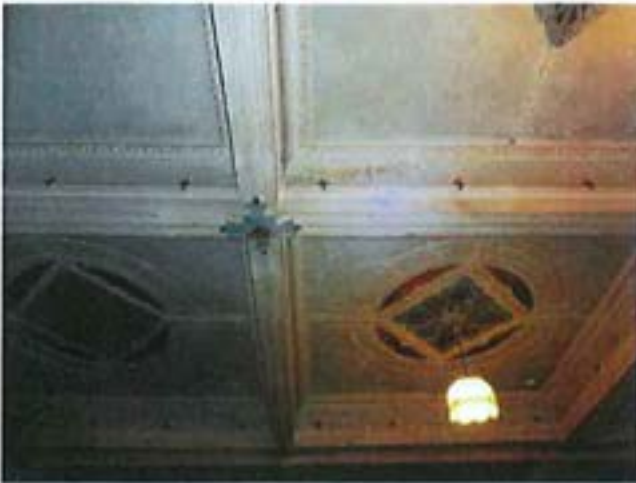
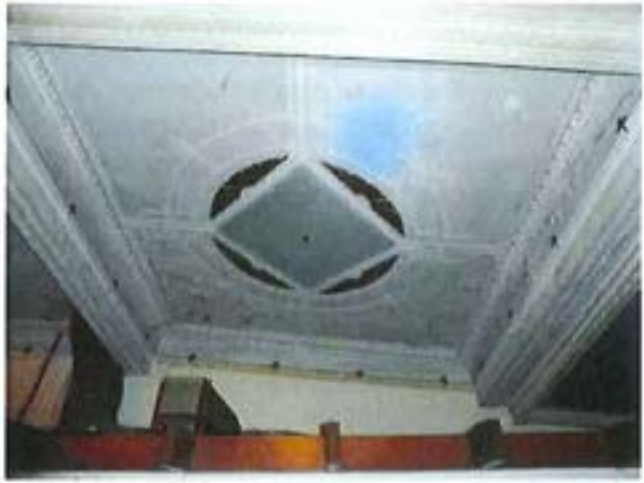
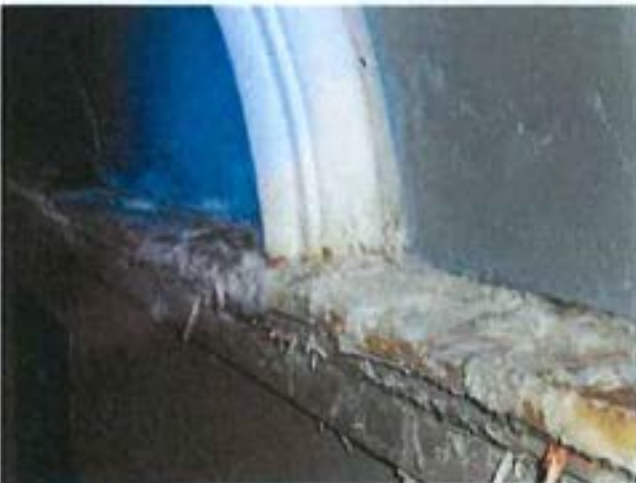
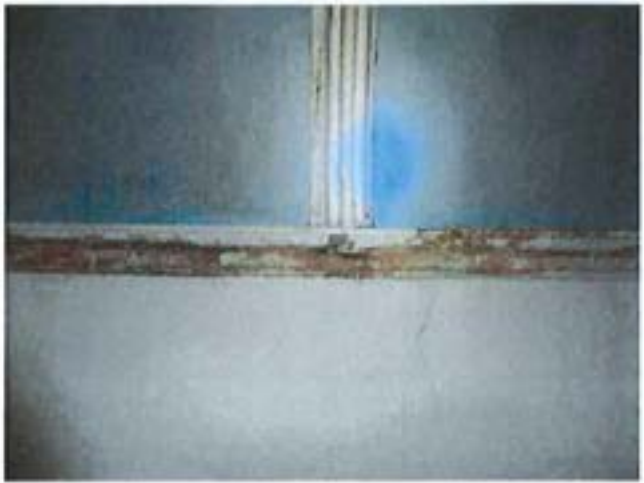
- 8.5 The ceilings throughout the property are decorative moulded fibrous plaster, custom wood, plasterboard, hard board, with soft board ceiling tiles above the stage and all appear in reasonable to average condition and decorative order.
- 8.6 There are numerous areas of aged and flaking paint to the decorative plaster ceilings. There is damage to the decorative mouldings along the southern wall in particular, which is likely as a result of moisture penetration and these will require remedial / restorative works.
- 8.7 Electric ceiling fans are installed and suspended from the main ceilings, with hub-mounted rotating paddles to circulate air. This were not tested for operation at the time of inspection.

- 8.8 There is a current leak through the ceiling above the stairs in the kitchen which requires further investigation and remedial works.

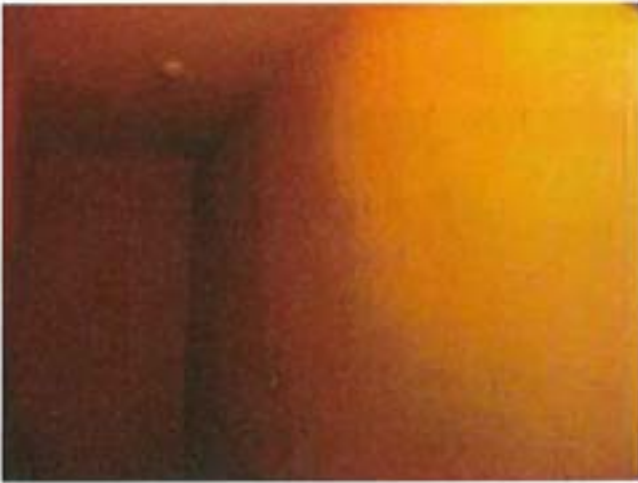
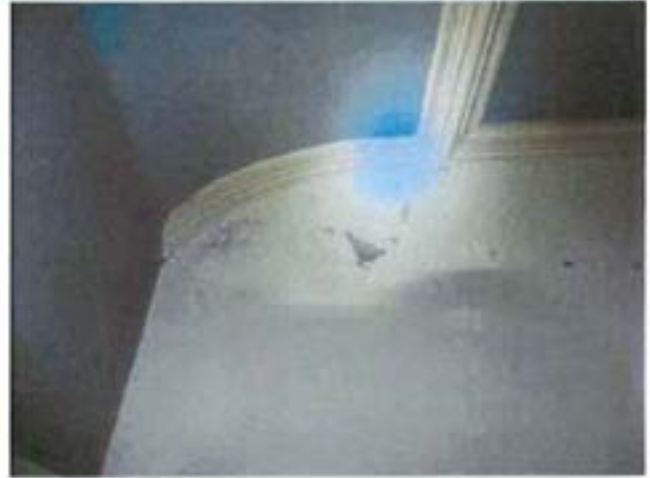
- 8.10 Internal walls and partitions are generally believed to be solid plaster, custom wood timber panelling, 'seratone' water resistant linings to wet rooms and appear in reasonable to average condition being aged with damage according with general wear and tear due to the usage of the venue. The wall linings throughout would benefit from re-decoration and remedial works where required.
- 8.11 There is evidence of paint and plaster failure to the interior of the external walls, which is likely as a result of moisture penetration. There is some random cracking to the plaster at the north western corner of the property These areas will require monitoring and may need further investigation.

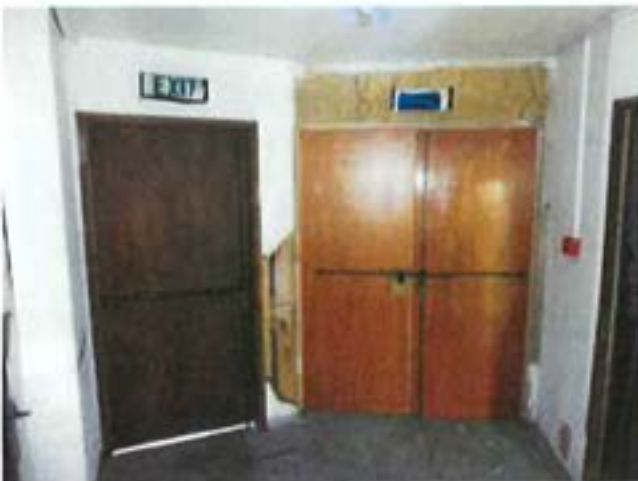
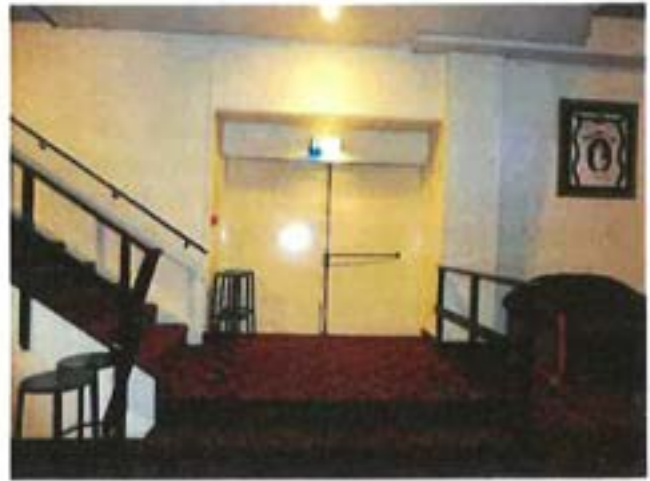
- 8.12 Skirtings, cornices, architraves, doors and doorframes all appeared in reasonable to average condition and decorative order. There are a number of internal doors which have sustained damage over time and would benefit from replacement. The fire exit doors were difficult to open and close and require easing and adjusting.
