# CONDITION REPORT

SAMMY'S ENTERTAINMENT VENUE,  
65 CRAWFORD STREET, DUNEDIN.

- Report commissioned by:** Feldspar – David Booth
- Report and site inspection undertaken by:** Grant Parker MSc Arch MNZIBS  
Registered Building Surveyor

- Date of Inspection:** Monday 26<sup>th</sup> September 2016 @ 9:00 am & 3:00 pm
- Other persons present:** The Current Owner, Agent, Fire Engineer and Valuer

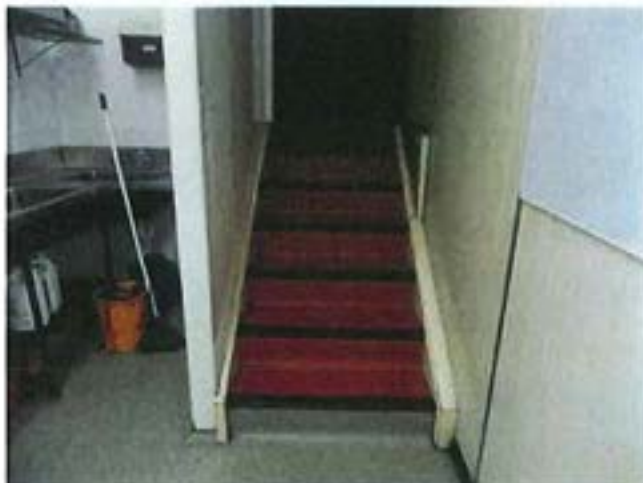
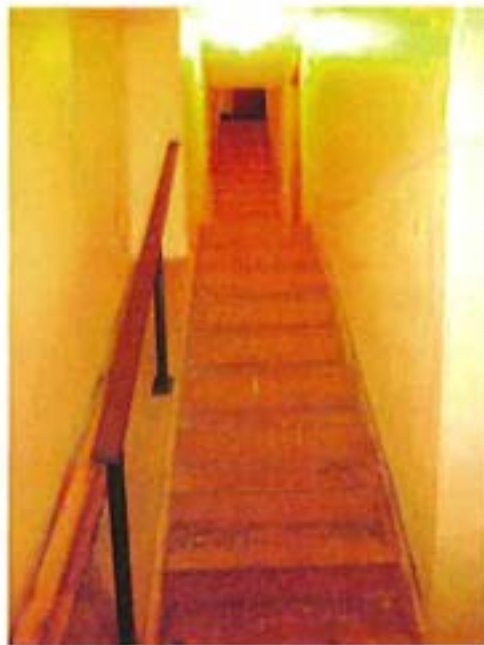
- 8.13 There are a number of public, private and fire egress stairs at the property. The public stairs to the gallery remain in reasonable condition, with no obvious or significant movement or deterioration. There is a timber handrail to the stairs and the balcony, which was secure at the time of inspection.
- 8.14 Regular checks should be made to establish that all stair treads and nosings are properly maintained in a firm condition and that stair and other carpeting is safe.

- 8.15 The barrier to the gallery is not considered to be safe by current standards and it is recommended that a suitable barrier is installed in accordance with current best practice to prevent accidents from falling.

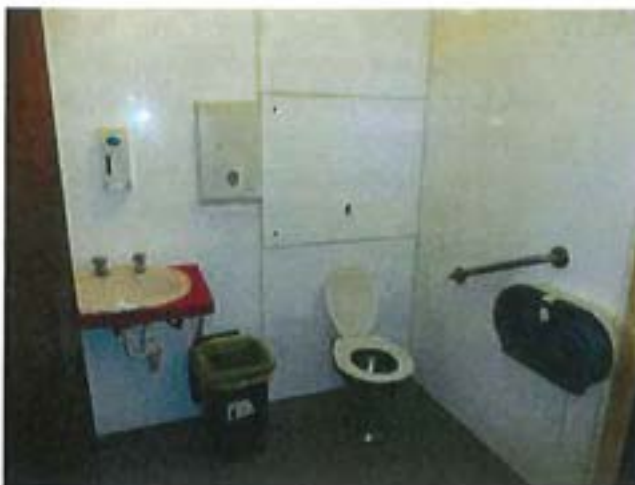
Photograph 136

8.20 Decor appears reasonable to the floor, walls and ceiling. This space generally contains the following fixtures and fittings:

- A ceramic WC with single flush hidden cistern, plastic seat and flap, with wall mounted grab rail
- A wall mounted toilet roll dispenser
- A wall mounted wash hand basin with separate hot and cold taps
- Wall mounted soap and paper towel dispensers
- Ceiling mounted extractor fan.

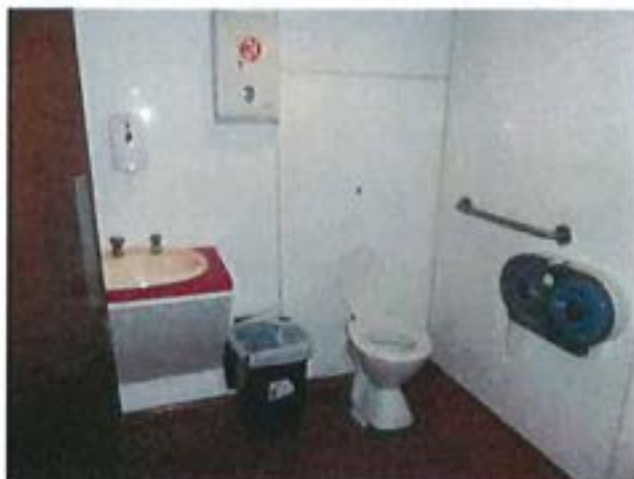
Photograph 137

8.21 The vent cover to the ceiling mounted extractor fan is missing and requires replacement.

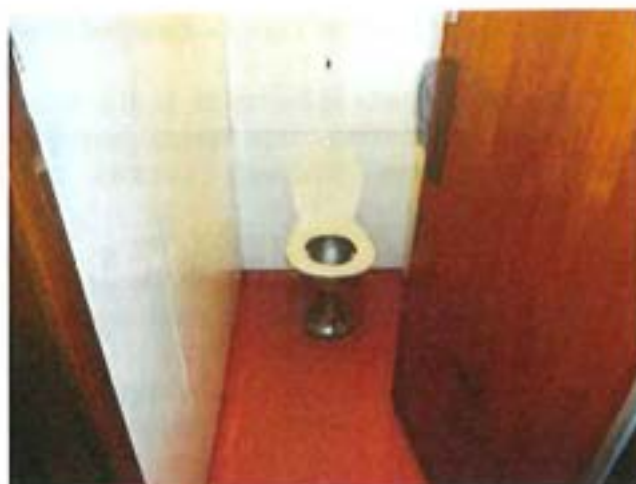
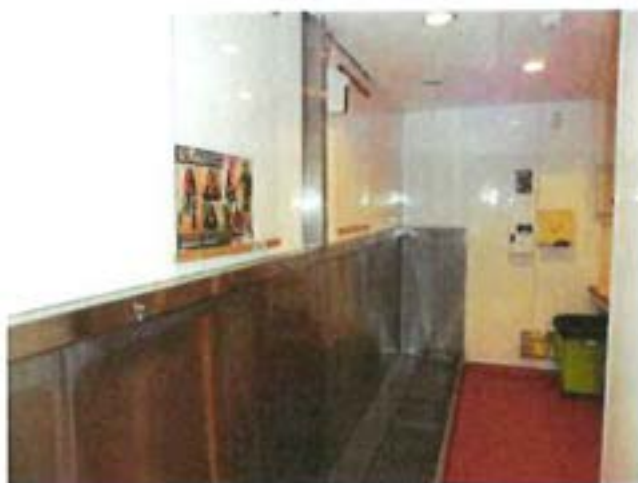
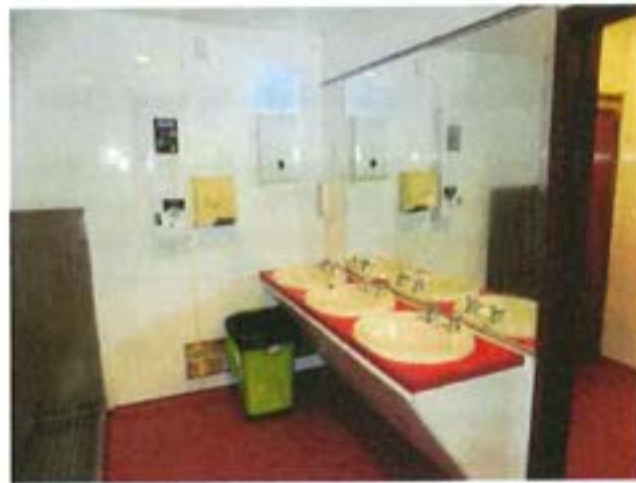
- A separate cubicle with stainless steel WC, single flush hidden cistern, plastic seat and flap. The flush is broken and requires replacement
- A wall mounted toilet roll dispenser
- A stainless steel urinal
- Three (3) inset wash hand basins with separate hot and cold taps and wall mounted mirror above
- Wall mounted soap and paper towel dispensers, with hand dryer
- Ceiling mounted extractor fan.

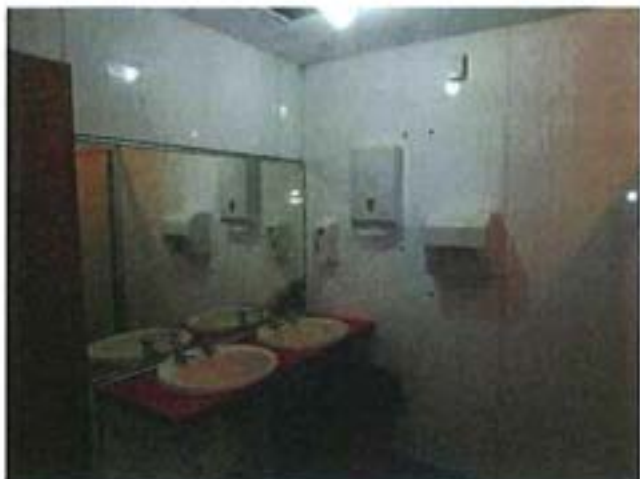
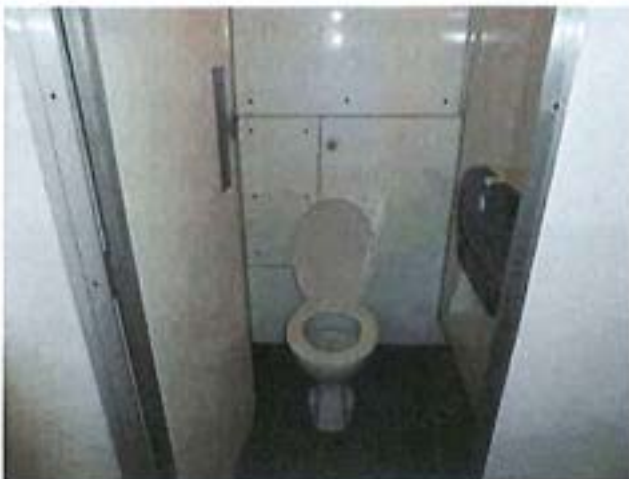
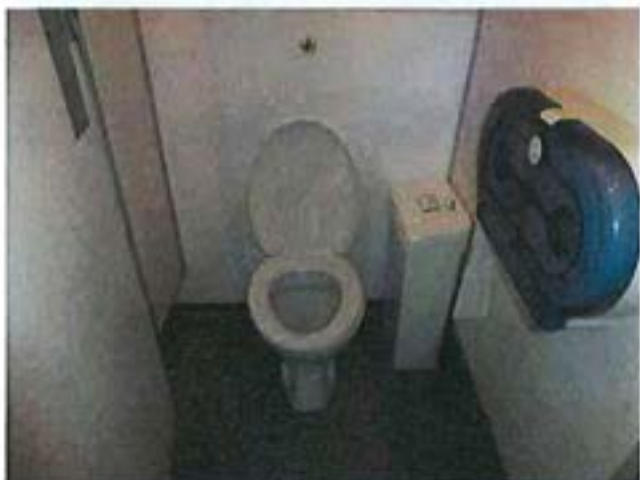
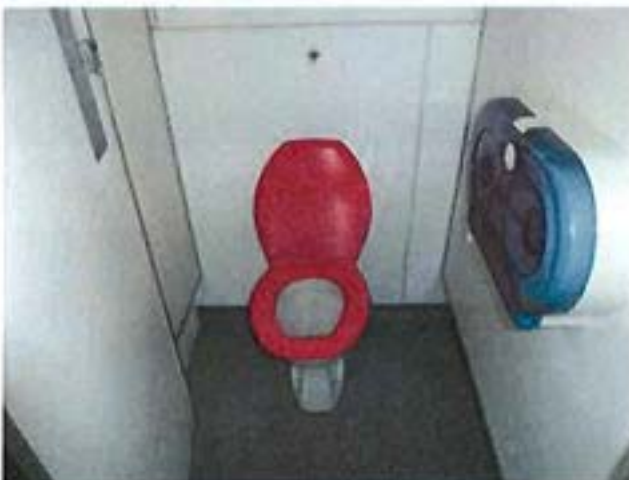
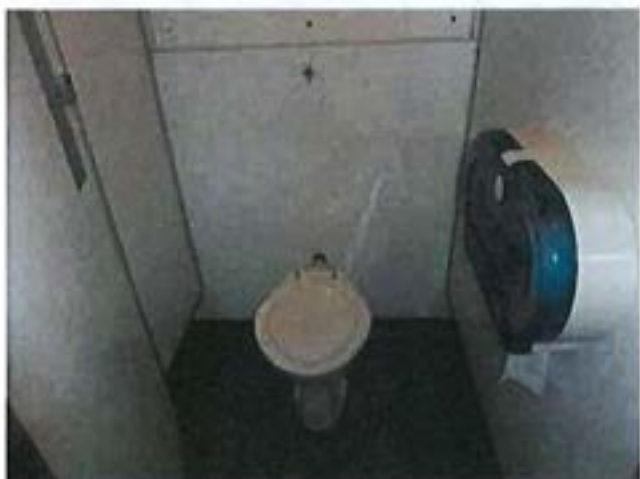
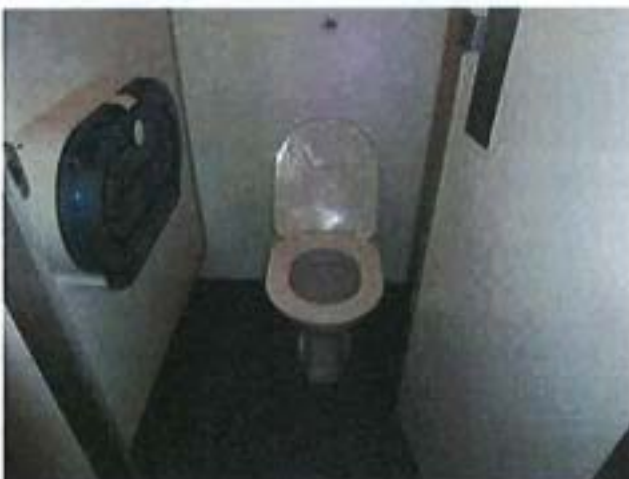
- 8.23 Decor appears reasonable to the floor, walls and ceiling. This space generally contains the following fixtures and fittings:
- Five cubicles with ceramic WC's, with single flush hidden cisterns, plastic seats and flaps; and toilet roll dispensers. The flushes were not easily operated and require adjusting
  - Two (2) inset wash hand basins with separate hot and cold taps and wall mounted mirror above
  - Ceiling mounted extractor fan.
- 8.24 One of the light fittings is broken and requires replacement.

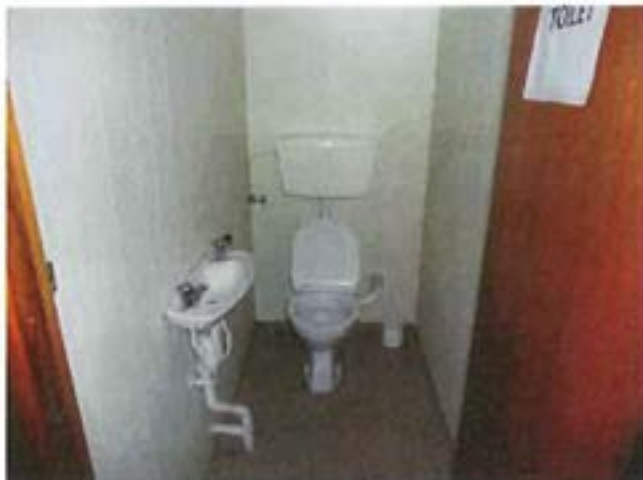
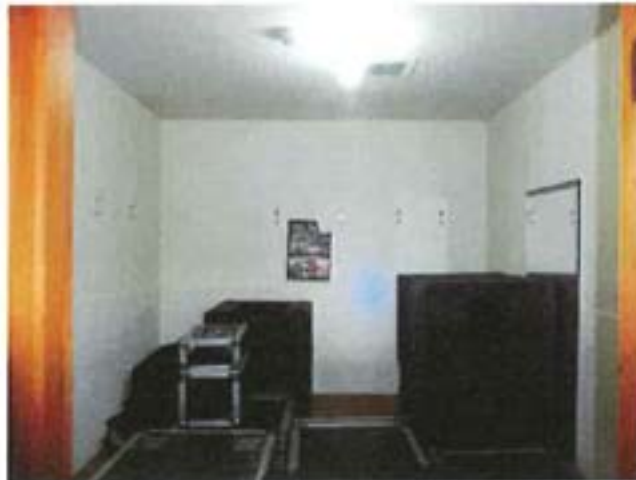
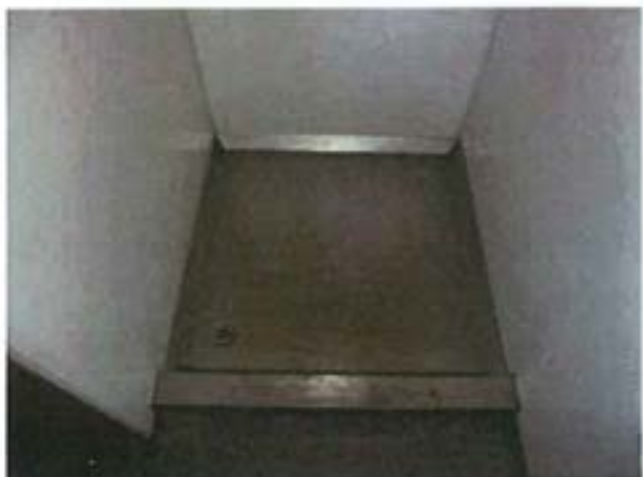
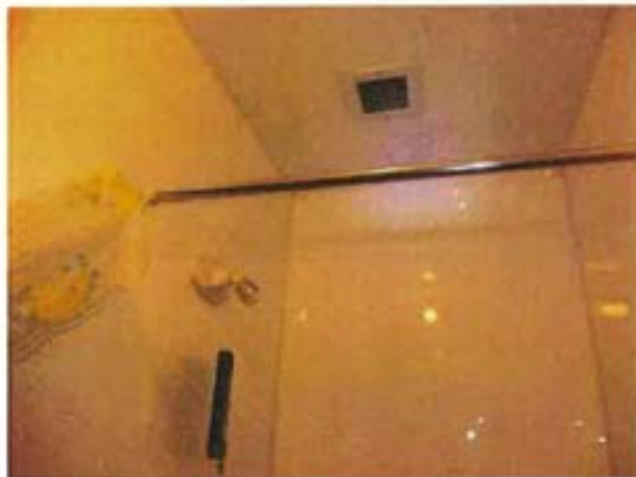
- A separate shower cubicle with stainless steel tray and fixed shower rose and mixer. This was difficult to operate
- A ceramic WC, single flush low-level cistern, plastic seat and flap
- A wall mounted wash hand basin with separate hot and cold taps
- Ceiling mounted extractor fan.

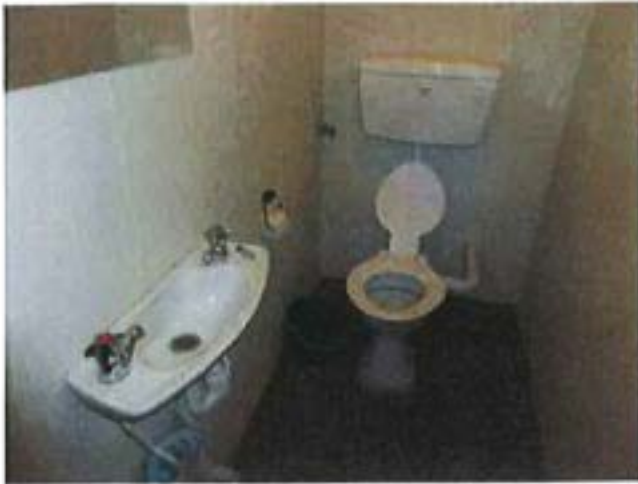
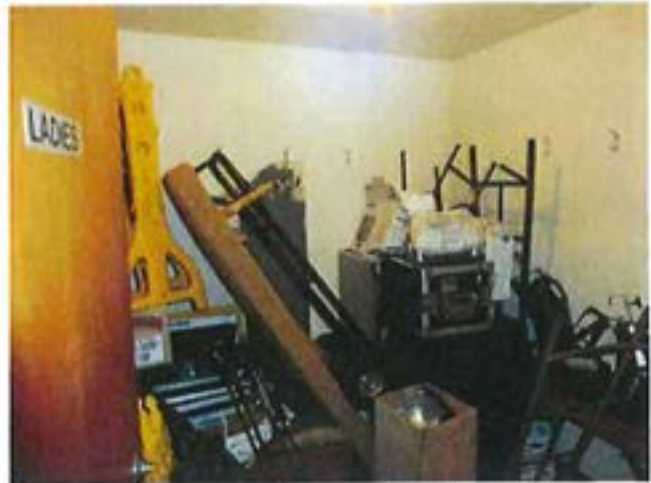
8.26 Decor appears reasonable to average to the floor, walls and ceiling. This space generally contains the following fixtures and fittings:

- A ceramic WC, single flush low-level cistern, plastic seat and flap
- A wall mounted wash hand basin with separate hot and cold taps
- Ceiling mounted extractor fan.

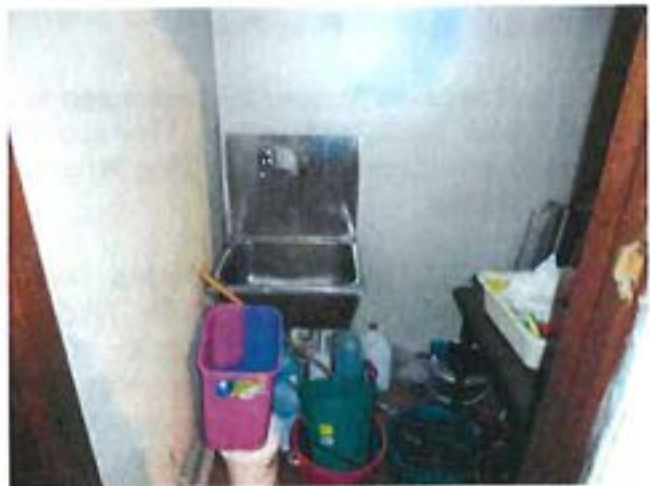
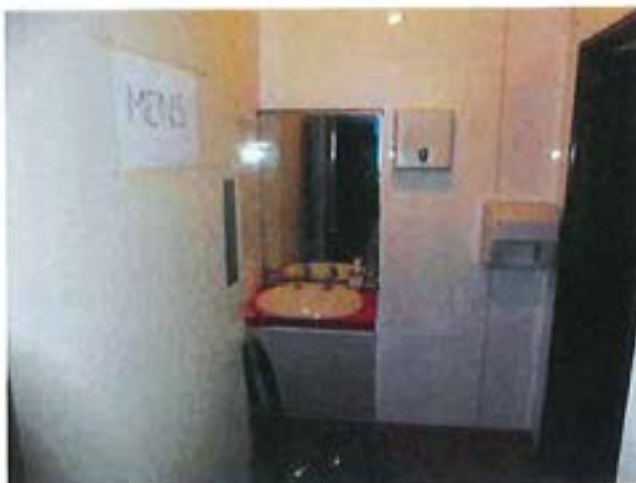
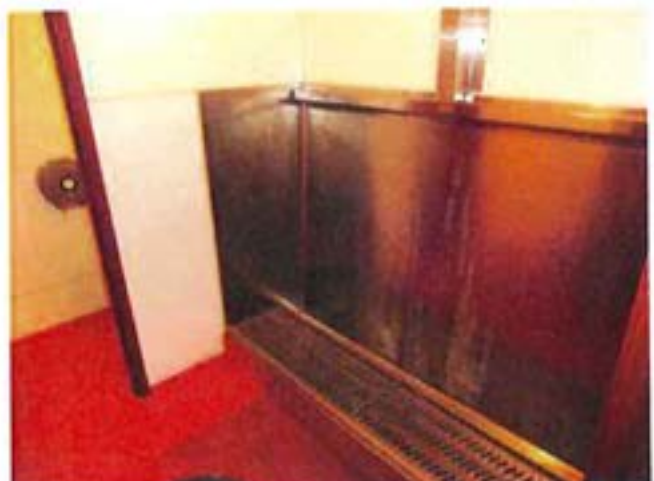
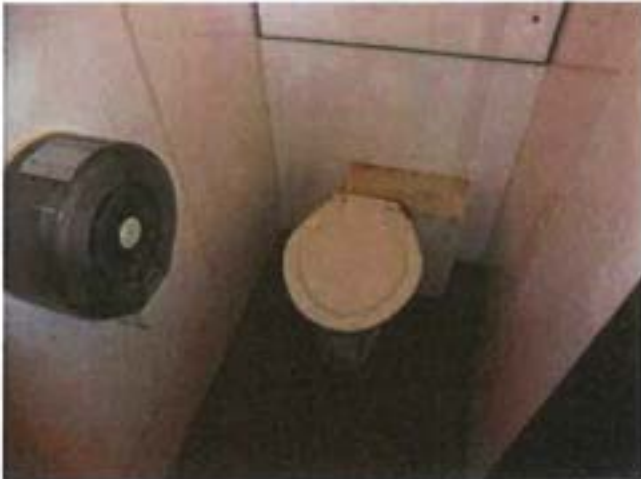
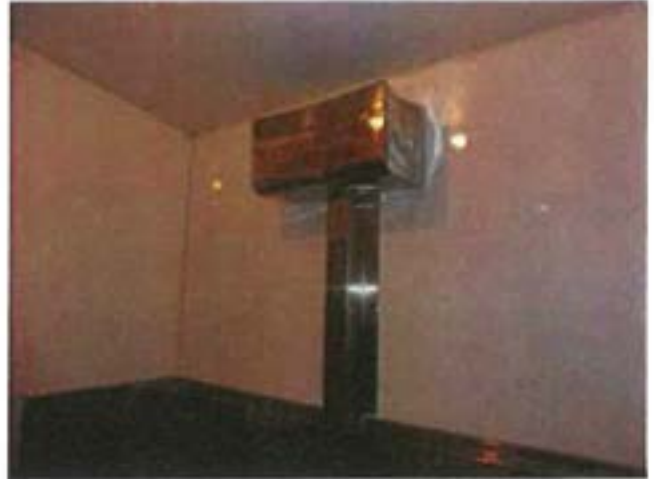
- A separate cubicle with ceramic WC, single flush hidden cistern, plastic seat and flap.
- A wall mounted toilet roll dispenser
- A stainless steel urinal and cistern. The cistern is dented.
- A wash hand basin with separate hot and cold taps and wall mounted mirror above
- Wall mounted soap and paper towel dispensers, with hand dryer
- Ceiling mounted extractor fan.

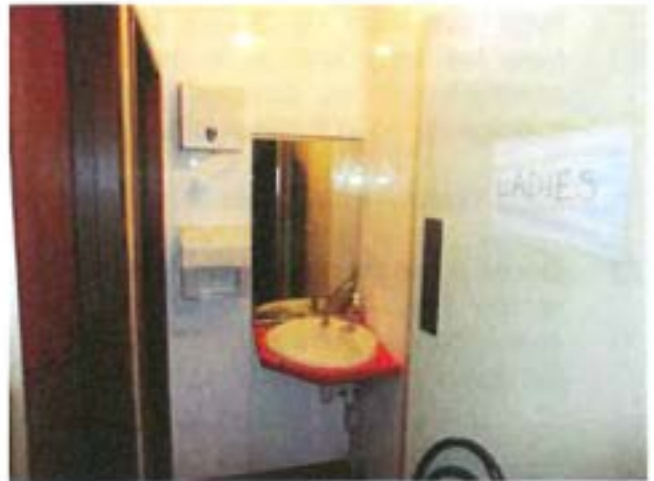
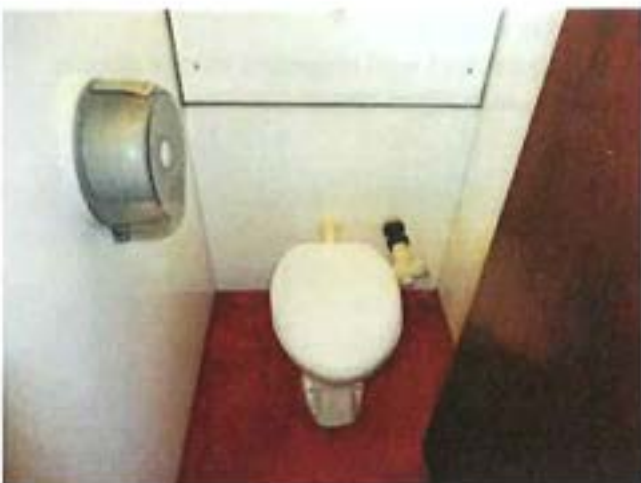
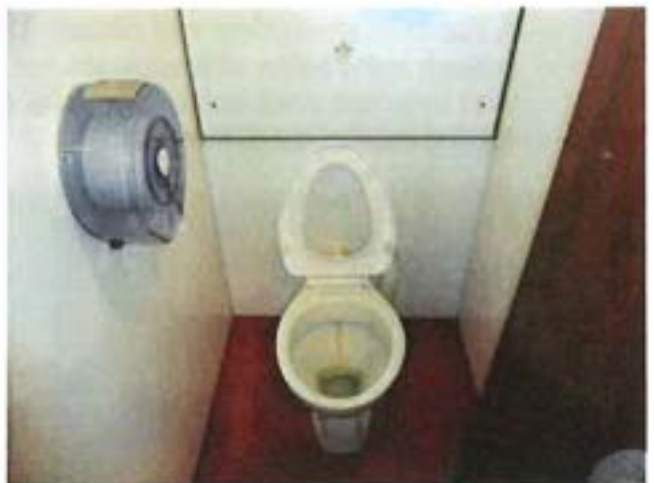
8.28 Decor appears reasonable to average to the floor, walls and ceiling. This space generally contains the following fixtures and fittings:

- Two (2) separate cubicles with ceramic WCs, single flush hidden cistern, plastic seats and flaps
- Wall mounted toilet roll dispensers
- A wash hand basin with separate hot and cold taps and wall mounted mirror above
- Wall mounted soap and paper towel dispensers, with hand dryer.

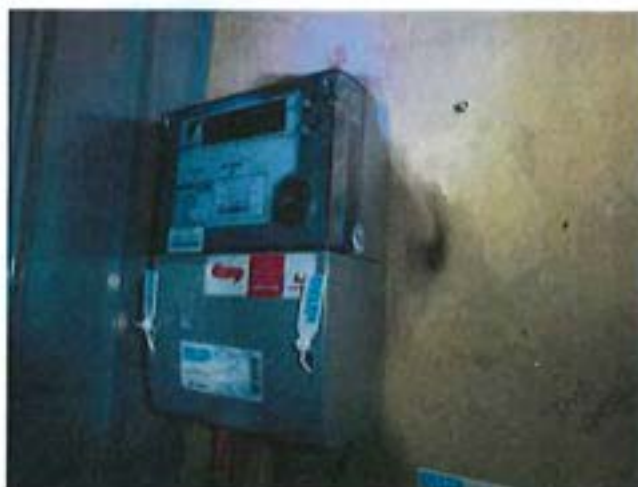
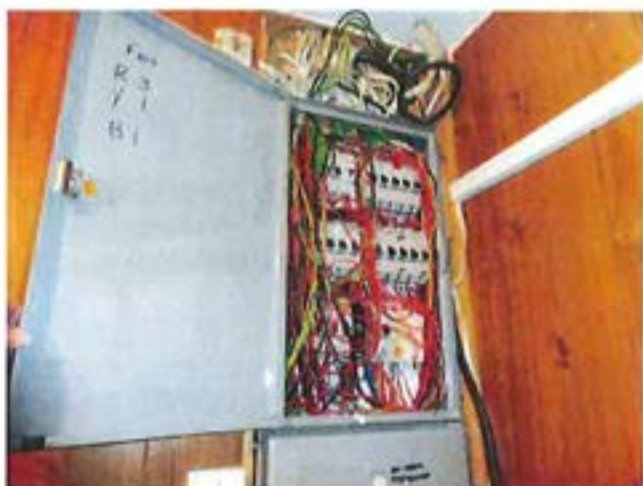
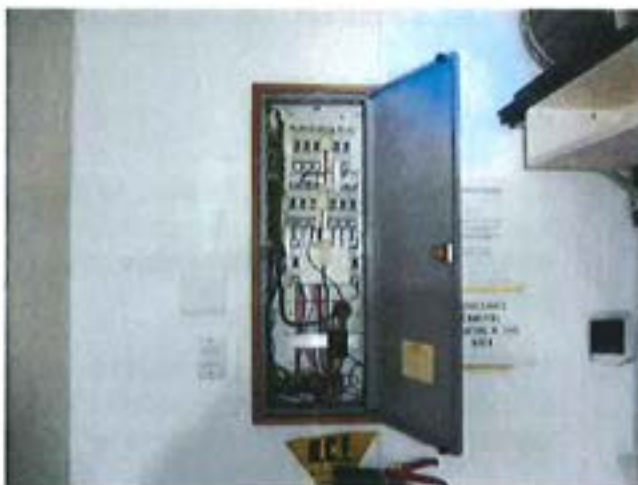
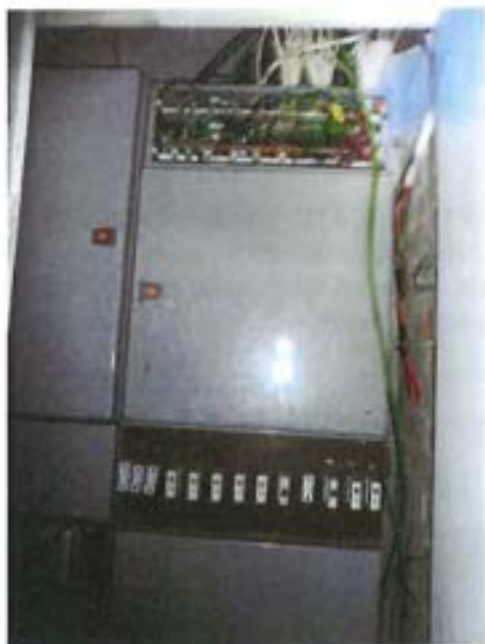
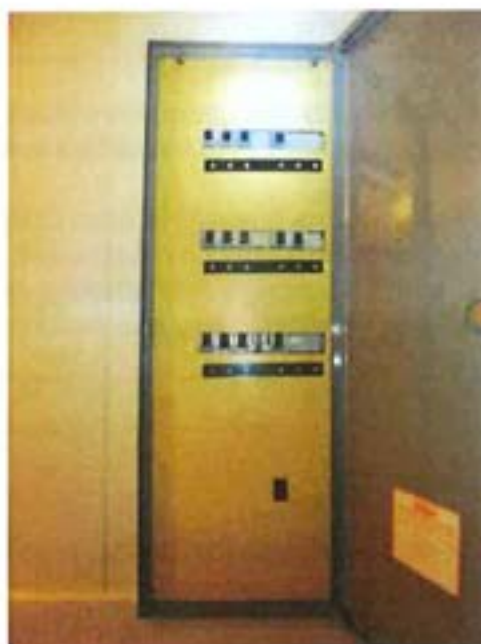
- 10.1 Electrical reticulation to the property is believed to be via underground cables which enter the property on the south eastern elevation on Vogel Street. The mains electrical meter is housed within a metal box in the south eastern store room. This is a three-phase advanced meter with LCD display, which provides remote automated readings from the property. The mains electrical distribution board is in the same cupboard and there are various sub boards installed around the property

- 10.2 An electrical certificate of compliance (COC) / electrical safety certificate (ESC) should have been issued for any more recent works to ensure that the work meets the Electrical Safety Regulations. These records, if available, should be requested from the current owner.
- 10.3 If there are any concerns in regard to the electrical installation, then a full electrical report should be commissioned. It is recommended that the electrical installation is checked regularly in accordance with the Electricity Company's recommendations at least once in every 5 years to confirm that there is no deterioration in either the cables or fittings and that it is in good condition. If defects occur, they should be corrected immediately by a qualified electrician. Do not make any alteration to the electrical wiring without qualified advice.

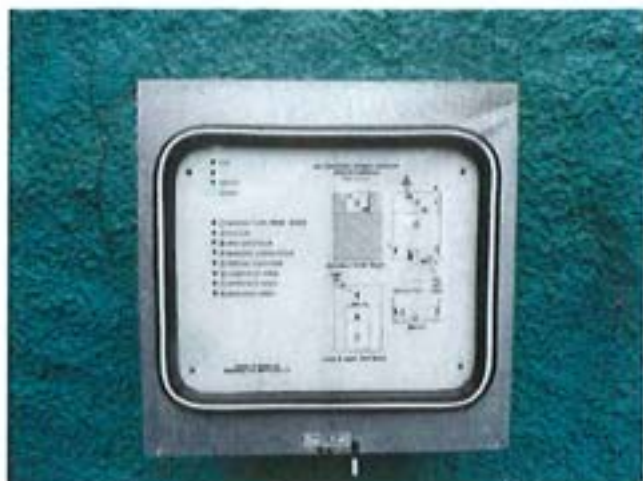
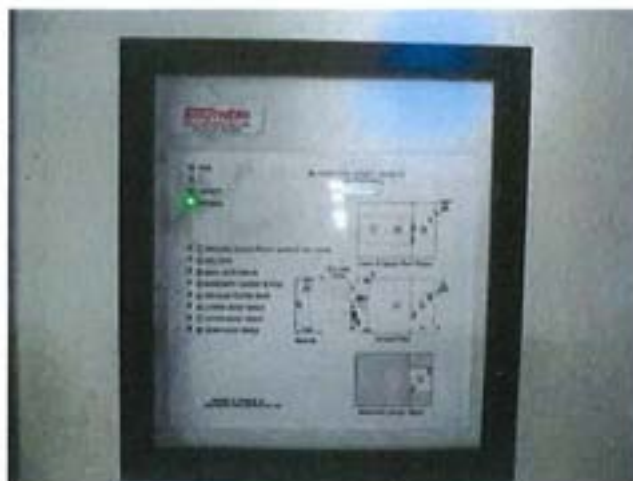
- 10.1 A fire alarm system is installed to the property, with the external control panel installed to the western elevation and an internal panel in the entrance hallway. The current owner should have records of all inspections and maintenance and any repairs undertaken in the previous 24 months.
- 10.2 The compliance schedule should be available for your perusal, which should record details of the fire alarm warning system including smoke detectors and emergency lighting and signs. This system was not tested for operation at the time of inspection.

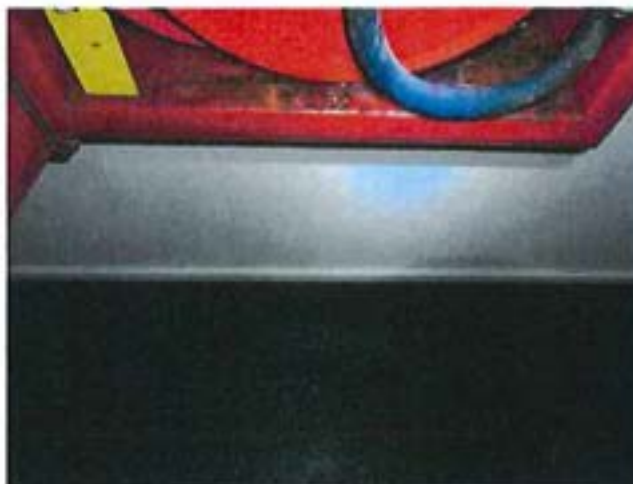
Photograph 169

- 10.4 The fire hose reel to the upper balcony is currently leaking and requires immediate attention.

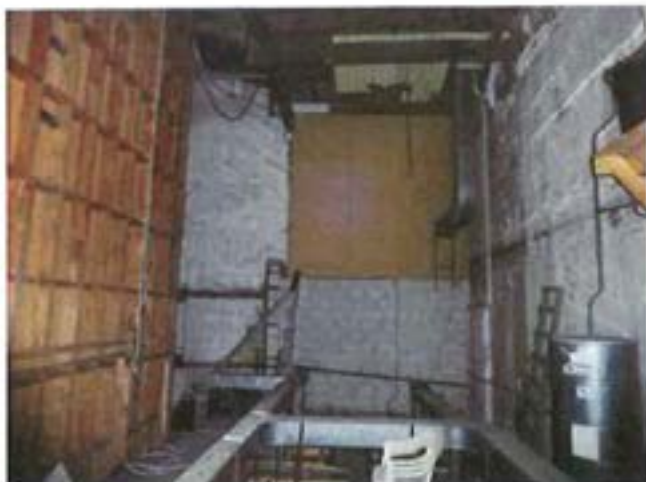
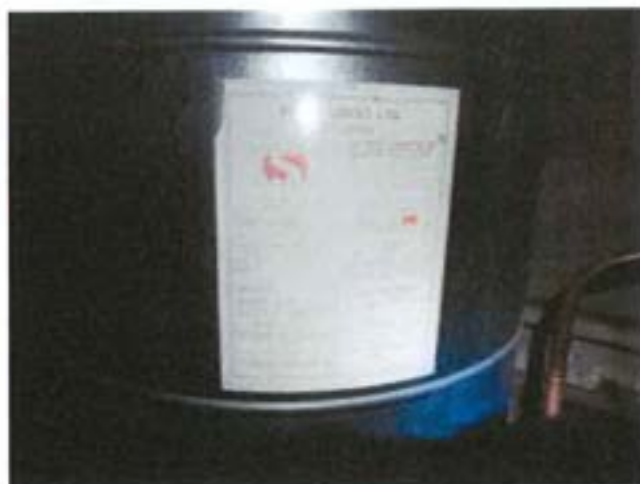
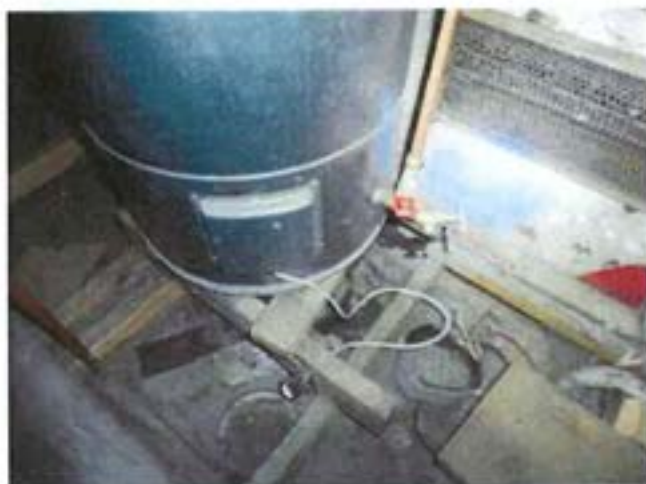
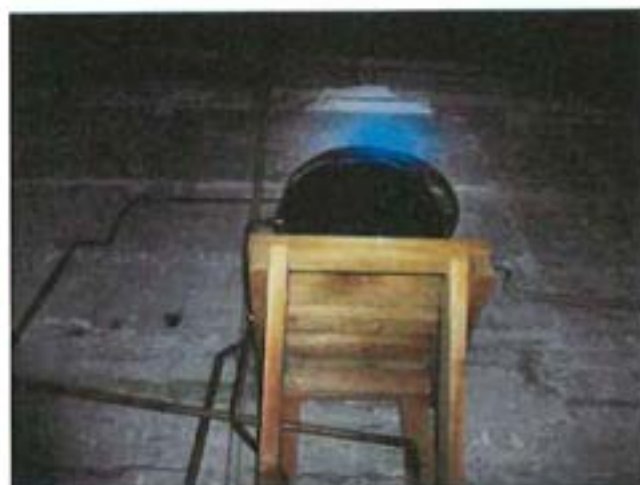
- 10.5 Water supply is believed to be fed from a Dunedin City Council water valve however this was not located or tested for operation at the time of inspection. Water pressures were tested at the sinks and wash hand basins and found to be reasonable, with water freely draining away.
- 10.6 There is a hot water cylinder located within the ceiling space above the north eastern accommodation. This is a low pressure cylinder manufactured by 'Peter Cocks Ltd' of Christchurch and has a capacity of 270 litres and a manufacture date of 2000. This cylinder has not been seismically restrained.
- 7.13 The polythene header tank is seated onto a timber platform secured to the brickwork on the northern wall and has a uPVC overflow pipe, which extends to the exterior. The tank does have a lid fitted, however, is not seismically restrained.

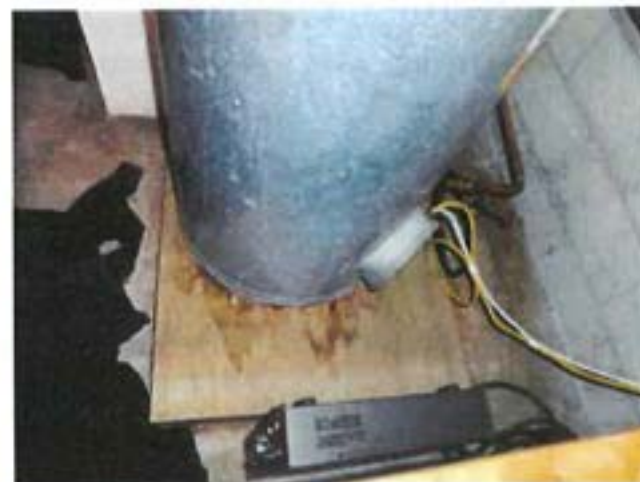
Photograph 175

- 10.7 There is another hot water cylinder located to the basement area to the southern side. This is a low pressure cylinder manufactured by 'Valley Industries' of Dunedin and has a capacity of 180 litres and a manufacture date of May 1991. This cylinder has not been seismically restrained. The cylinder sits onto a plywood platform and it appears that there may be some leakage. This requires further investigation and monitoring.

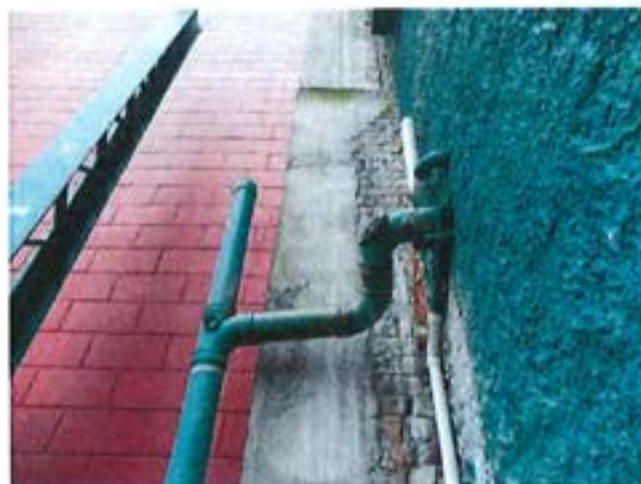
Photograph 178

- 10.10 Hot and cold pipework viewed was copper. The pipes viewed were not lagged and consideration could be given to fully lagging all exposed pipes to prevent the risk of localised freezing in extended cold periods.
- 10.11 Foul water drainage viewed to the north western corner is uPVC, which discharges to a clay gully and is then believed to connect to the main sewer on Crawford Street to the west. The gully trap is at external ground level and will require checking and clearing on regular basis to reduce the risk of blockage.

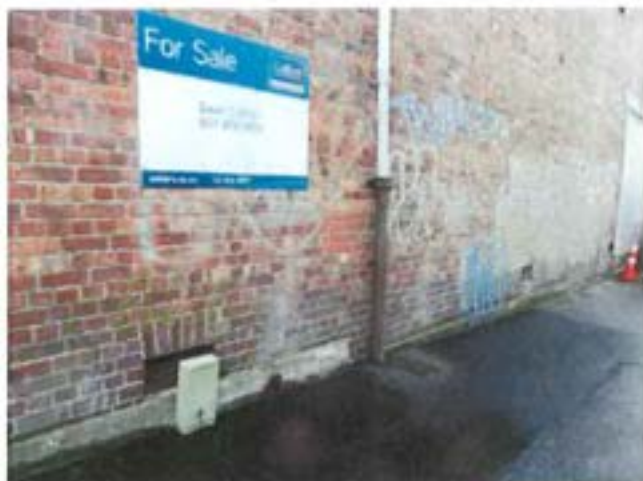
Photograph 180

- 10.12 One of the vent pipes on the eastern elevation has been partially replaced with uPVC however, the original iron pipe remains at low-level. The vent pipe to the north is corroded and is not connected. This requires further investigation and if still in usage will require replacement.
- 10.13 For further clarification, reference should be made to the Dunedin City Council Property File or LIM documentation, however for older properties these records may not be particularly accurate or up to date.
- 10.14 Stormwater drainage discharges to gullies to the west and direct to below ground drainage to the east.
