Landslide Monitoring 2014/15

Dunedin City Council – Civil Defence Landslide Monitoring 2014/15 Brighton Road (Survey #17)

Dunedin City Council – Civil Defence Landslide Monitoring 2014/15 Cargill Street (Survey #10)

DCC CD Landslide Monitoring 2014/15
Cockerell Street Slide, Brockville

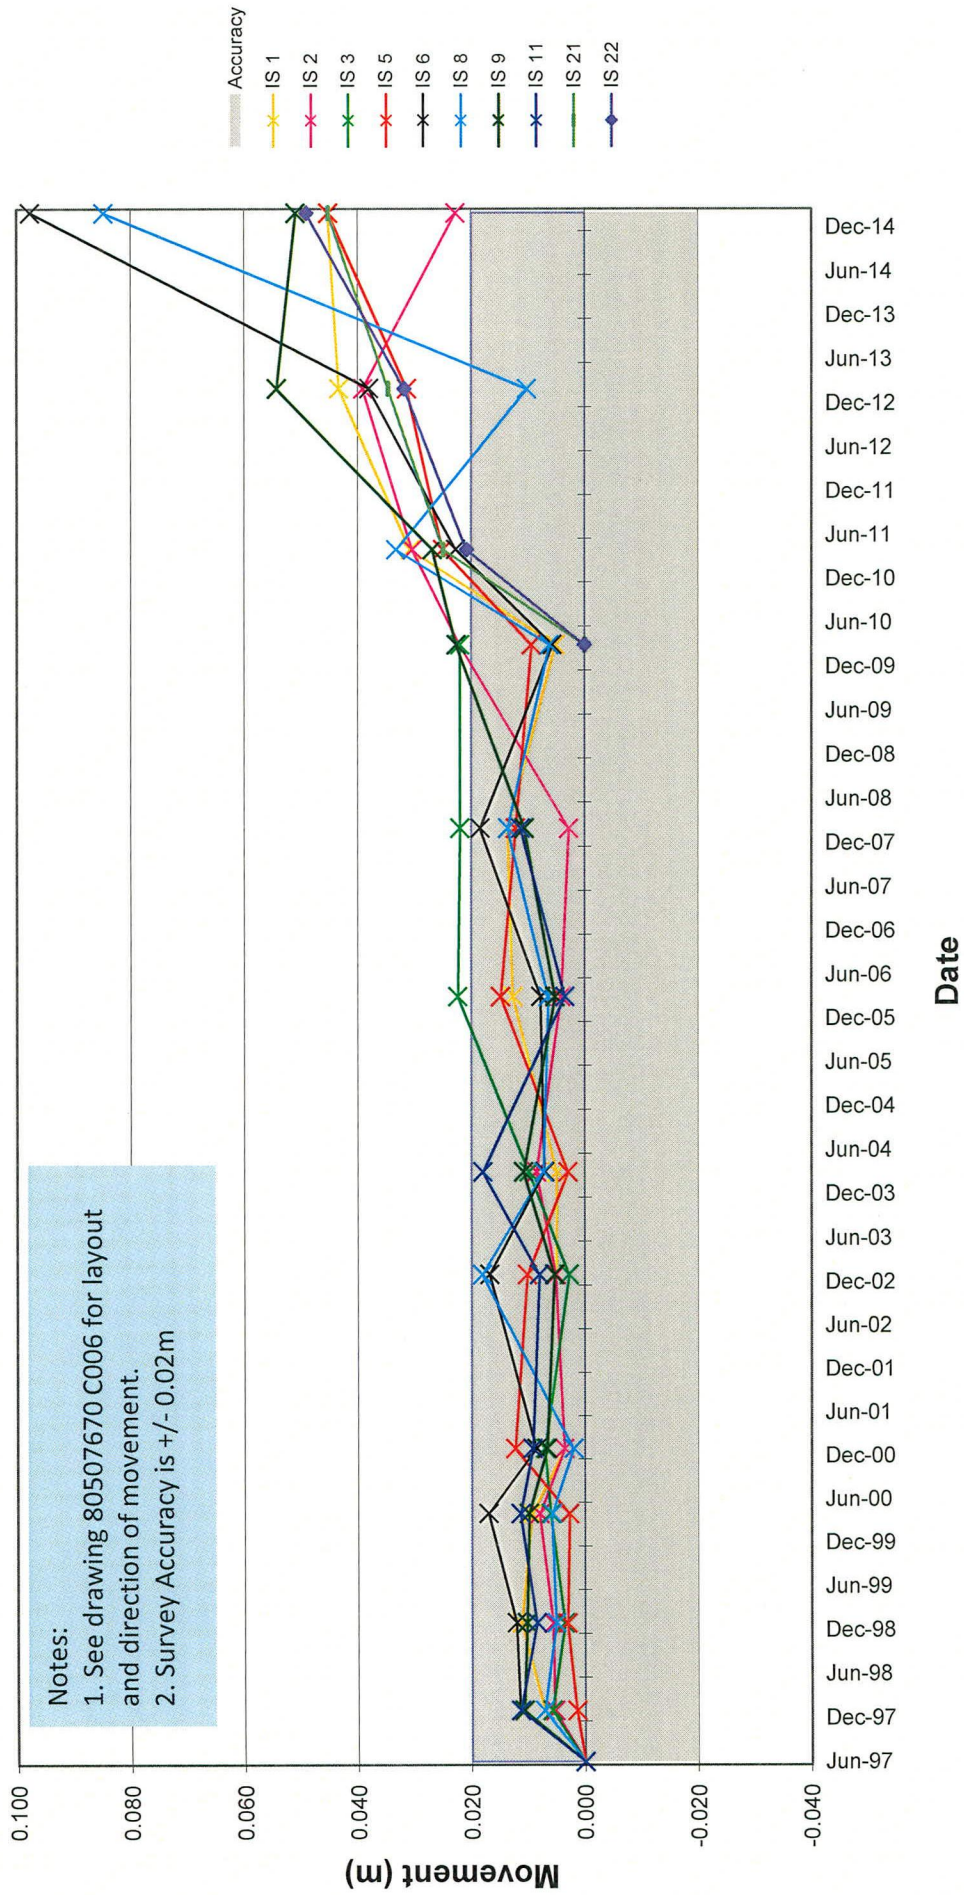
DEFORMATION MARK DIAGRAMS

The observed displacements are in the range of 11-78mm for all marks since the previous survey. Most displacement vectors are at or close to the practical limit of accuracy for RTK GPS and our analysis indicates that there is the possibility that some movement might be taking place.

The greatest movement was observed at IS6 (68mm) and IS8 (78mm) which are situated at the top of hummocky ground.

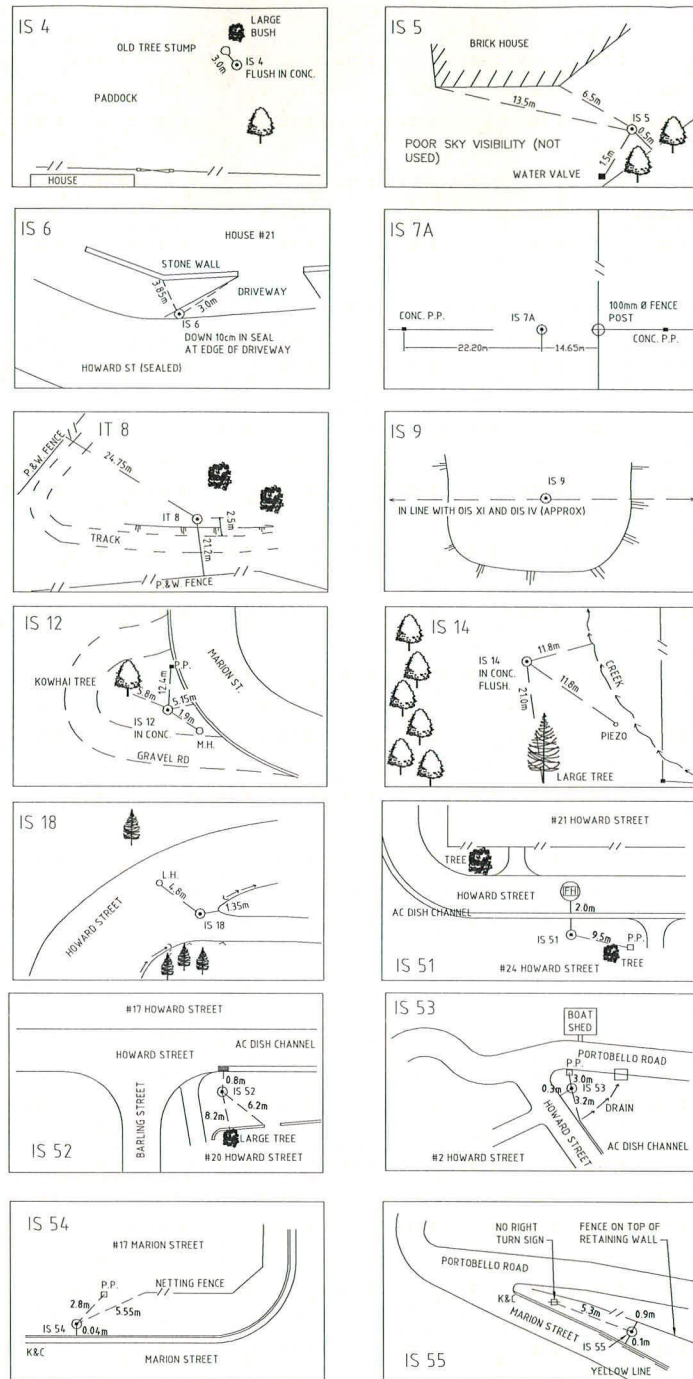
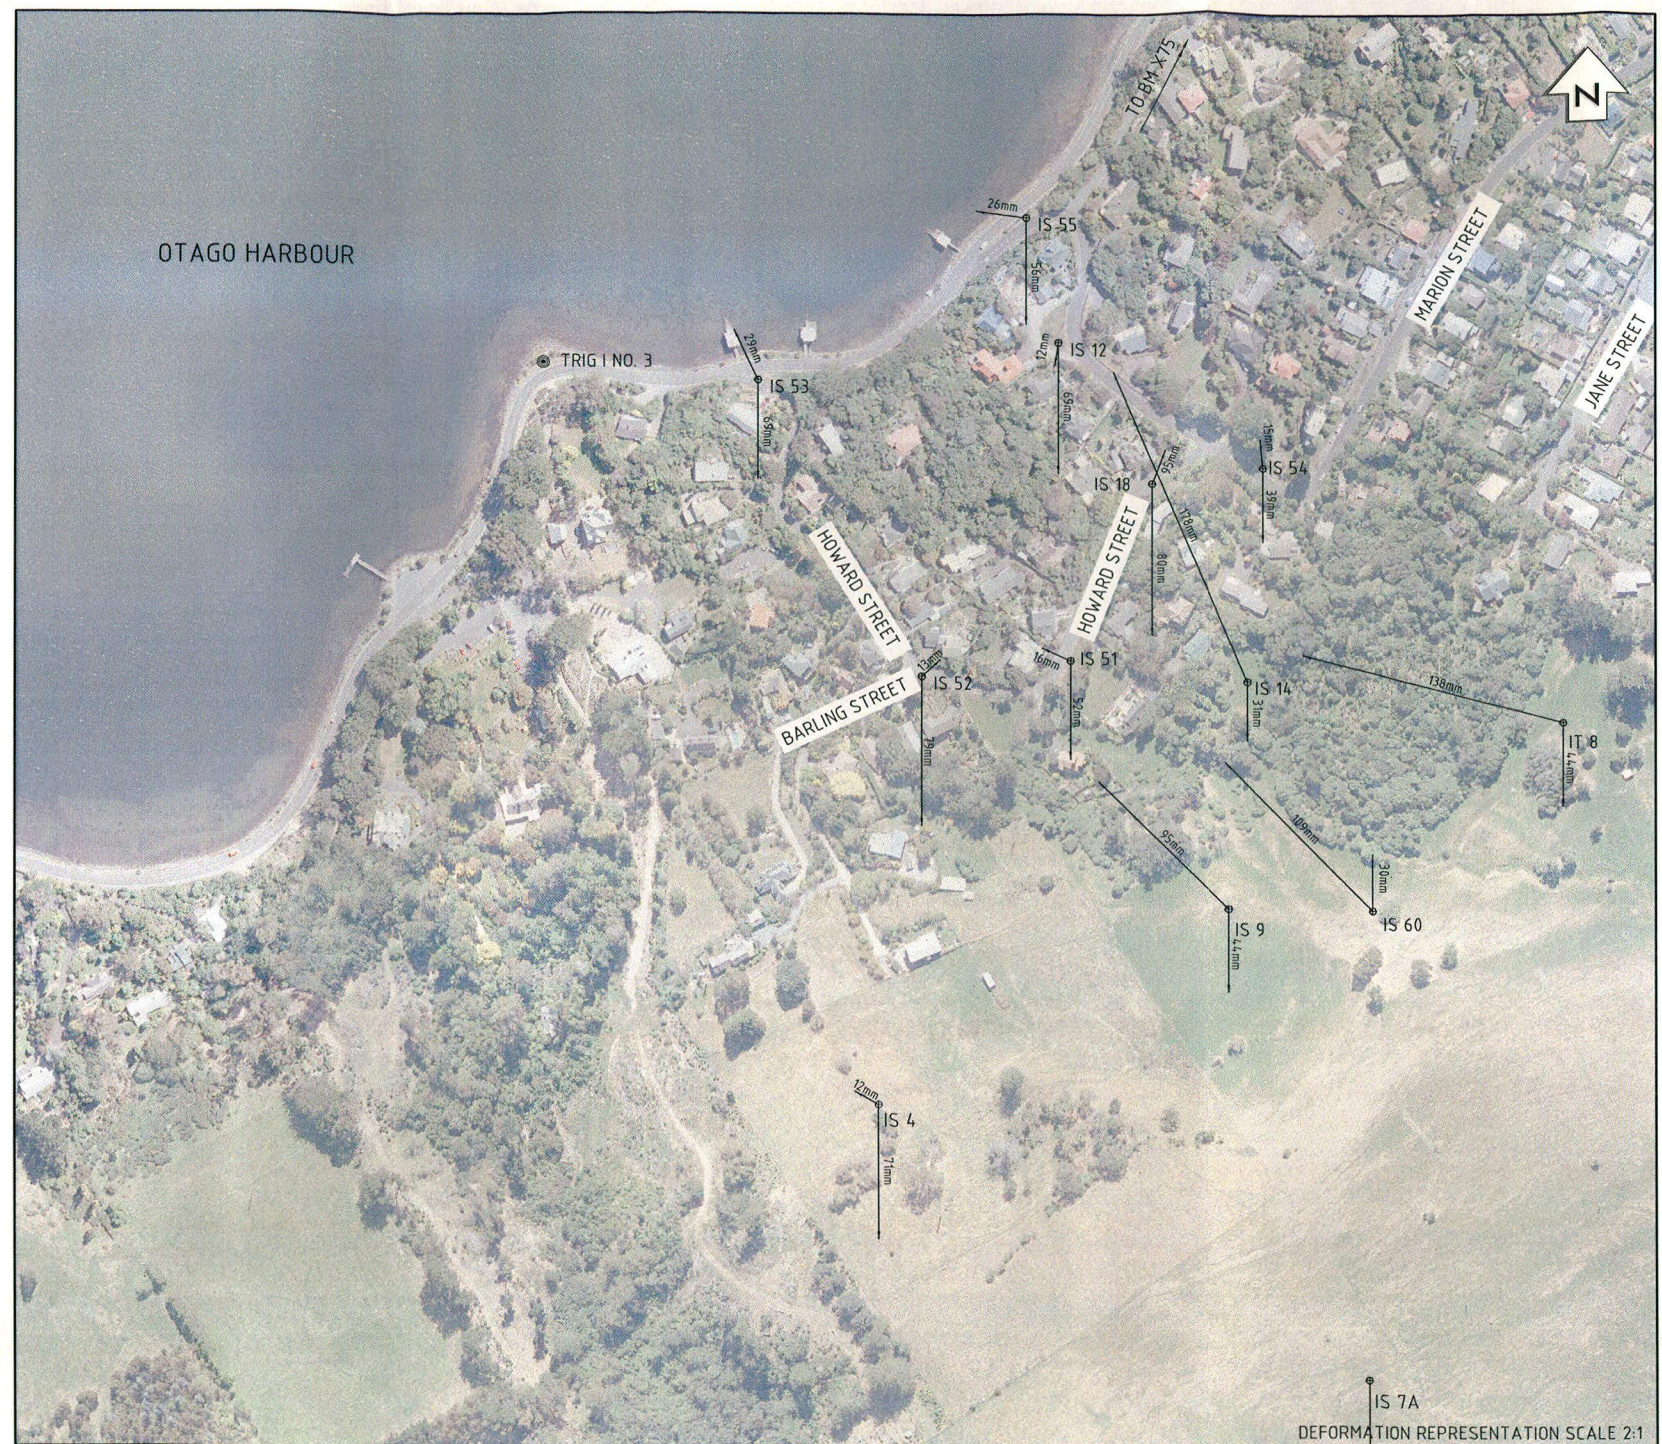
DEFORMATION MARK DIAGRAMS

The observed displacements are in the range of 3-33mm for all marks since the previous survey. Most displacement vectors are at or close to the practical limit of accuracy for RTK GPS and our analysis indicates that these are unlikely to represent significant displacement.

For the Howard Street site cumulative movement of between 39-60mm in a north to north-westerly (downhill) direction has been observed at IS's 8, 9 and 14. These marks located in the paddocks above Howard Street have historically been the most active portion of the landslip area. The general trend in this area is a downhill displacement at a rate of 3-4mm per year.
