Dunedin City Council

LTES LONG-TERM LANDSLIDE MONITORING PUKETERAKI LANDSLIDE

13 FEBRUARY 2025

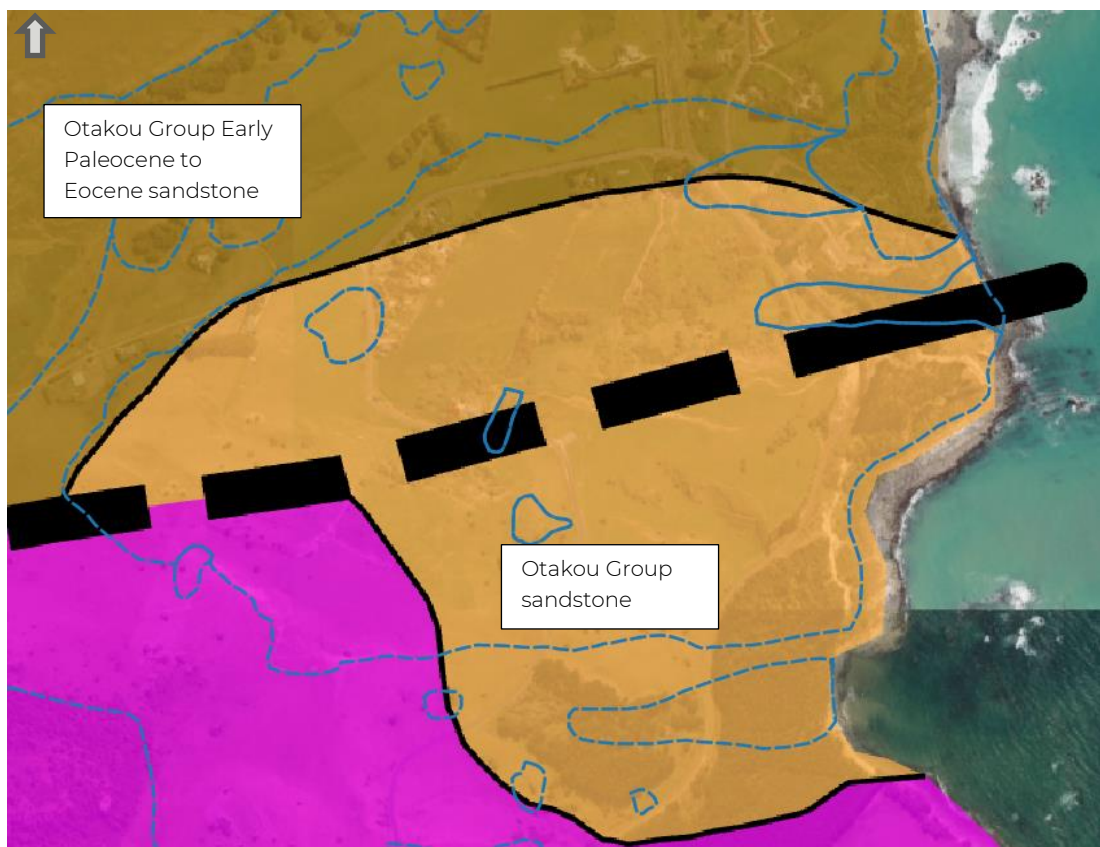
Figure 2: Geology as indicated by GNS with the outline of definite landslides in blue dashed lines. The thick black line indicates an inferred fault trace

No active faults are noted within 50 km of the site. The GNS Geology Web Map indicates a potential fault trace that passes through the site, however there is no information regarding this fault expression Figure 2. Given the distances of active faults from the site, the risk of associated ground movements at the site in the event of a rupture is considered to be ‘low’.
