From: [Kristy Rusher](#)
To: [lgoima](#)
Subject: FW: LGOIMA response re seismic assessments
Date: Thursday, 26 October 2017 04:05:24 p.m.
Attachments:

Street Number & Name:	1 Balmacewen Road, Maori Hill	Job No.:	12174
AKA:		By:	Ralf Schrub
Name of building:	Coronation Hall	Date:	21/11/2014
City:	Dunedin 9010	Revision No.:

Report

Prepared by Beca Limited

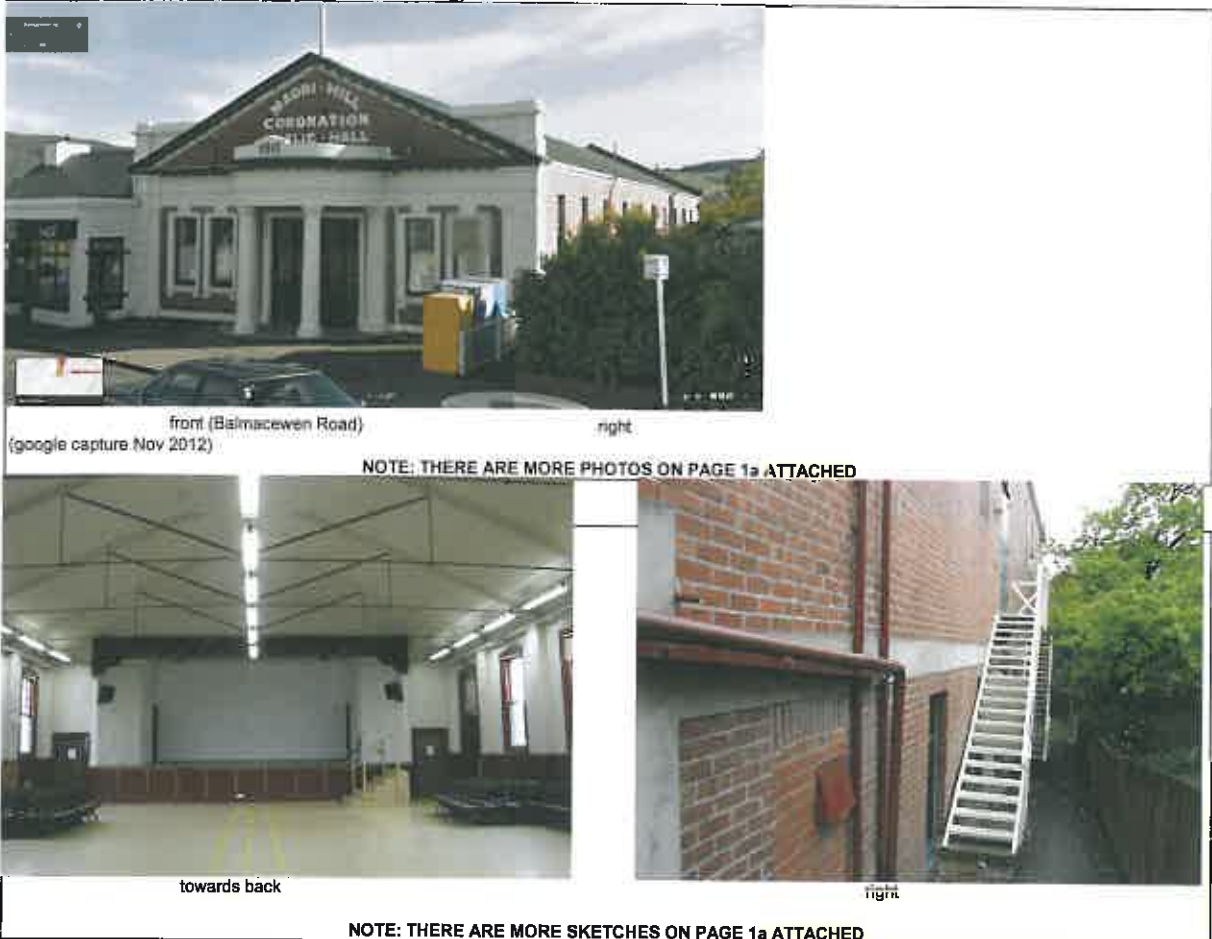
This two storey building was originally built in 1911. A substantial alteration to the basement has been carried out in 1994. The ground floor is suspended timber on engaged brick columns and on steel beams and columns respectively; external walls are double brick (probably not tied) with engaged columns and concrete bond beam at approximately ground floor support level; roof has steel trusses (timber top chord) with sarking and with corrugated iron cladding. It is the original that governs this IEP.

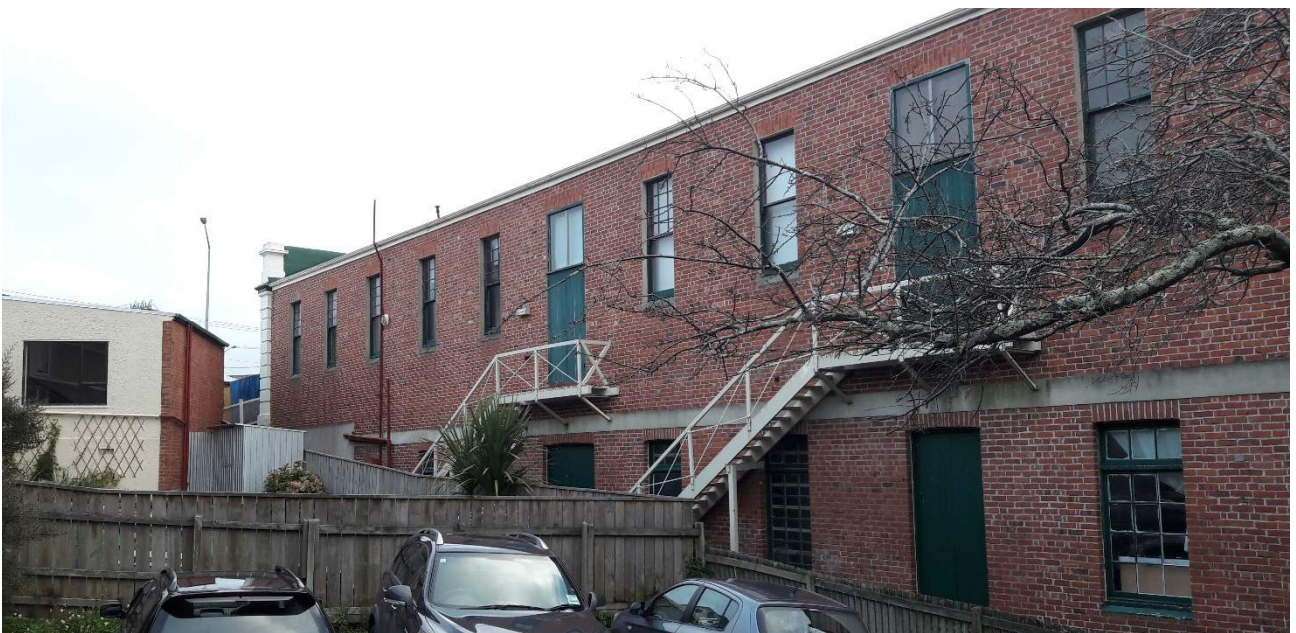
Figure 3 – Elevation of East Wall (west wall is similar)

- The cavity brick side walls in the southern rooms are tall and narrow and are therefore vulnerable to out-of-plane failure and collapse.
- The connections from the roof to the North and South end walls (both at eaves and roof levels) are not adequate to resist the loading demand.

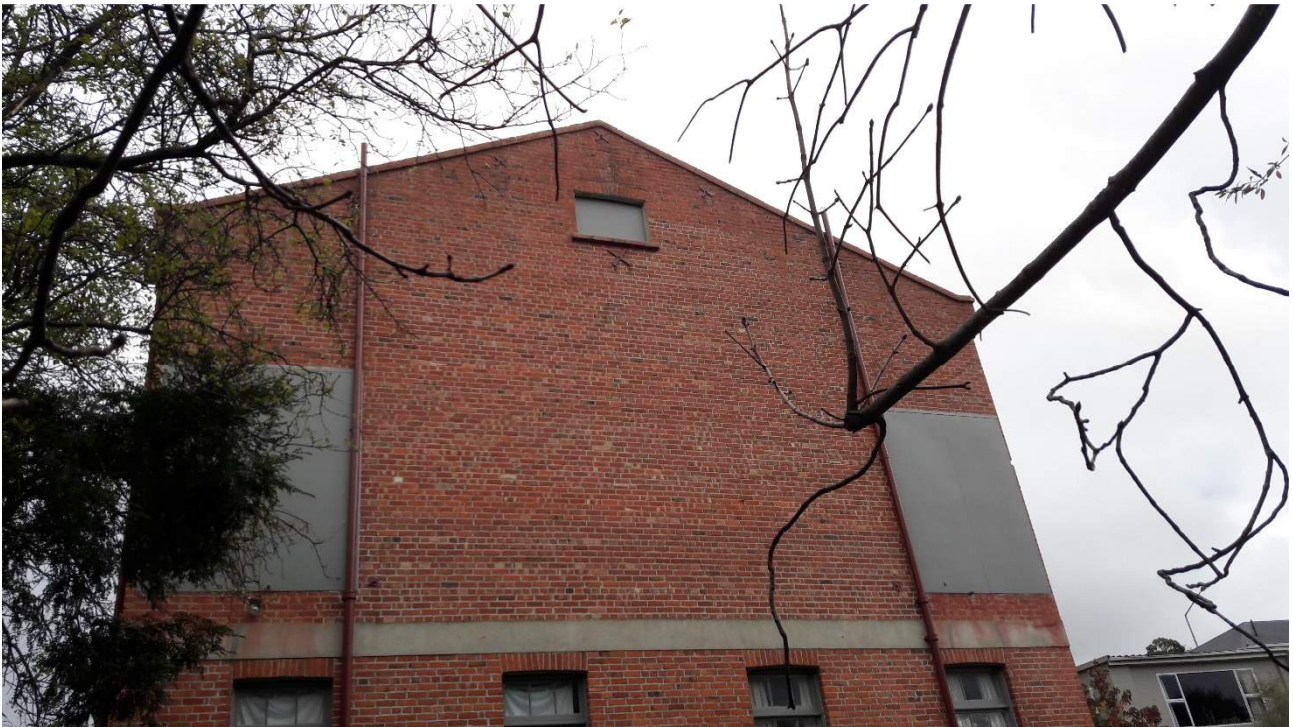
Figure 4 – Elevation of Northern End Wall – Ground Floor

- The cavity brick side walls in the southern rooms are tall and narrow and are therefore vulnerable to out-of-plane failure and collapse.
- The connections from the roof to the North and South end walls (both at eaves and roof levels) are not adequate to resist the loading demand.

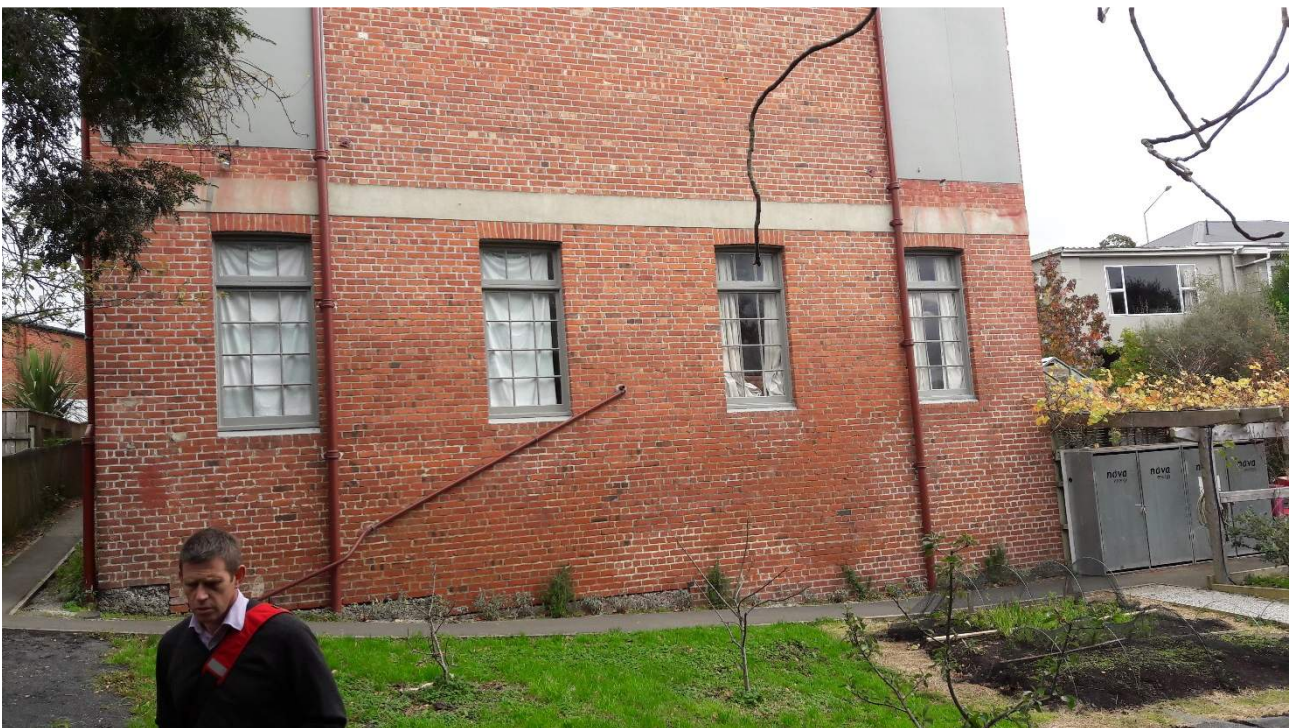
Figure 5 – Elevation of Northern End Wall – Basement Level

System	Direction	Seismic Performance in %NBS	Notes
Floor Beam to Pilaster Connection	Transverse	35-40%NBS	
Basement URM North Wall in Out-of-Plane Bending	Longitudinal	20-25%NBS (governed by connection capacity)	Element would score 90-95%NBS once the connection is strengthened. The wall itself is limited by the poor condition of the foundation.
Floor Diaphragm to North Wall Connection	Longitudinal	20-25%NBS	
Floor Diaphragm to South Wall Connection	Transverse	<20%NBS	Limited by lack of connection between floor diaphragm and end wall.
Parapet at Front of Building	Longitudinal	55-60%NBS	
Diaphragm at Roof Level	Transverse	>100%NBS	Note this is for the ceiling diaphragms in the rooms to the south and over the stage. The hall ceiling does not act as a diaphragm in the transverse direction as there is no restraining elements at each end.
	Longitudinal	>100%NBS	
Diaphragm at Floor Level	Transverse	45-50%NBS	Limited by shear strength of the floor.

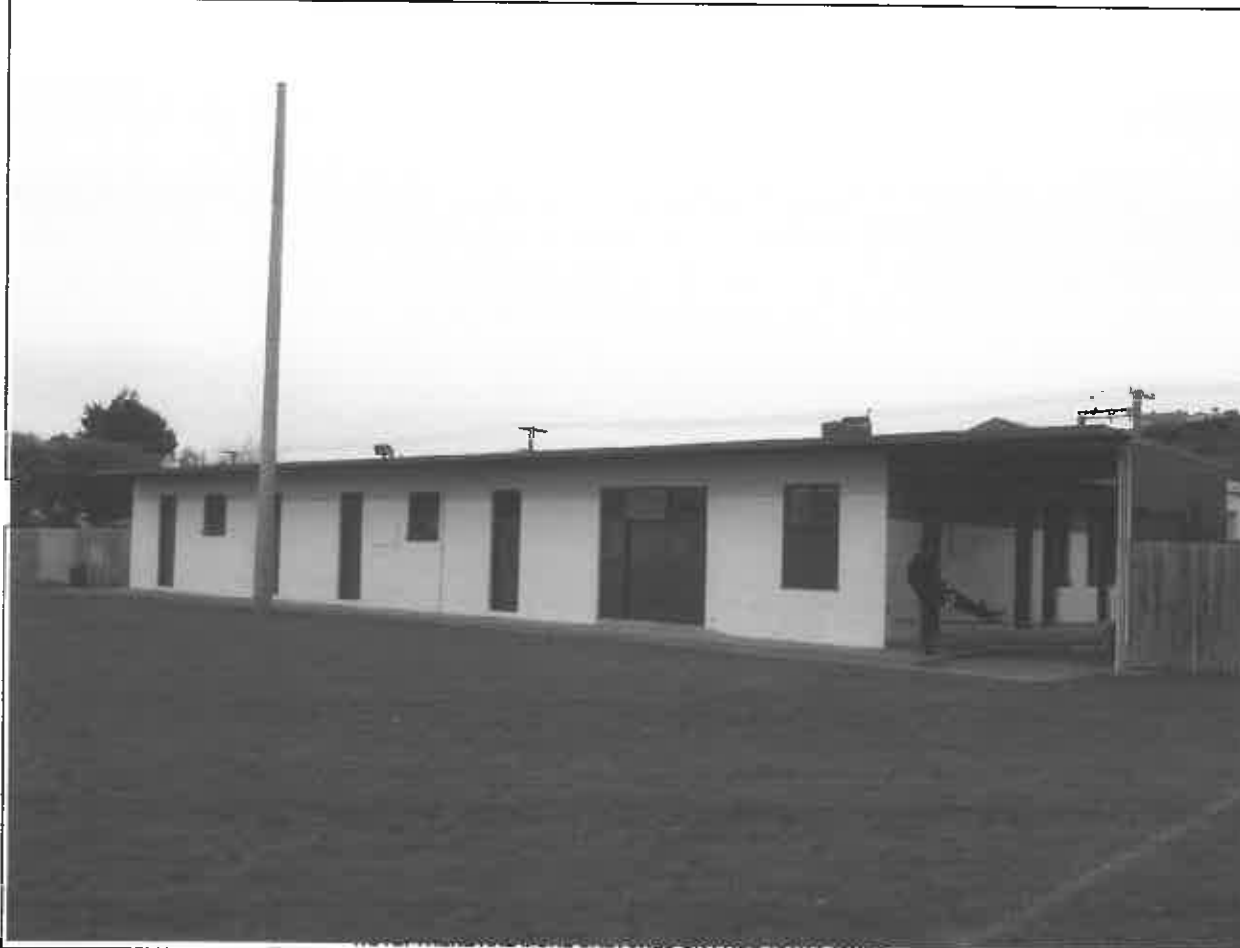
The building is 20 series exterior concrete block on wide (750 mm) concrete footings. Interior partitions are 100 concrete block. Ground is likely to be soft. Roof is light metal on timber rafters and trusses.

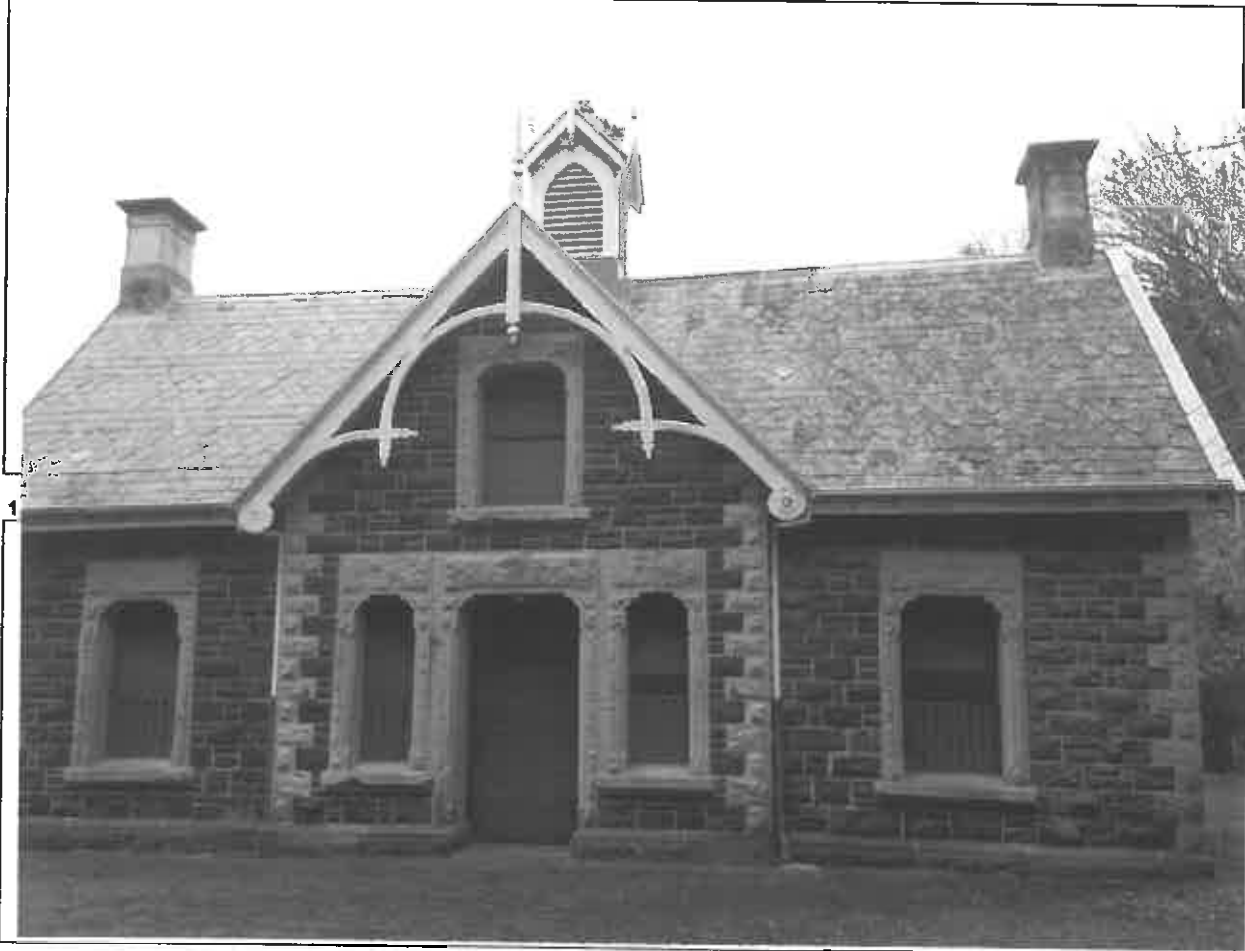
The original building was built in 1872. The lower level stone walls are up to 600 mm thick reducing to 300 mm thick to the upper level. The upper level floor and roof are timber framed. The roof is slate tiles (heavy). In 1981 alterations were made to the building to add toilets and a kitchen. A wall was removed in the south room and the vertical support replaced with a beam and posts. This wall could have been useful to provide lateral support in the longitudinal direction as the valley rafters land along this line. The upper level diaphragm floor would be required to transfer loads for the full width of the building and the removal of the wall would reduce its effectiveness.

The wall above the high level window on the east side has a crack in the lintel – otherwise there are no indication of settlement or other movement distress.

The ISA is considered to provide a relatively quick, high-level and qualitative measure of the building’s performance. In order to confirm the seismic performance of this building with more reliability I recommend that a DSA be carried out.

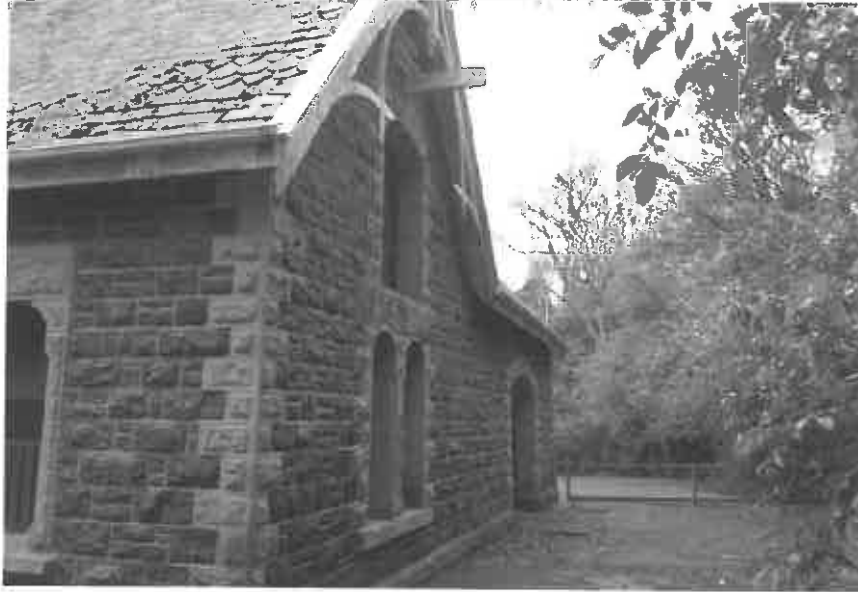
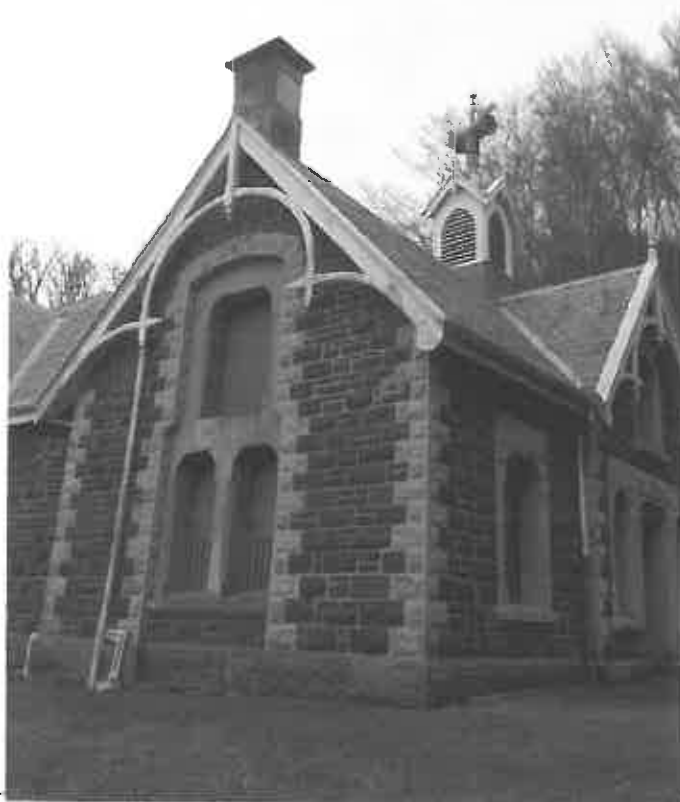
Table IEP-1a Additional Photos and Sketches

The wall removed and replaced with a beam and posts in the 1981 alterations would have provided a more balanced lateral support in the longitudinal directions. It is not known if this was considered as part of this structural alteration.

A closer look at the 2 chimney is recommended.
