## Waikouaiti Metals Sampling Plan

## Pipe Condition and

This report has been prepared by WSP New Zealand Ltd (WSP) for Dunedin City Council (Dunedin CC), to document our findings and recommendations based on the two Cast Iron (CI) pipe samples received for condition and lead joint integrity assessment.

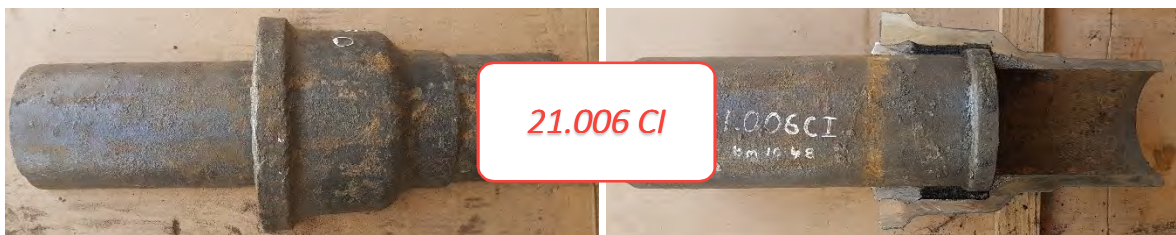
4" (DN 100), Cast Iron Pipe with Run-Lead Joint – 111 Edinburgh Street

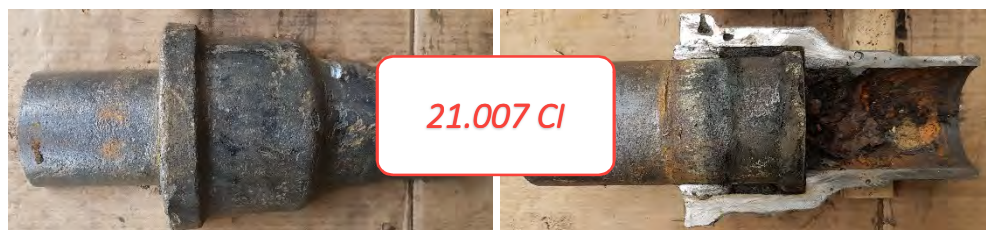
3" (DN 75), Cast Iron Pipe with Run-Lead Joint – Perth Street

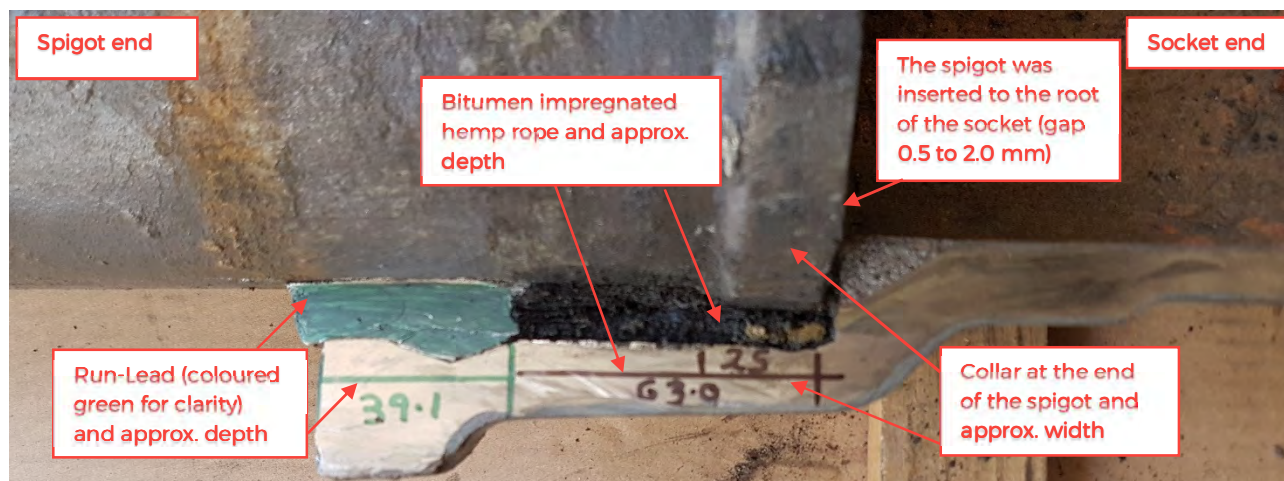
Figure 5-1 longitudinal section view of pipe sample 21.006 CI run-lead joint assembly

- Regarding the two spigot and socket run-lead joints inspected:
  - These joints were still providing a watertight seal.
  - The interior surface of the pipe spigots showed some minor corrosion pits, however, Full Wall Graphitisation (FWG) has not occurred and the lead was not in contact with the water supply.

- At the boundary between the lead and hemp rope in the socket, the hemp was still firmly bonded in the lead and there was no visual sign of deterioration of the lead.

- This pipe and joint sample has been assessed as **Grade 5 – Very Poor Condition**.
  - FWG is likely in the barrel of the pipe now, a 'gushing leak' has already occurred in 2015.

The top half (as-laid) of the socket was cut longitudinally at the approximate spring line of the pipe and removed so the joint assembly could be clearly seen, as shown in Figure 5-1 (21.006 CI) and Figure 5-2 (21.007 CI).

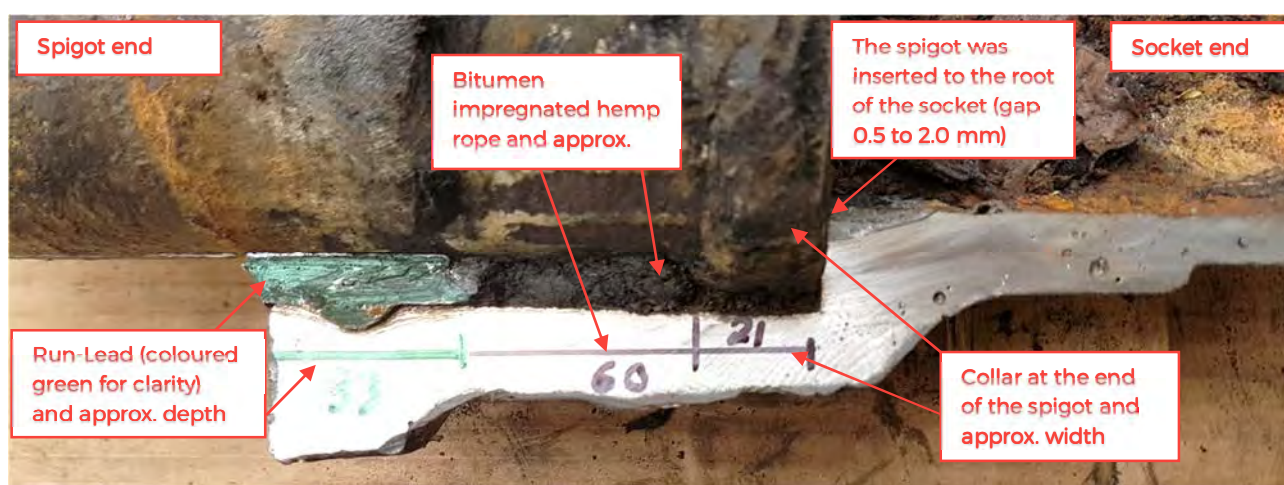
Figure 5-2 longitudinal section view of pipe sample 21.007 CI run-lead joint assembly

- This pipe and joint sample has been assessed as **Grade 5 – Very Poor Condition**.
  - FWG is likely to have occurred in the late 1990's or early 2000's where the pipe wall is thinnest.

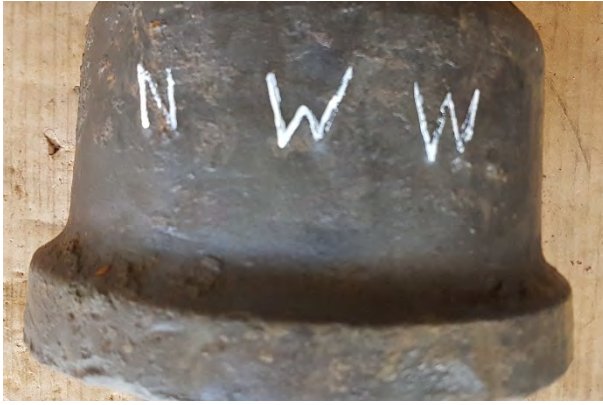
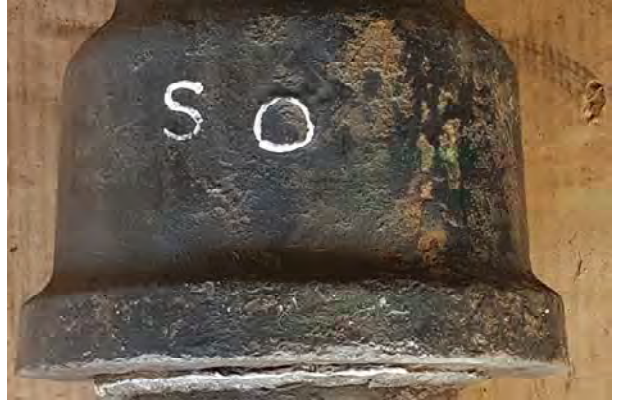
**Photos A3 and A4**

- Manufacturers markings on the socket were marked with a white pen for clarity. The markings are of unknown meaning, however, they are like those also present on pipe sample 21.007 CI, refer to Appendix B, photos B3 and B4.

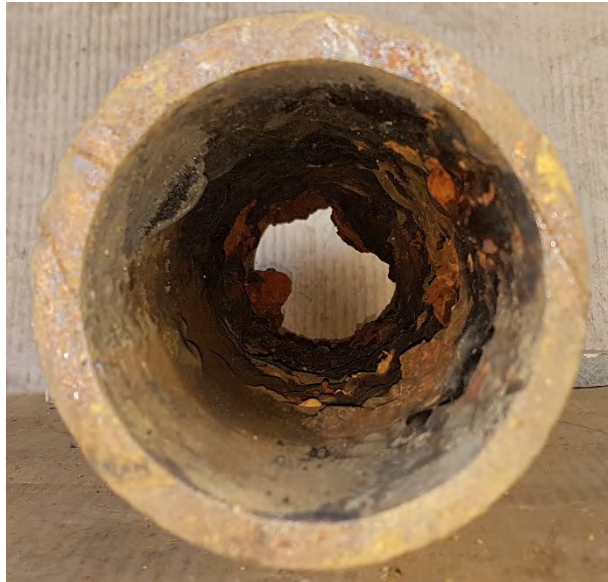
**Photo A5**

- Internal view of the pipe sample.
- Some minor tuberculation nodules were present at the far end of the sample (it is likely that the tuberculation at the near end was dislodged during sample recovery).
- We estimate a 25% effective reduction in the bore.

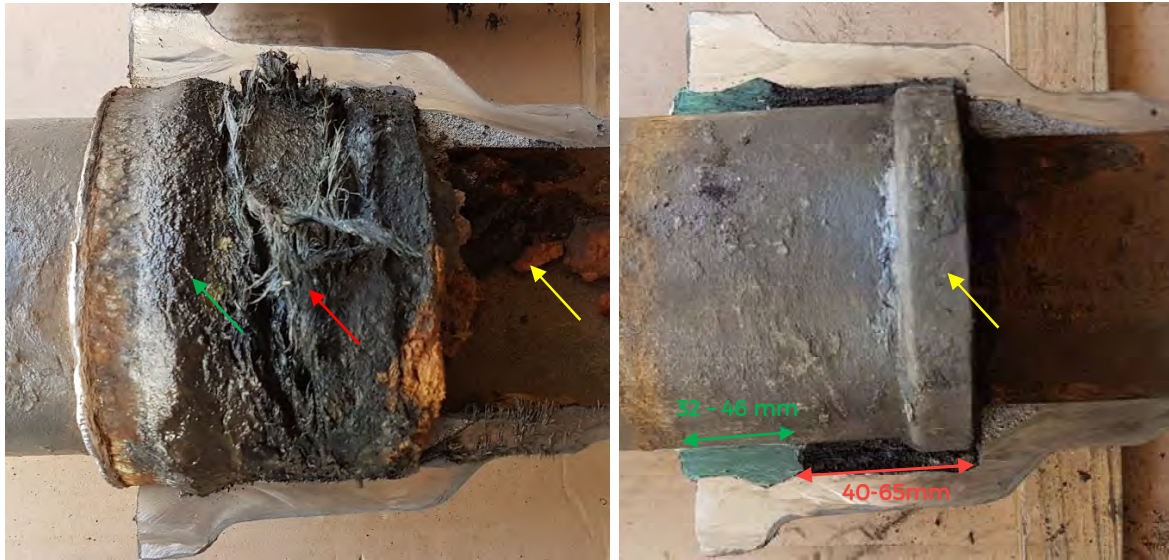
**Photos A6 and A7**

- The pipe was cut longitudinally at the approximate spring line and the top half of the spigot (as-laid) was exposed

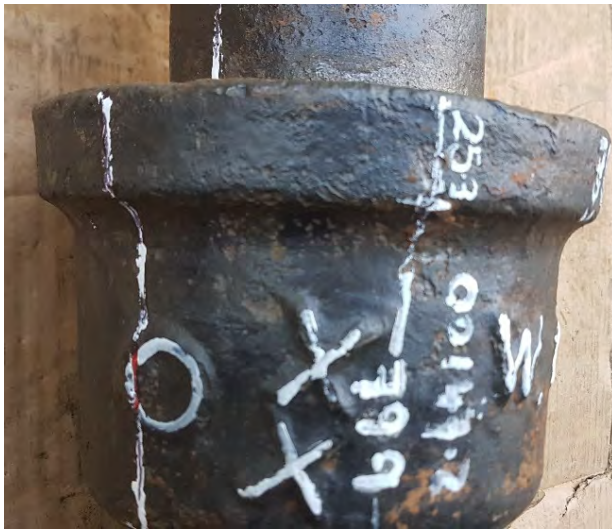
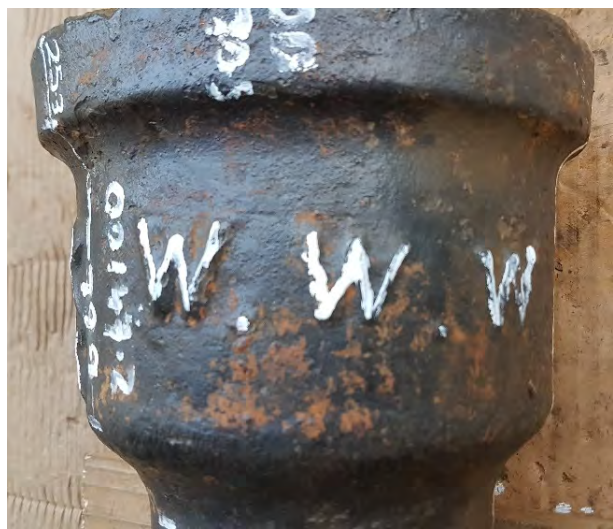
**Photos B3 and B4**

- Manufacturers markings on the socket were marked with a white pen for clarity. The markings are of unknown meaning, however, they are like those present on pipe sample 21.006 CI, refer to Appendix A, photos A3 and A4.

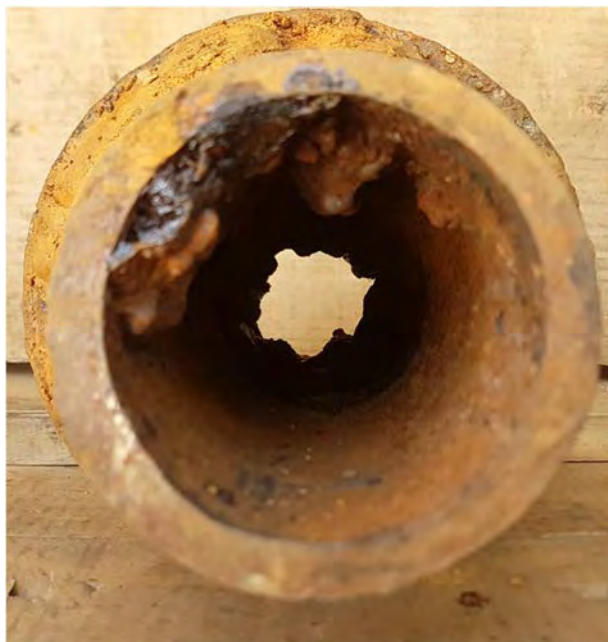
**Photo B5**

- Internal view of the pipe sample.
- Some significant tuberculation nodules were present.
- There is up to 40% effective reduction of the bore in places.

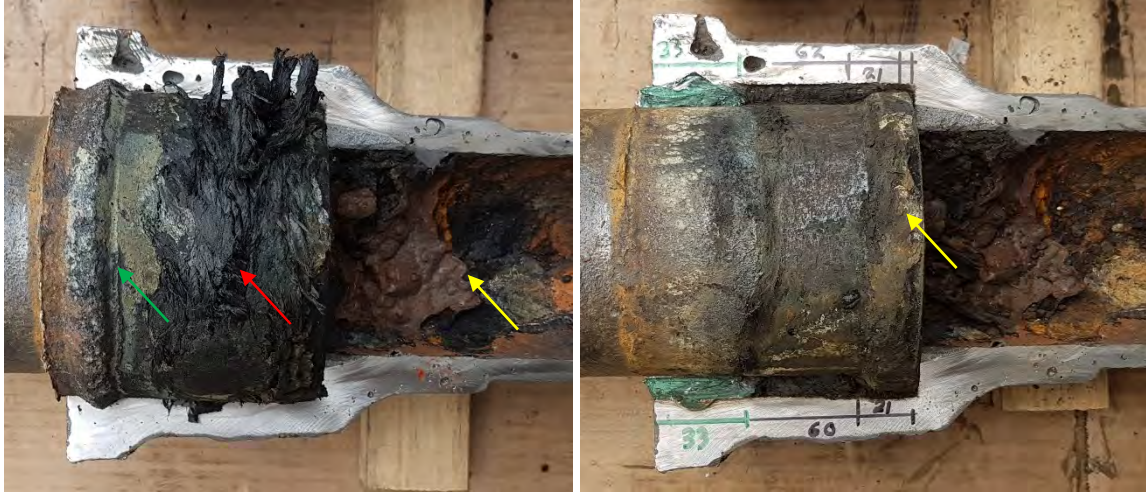
#### Photos B6 and B7

- The pipe was cut longitudinally at the approximate spring line and the top half of the spigot (as-laid) was exposed

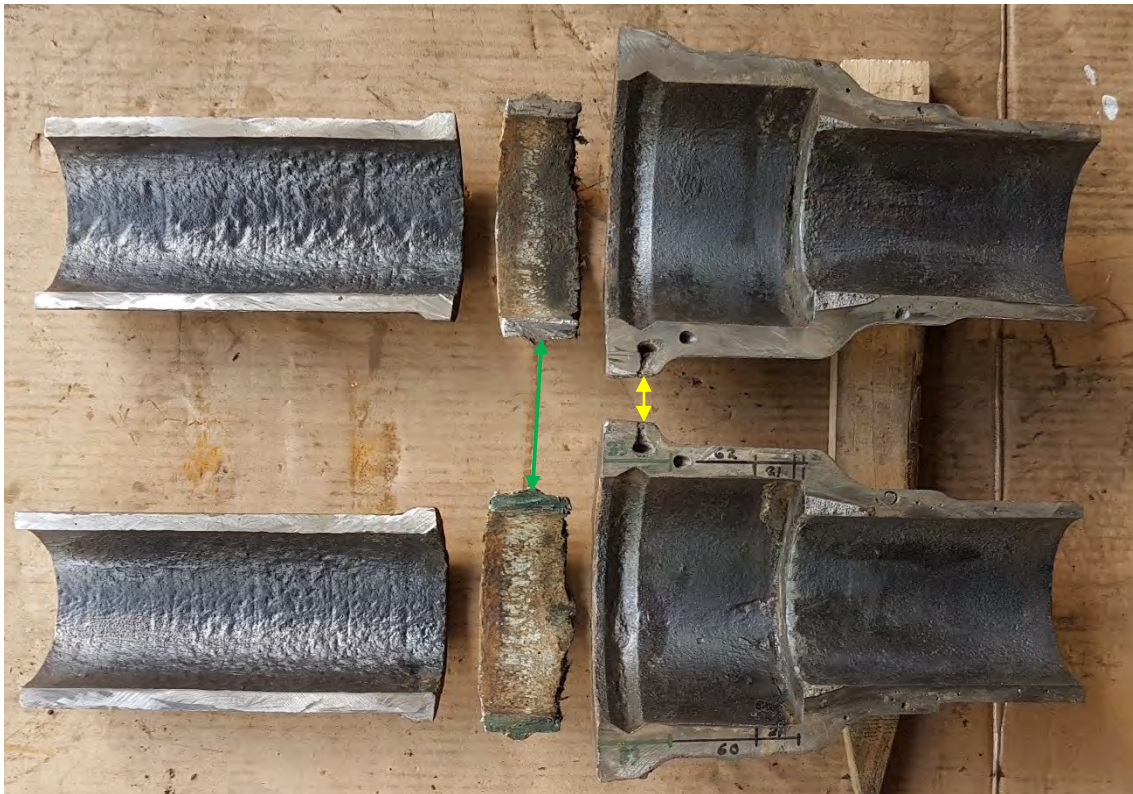
**Photo B10**

- Interior view of the pipe sample after the tuberculation was removed with a power wire brush.
- The bitumen dipped composite is still visible and covered ~95% of the pipe sample however, some graphitisation of the iron is visible.
- The lead between the spigot and socket is shown (green arrow).
- Porosity is present in the socket. This porosity was deepest at the mouth of the socket, the larger of the two voids (yellow arrow) had a combined depth of  $\approx 12.3$  mm.

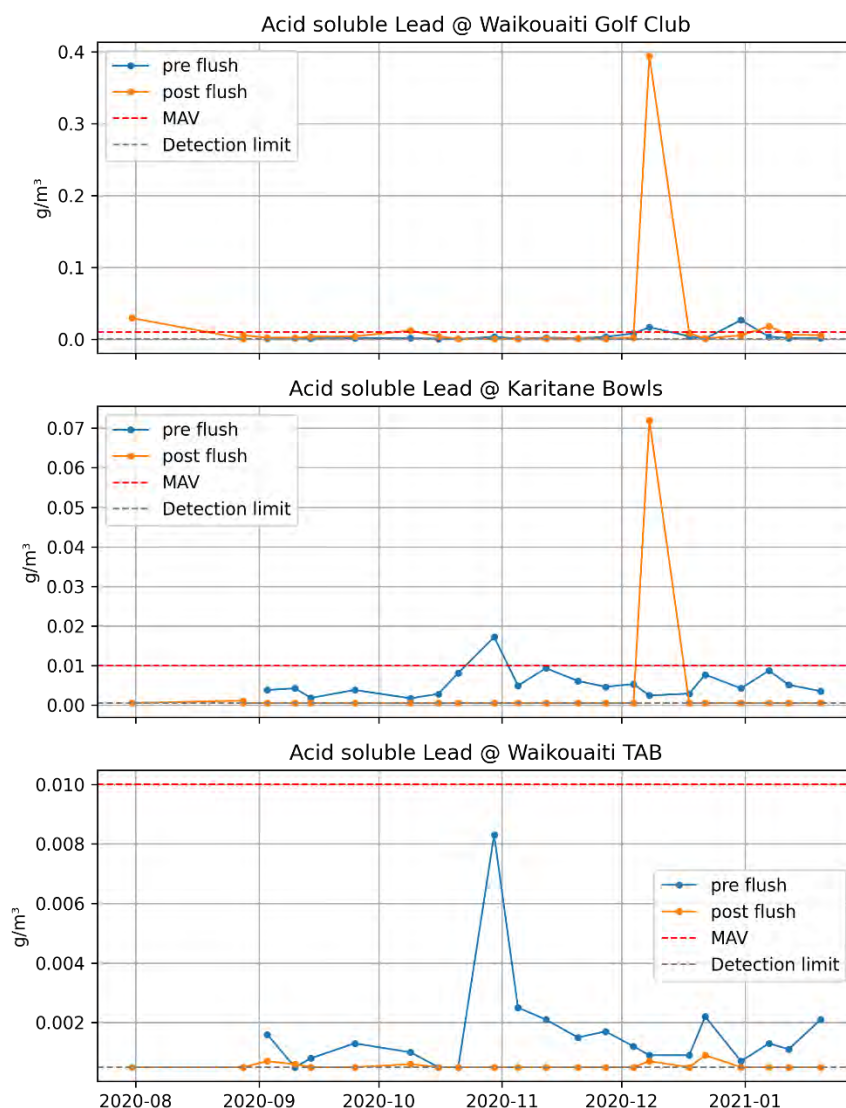
Acid soluble lead results for network sampling points are depicted in Figure 5. These indicate a peak in lead concentrations on 8 December 2020 at both Waikouaiti Golf Club and Karitane Bowls Club. Note that this lead spike is approximately an order of magnitude higher at Waikouaiti Golf Club than at Karitane Bowls Club.

Figure 5: Acid soluble lead concentrations in network water samples. Note y-axis limits vary between sample locations.

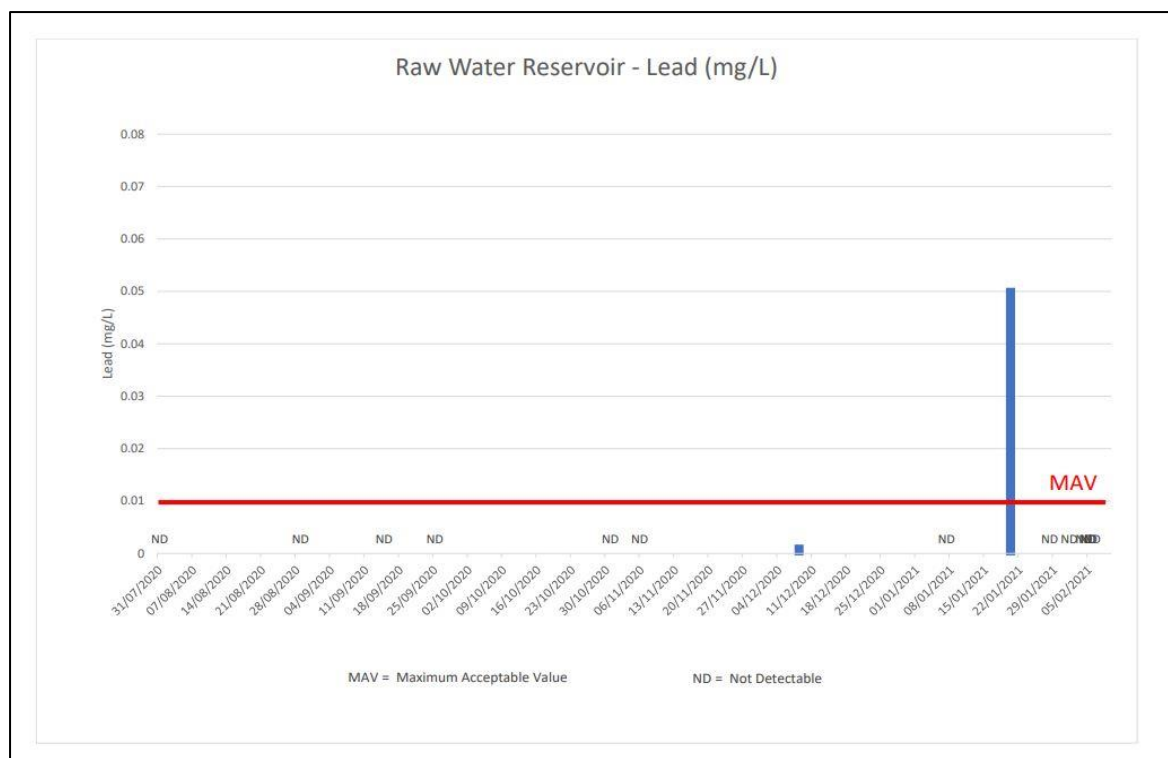
Intermittent analysis for total lead has been undertaken from the raw water reservoir since July 2020. Results have generally shown lead levels below, or close to laboratory detection limits, except for a single spike of 0.05 mg/L (total) on 20 January 2021. The spike exceeded the DWSNZ MAV of 0.01 mg/L (Figure 6 below). Corresponding samples collected from the treated water reservoir analysed for acid soluble lead during the same time period has not shown any elevated lead post-treatment. This result indicates that the lead within raw water may have been removed by the WTP.

Figure 6: Summary of total lead in water collected from the raw water reservoir (source: DCC).

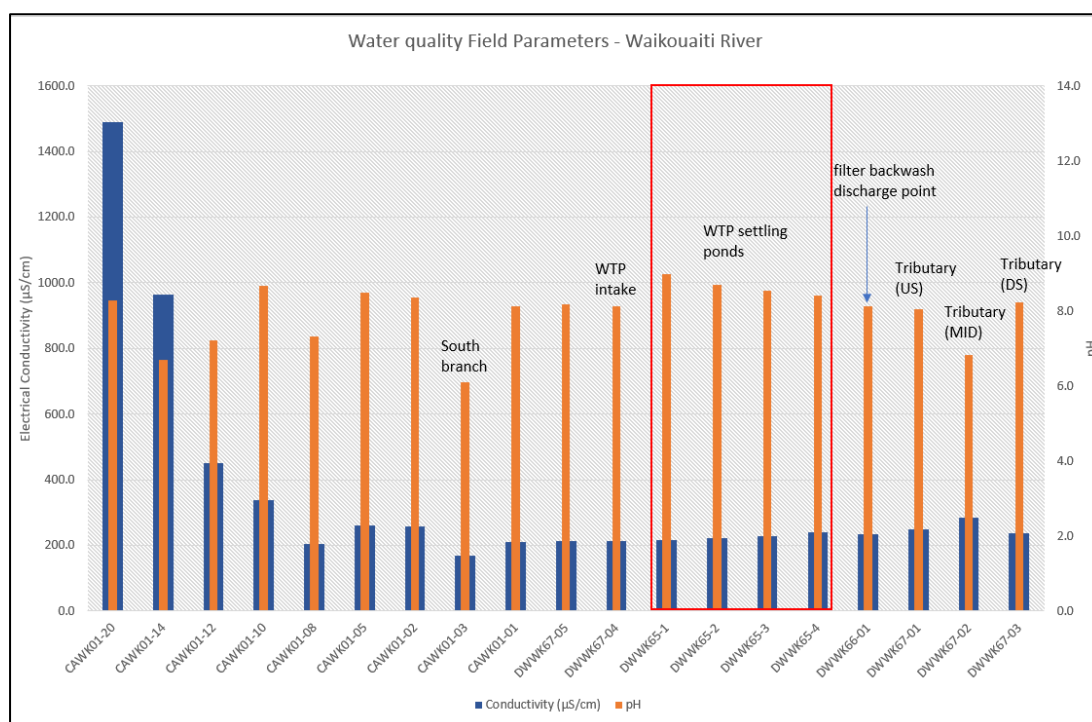
Figure 12: Summary of key field parameters.

Field readings of water quality parameters collected during sampling show a general declining trend in electrical conductivity from the upper reaches down to the Eldorado Station, approximately 20 km upstream of the WTP intake. From the Eldorado station to the WTP intake, electrical conductivity (EC) is generally stable at approximately 200  $\mu\text{S}/\text{cm}$ . This trend is consistent with the results from analysis of inorganic parameters presented in the next section. pH, redox potential and dissolved oxygen all appear to be relatively consistent across all of the sites sampled (refer Appendix D1 for tabulated field data).

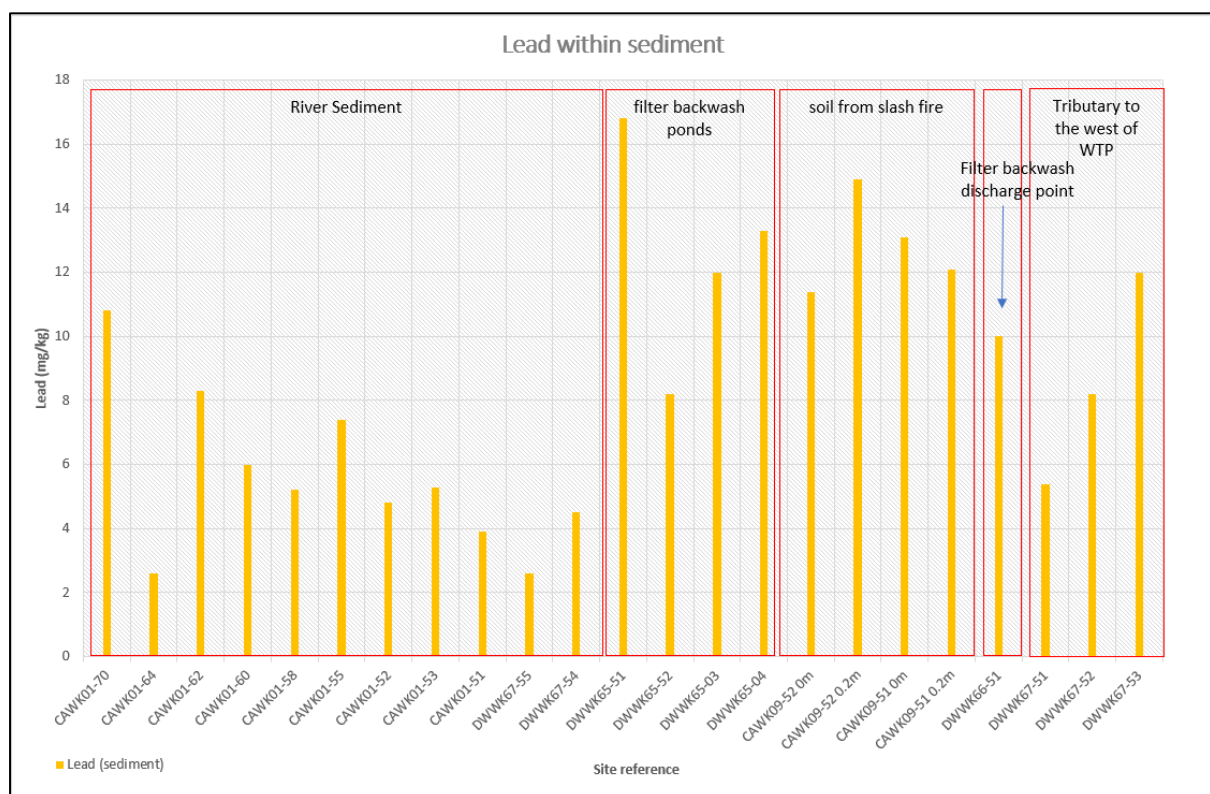
Figure 13: Summary of sediment-lead and soil-lead results for the Waikouaiti River, WTP site and slash fire area.

Total and dissolved lead within water samples collected at all sites were generally at, or below laboratory detection limits. Lead in sediments, sludge and soil at all sites range from 2.63 - 17.3 mg/kg (refer Figure 13 below), which is within published background concentrations for Otago Schist<sup>3</sup>.

Although the sediment-lead results are all with background levels, results from areas associated with the WTP and the slash-fire area generally appear to be higher than those from the river sediments. However, this could be associated with a qualitative difference in particle size between these two areas: a visual inspection indicated that river sediments generally appear coarser than sediments at the WTP and slash-fire area). A slightly decreasing trend in sediment-lead is observable from the upper river to the lower river.

These results indicate that chronic discharges of elevated lead are unlikely to be occurring within the catchment. However, slightly higher lead associated with the WTP could be attributed to an accumulation of short-term “pulses” of lead being captured within raw water and treatment infrastructure, or to the difference in particle size distributions in the different sediment samples.

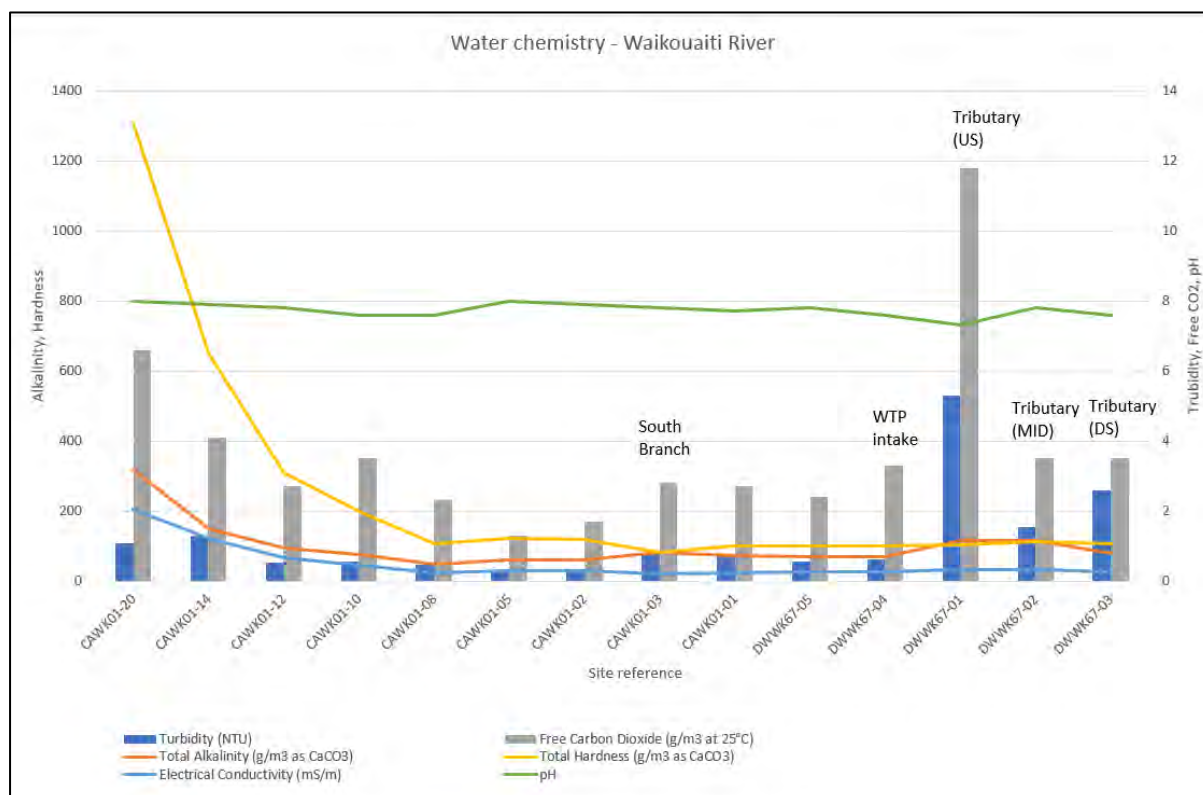
Figure 14: Summary of inorganic water chemistry.

Inorganic parameters appear to generally decline from upstream to downstream (refer Figure 14 below). This suggests that inputs of elevated inorganics near the headwaters of the river are being gradually diluted by compounding inputs to the river moving downstream. Given the sample locations, the most likely explanation is discharges from the OG site, either direct, or as groundwater baseflow to the river. Results from the small tributary to the west of the WTP show elevated turbidity, which could be resulting from recent DCC activities (raw water reservoir drainage), or upstream activities.

pH within the river appears to be relatively spatially consistent, and is above neutral.

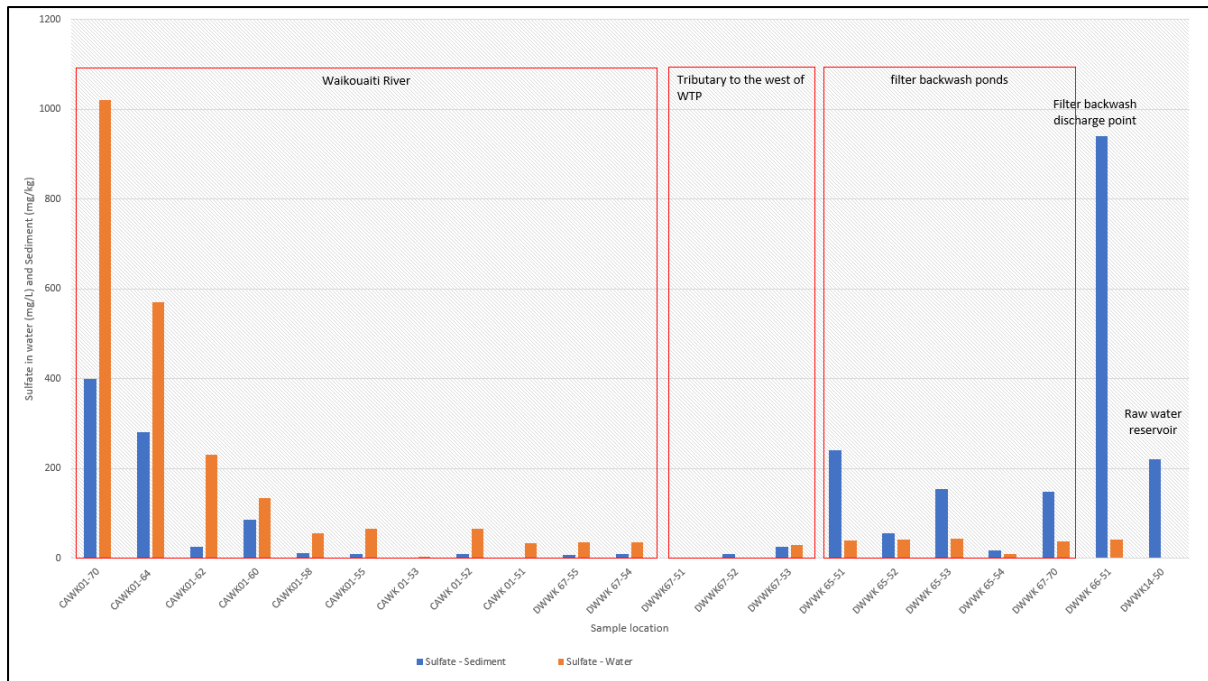
Figure 15: Summary of water-sulfate and sediment-sulfate results.

The water quality results also show a declining spatial trend in sulfate, both within river water and sediment. Relatively low water-sulfate, but relatedly high sediment-sulfate concentrations are shown in the WTP settling ponds and the tributary (Figure 15).

Sulfate present within the upper reaches of the river is predominantly present in the dissolved phase, as opposed to the WTP settling ponds and at the filter backwash discharge point, where sulfate is predominantly found in the sediment, rather than in the water. Similar to the slight observed elevations in lead within the WTP sediment, it is possible that sulfate is being accumulated in the sediments of the settling ponds, raw water reservoir and at the WTP filter backwash discharge from “pulses” of sediment coming down the river.

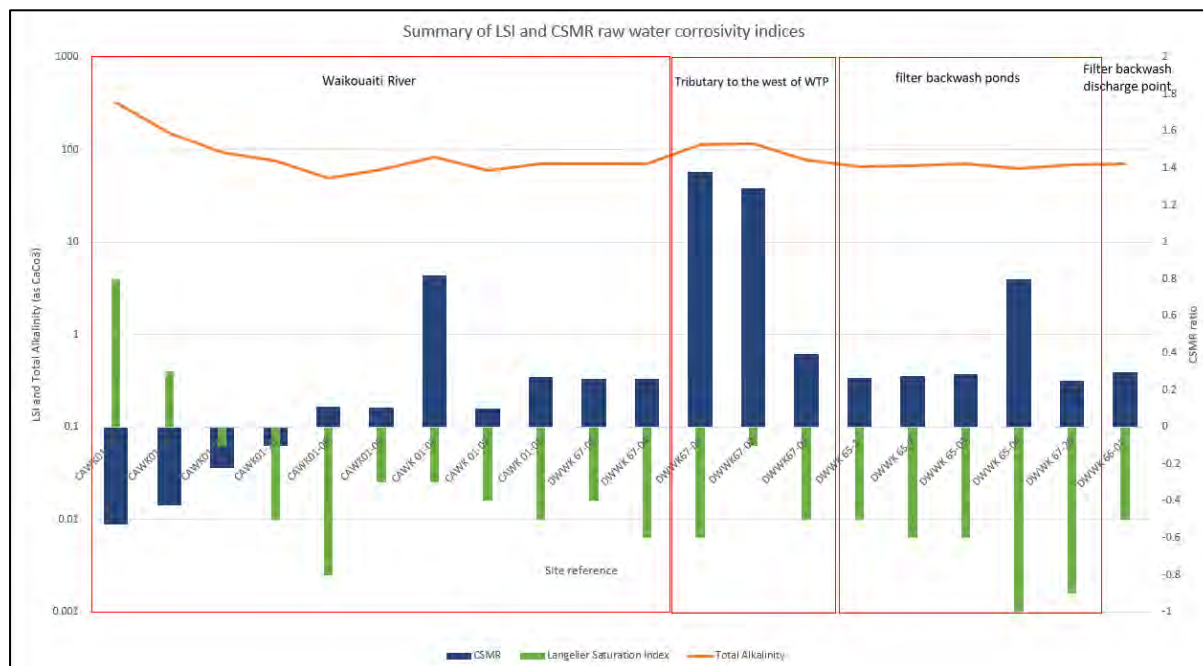
Figure 16: Summary of Langelier Saturation Index (LSI) and the ratio of chloride to sulfate (CSMR) results.

The results depicted in Figure 16 generally show low corrosivity/scale-forming waters within the upper reaches of the river, transitioning to slightly indeterminate/low PPGC nearer to the WTP intake. Water sampled from the small tributary to the west of the WTP and from the WTP settling ponds shows moderate PPGC, but is limited by relatively high alkalinity (of around 100 mg/L as CaCO<sub>3</sub>).

These results show that although there appears to be a spatial trend of increasing corrosivity downstream, source water corrosivity at the WTP intake is still relatively low. However, these results must be interpreted as a single moment in time. Significant discharges within the catchment, or treatment processes may cause temporal changes to raw or treated water corrosivity.

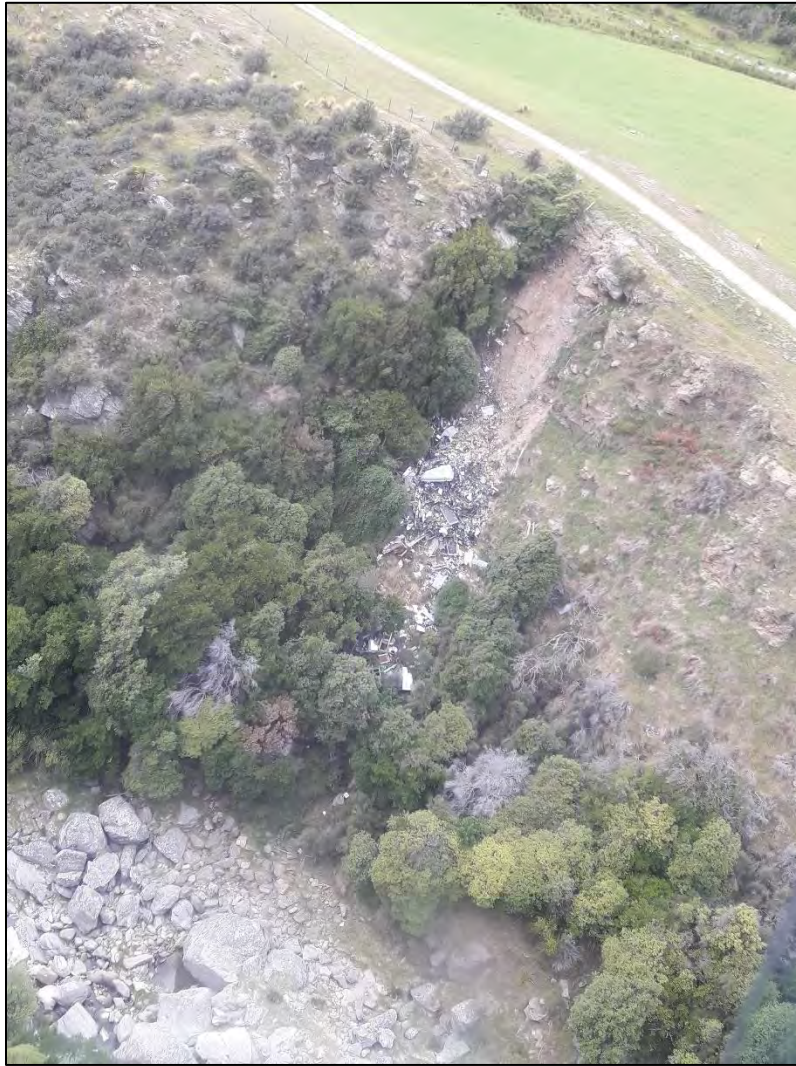
*Photograph 1: aerial view of the fly dump. Photo taken by ORC on 3 February 2021.*

Notes taken during by ORC during an aerial inspection of the catchment using a helicopter on 3 February 2021 indicate that a fly dump is located >25 km upstream of the WTP intake on a cliff above a tributary of the North Branch (see photo below and location on Photograph 1 below). Given the size and location of the fly dump above the tributary, it is likely that wastes are able to mobilise to surface water, and subsequently into the Waikouaiti River, particularly during significant rainfall or flooding events.

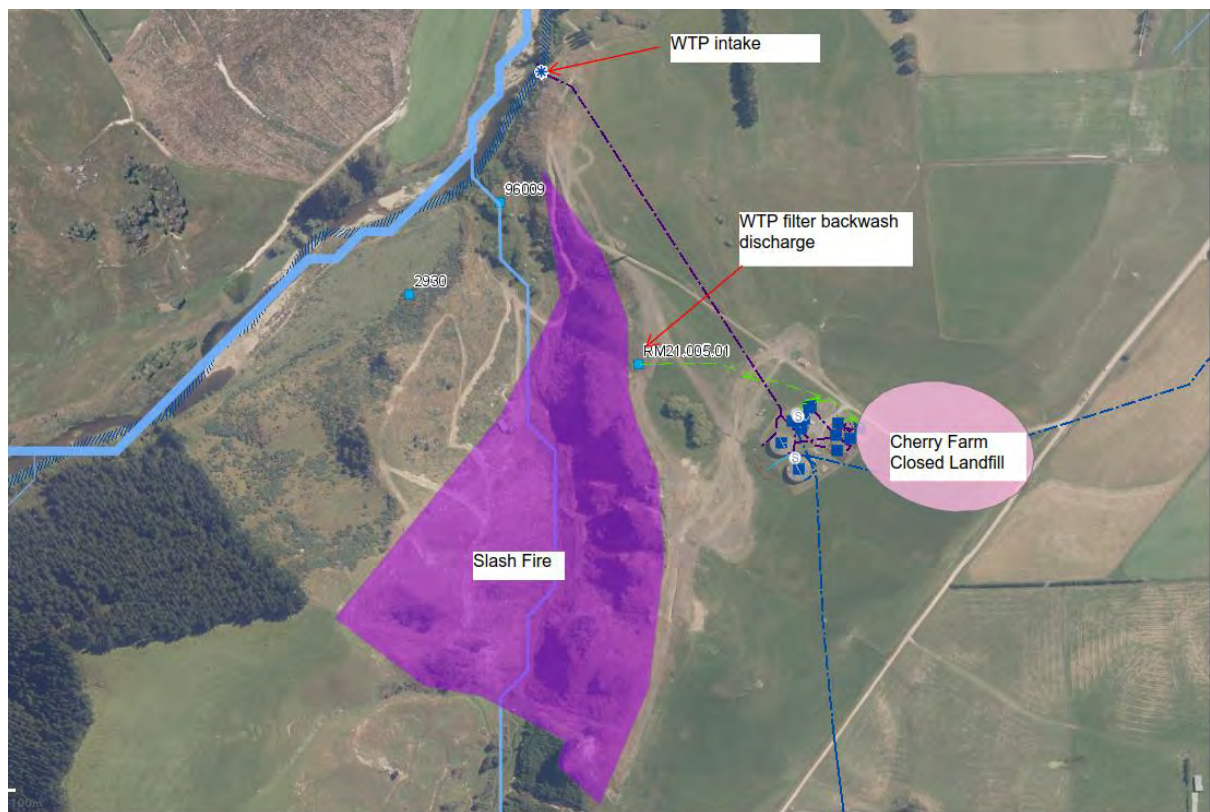
Figure 17: Summary of potential contaminant sources within the vicinity of the WTP

Anecdotal accounts from DCC staff also describe a fire during early 2020. Forestry slash located on the hillside above a small tributary that enters the Waikouaiti River about 125 m upstream of the intake. Residual ash from the fire may have elevated lead concentrations. See Figure 17 in Section 6.4 below for approximate extent.

ORC have completed a review of available reporting for the Cherry Farm former landfill site, including a review of historical aerial imagery (review provided in Appendix B). The review concluded that the landfill is likely to be located immediately to the east of the WTP (as shown in Figure 17 below). However, the exact location, extent and contents of the landfill are still highly uncertain. Historical correspondence between Otago Regional Hospital and Waikouaiti County Council indicates that the landfill received waste from the Otago Hospital (likely waste water treatment plant sludge).

Beyond the immediate vicinity of the WTP intake, the following potential contamination sources were identified:

- Unknown "blue containers" located next to the river at Bucklands Crossing,
- Ash associated with the 2019 forest fire at Bucklands Crossing,
- Pesticide or other chemical storage The Eldorado Farm stockyards and shearing sheds,
- General soil disturbance during farming (reseeding/cropping) and forestry harvesting widespread across the catchment,
- A relatively large fly dump located on a tributary near Eldorado Farm (location and contents to be confirmed),
- Macrae's mine various discharges from overburden and tailings pile drainage/dams that enter the upper reaches of the North Branch,
- Recreational activities (such as shooting using lead shot) within or adjacent to the river that may deposit lead into the waterway.

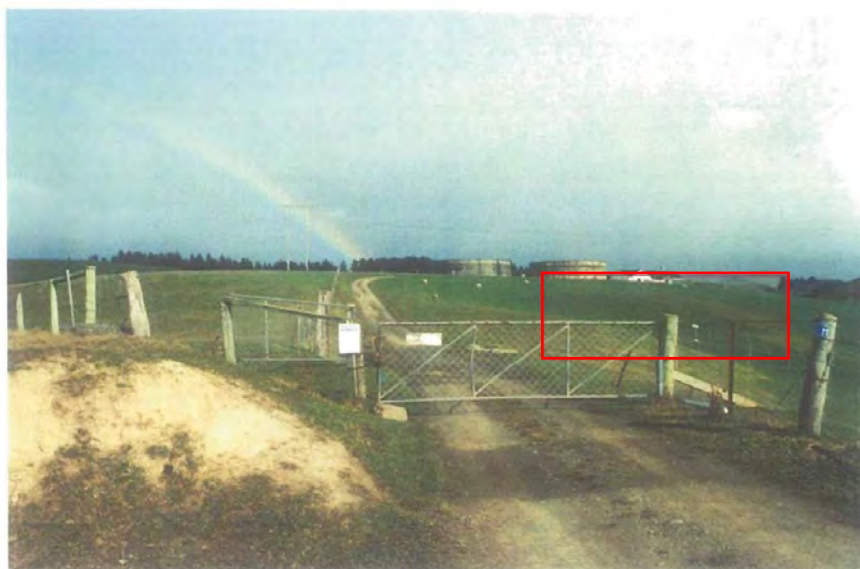
**Figure 6.2** Cherry Farm landfill (in red square, panoramic view)

**Figure 2:** The view towards the water treatment plant. The possible location of the landfill is indicated on the slope to the right side of Walker Road, according to the 2005 DCC Closed landfill report.

The vegetated landfill cap is intact and forms a mound that is “not obvious to the eye” (the mound blends in seamlessly with its surroundings). Figure 6.2 extracted from the report depict the general location of the landfill. The location on the above image implies that the footprint of the landfill does not extend beyond the access road (Walker Road) leading to the water treatment plant. The document also states that are no obvious drains or leachate collection structures.

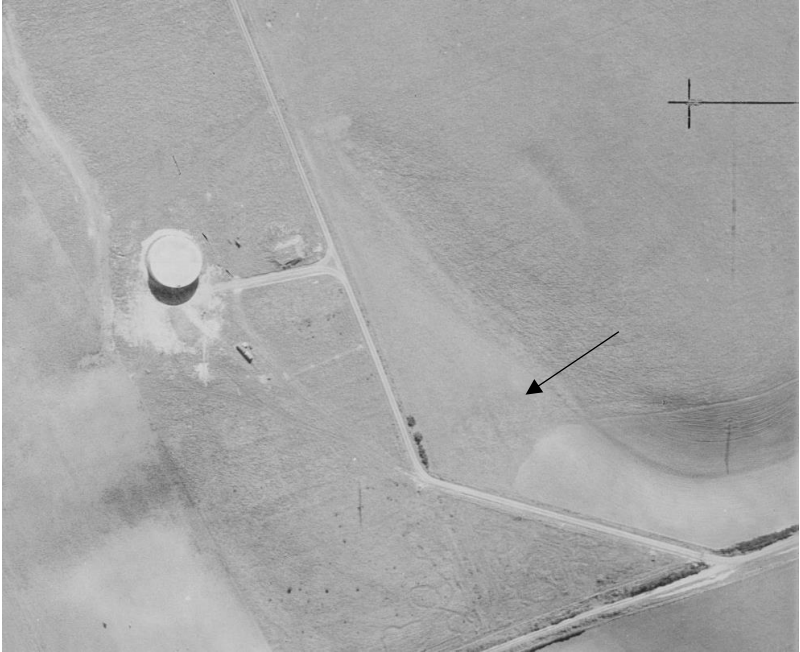
| <p><b>1956 Retrolens Aerial Photo extract of the study area</b></p> | <p>Figure 3: The Retrolens aerial photo extract above does not show visible indicators including exposed fill material within the general landfill footprint as described in the 2005 DCC Closed Landfill Audit Report. Surface disturbances resembling vehicle tracks are visible in the area between Mountain Road and Walker Road.</p> |

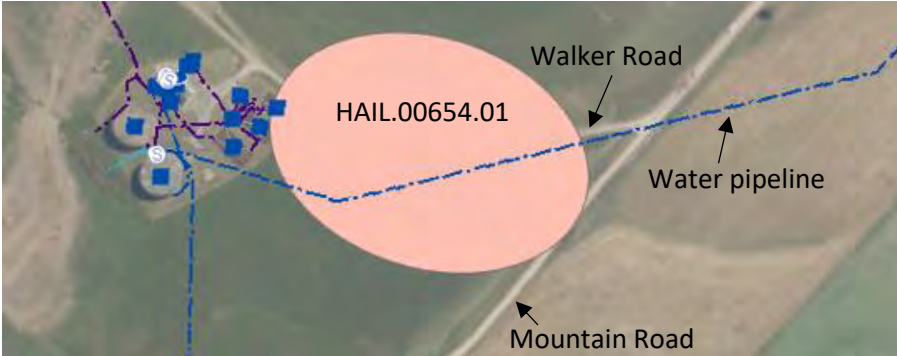
| <b>Conclusions:</b> | <p>The image below depicts the location of the Waikouaiti Water Treatment Plant and associated infrastructure, in relation to HAIL.00654.01 which indicate the general location of the former Cherry Farm Landfill Site . It is worth noting that the location as depicted in the HAIL Database, is not based on official survey plans.</p> <p>Based on the available information relating to the location of the former Cherry Farm Landfill, it is probable that the landfill footprint does not extend beyond Walker Road. However, it cannot be confirmed that the water pipeline is buried outside the former landfill footprint.</p> | | |
