Waikouaiti Metals – Investigation Report

A number of elevated lead results were found in the Waikouaiti, Karitane, and Hawksbury Village water supply scheme between 31 July 2020 and 20 January 2021. On 2 February 2021, the Dunedin City Council issued a Do Not Drink Notice (DNDN) for this scheme. Since then, an investigation team has been working to understand the causes of the results and determine the risks to public health as far as practicable. A key aspect of this is to understand the cause of the exceptional values observed on 8 December 2020 (at Waikouaiti Golf Club and Karitane Bowling Club) and 20 January 2021 (in the raw water reservoir).

This report details the investigation team's findings about the source of the elevated lead results. The investigation included a review of potential lead sources and a high-level overview of potential sources/causes of high readings is included in the table below.

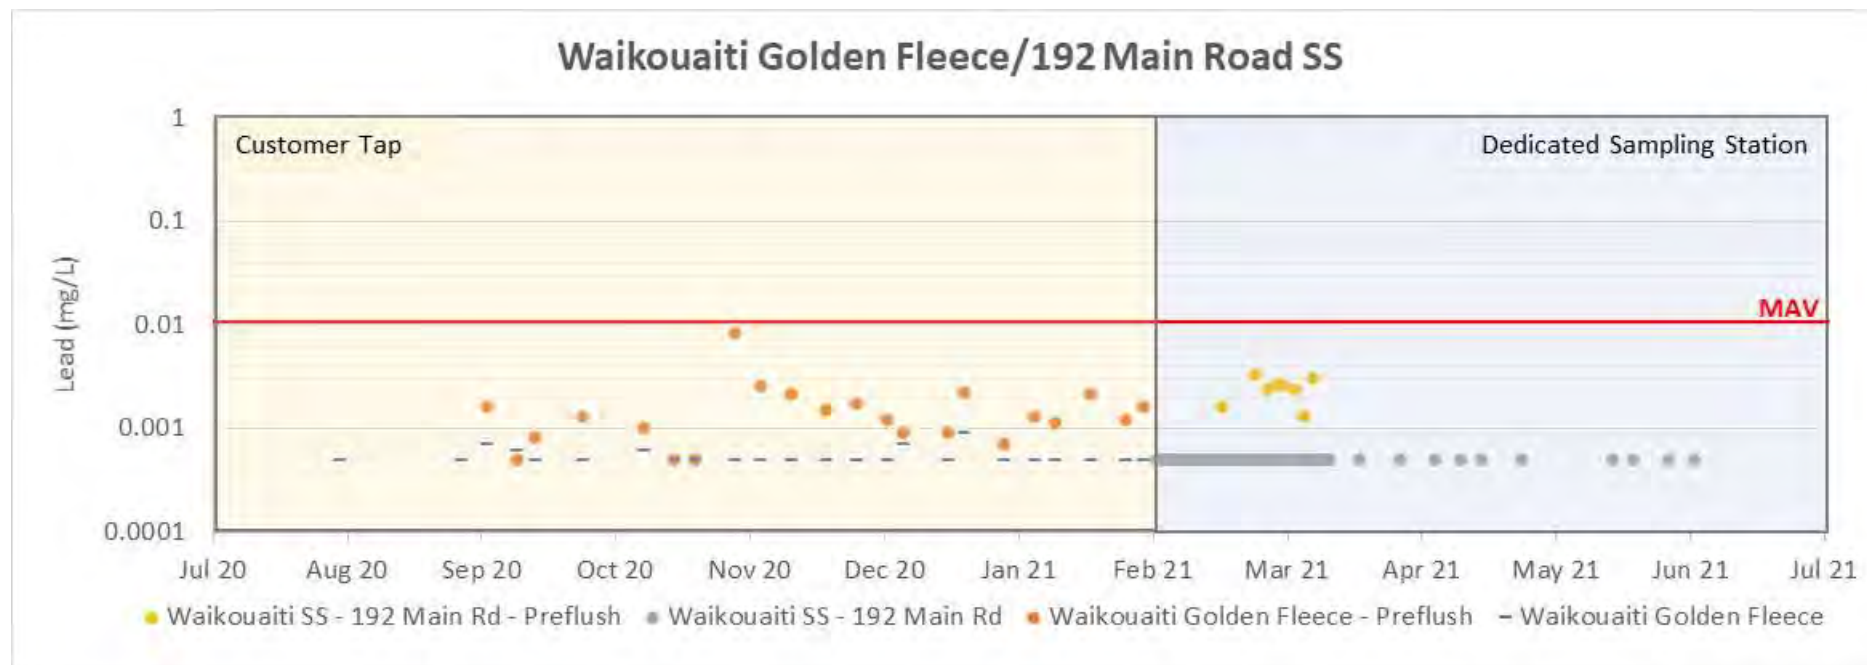
Figure 2: Lead Measurements at Waikouaiti Golden Fleece and 192 Main Rd SS (31/7/20 – 8/6/21)

Figure 2 - Data from Waikouaiti Golden Fleece Hotel/192 Main Road. Key observations are:

- Since the dedicated sample station was activated, post-flush lead results have been below the limit of detection in all 94 samples. This supports the theory that pre-flush lead results from Waikouaiti Golden Fleece Hotel are caused by localised lead leaching associated with the sample tap and associated pipework and fittings.

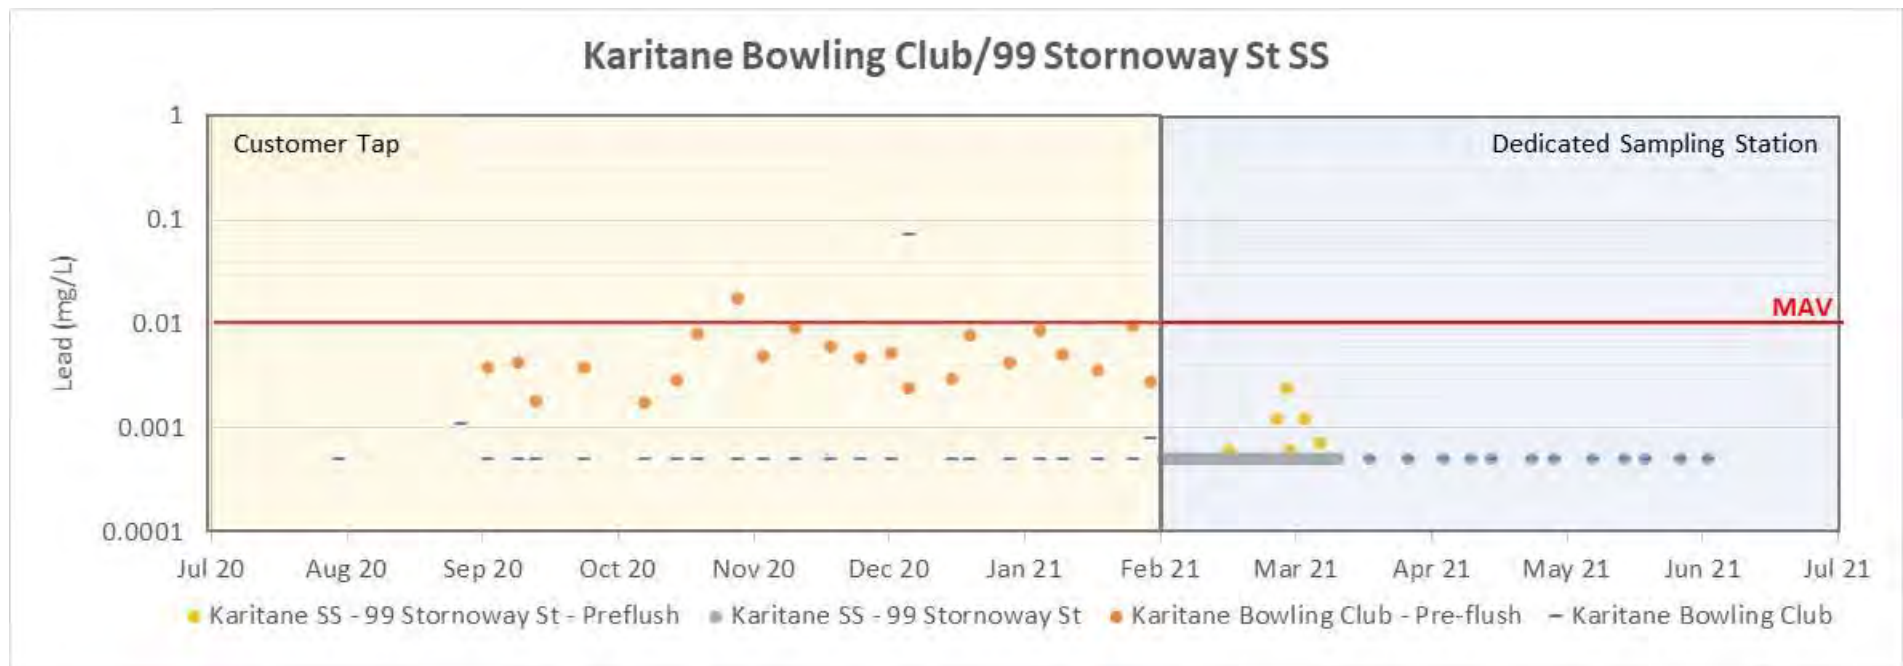
Figure 3: Lead Measurements at Karitane Bowling Club and 99 Stornoway St SS (31/7/20 – 8/6/21)

Figure 3 - Data from Karitane Bowling Club/99 Stornoway Street. Key observations are:

- An exceptional reading greater than 100 times typical values was recorded on 8 December 2020 (0.072mg/L). The following reading on 18 December 2020 showed a return to typical levels. Typical values of all post-flush results from the Karitane Bowling Club were observed to be less than LOD (more than 90% were less than LOD). Potential causes for the exceptional reading are discussed further in sections 5 and 6.

Club tap (potentially except for the abnormal value on 8 December) are caused by localised lead leaching associated with the sample tap and associated pipework and fittings. 6 out of 82 pre-flush samples were above LOD.

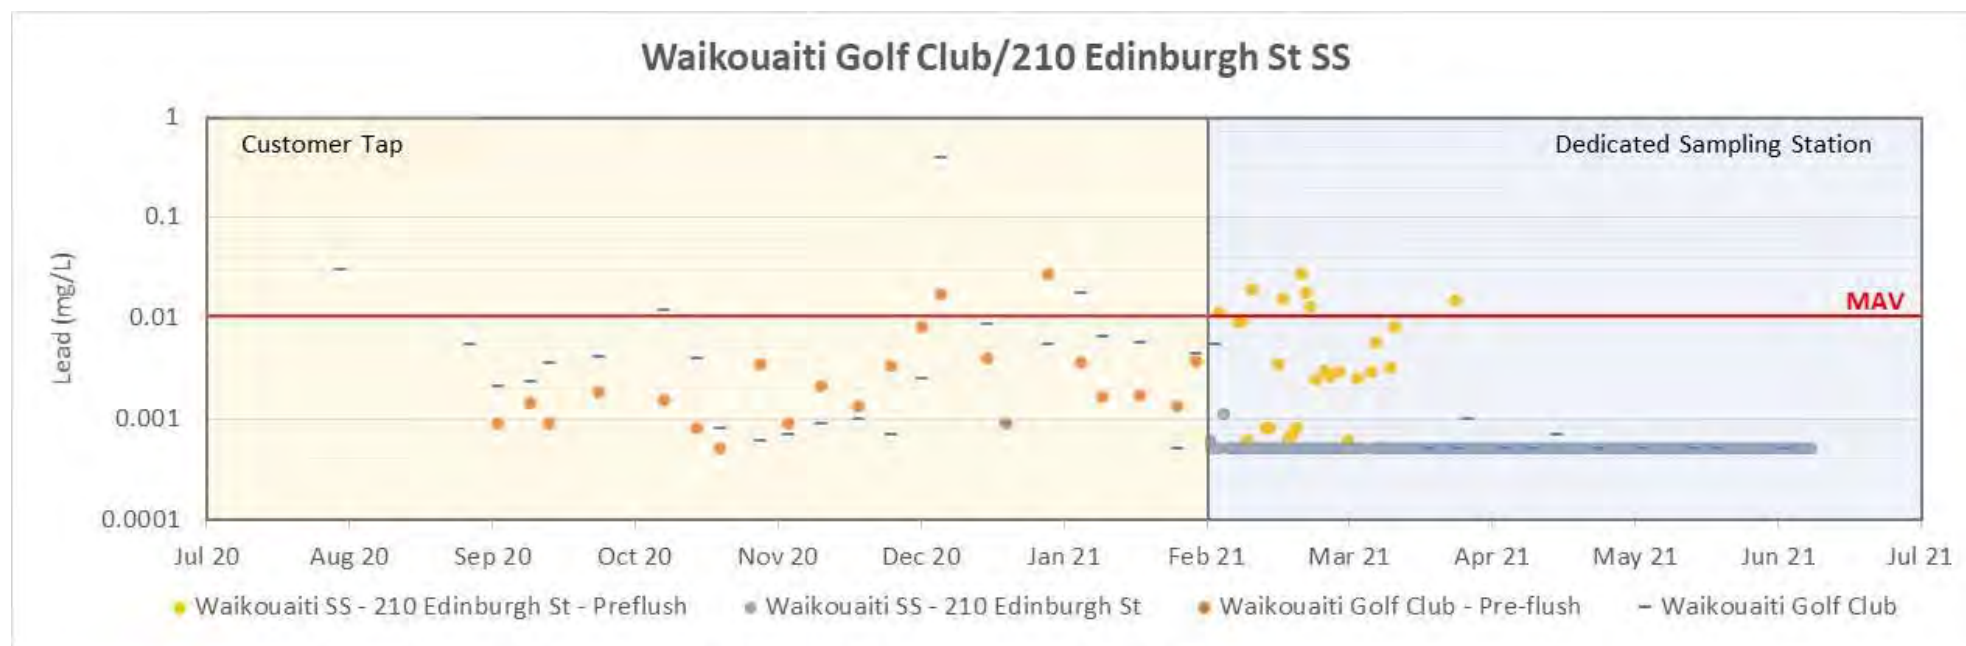
Figure 4: Lead Measurements at Waikouaiti Golf Club and 210 Edinburgh St SS (31/7/20 – 14/6/21)

Figure 4 - Data from Waikouaiti Golf Club/210 Edinburgh Street. Key observations are:

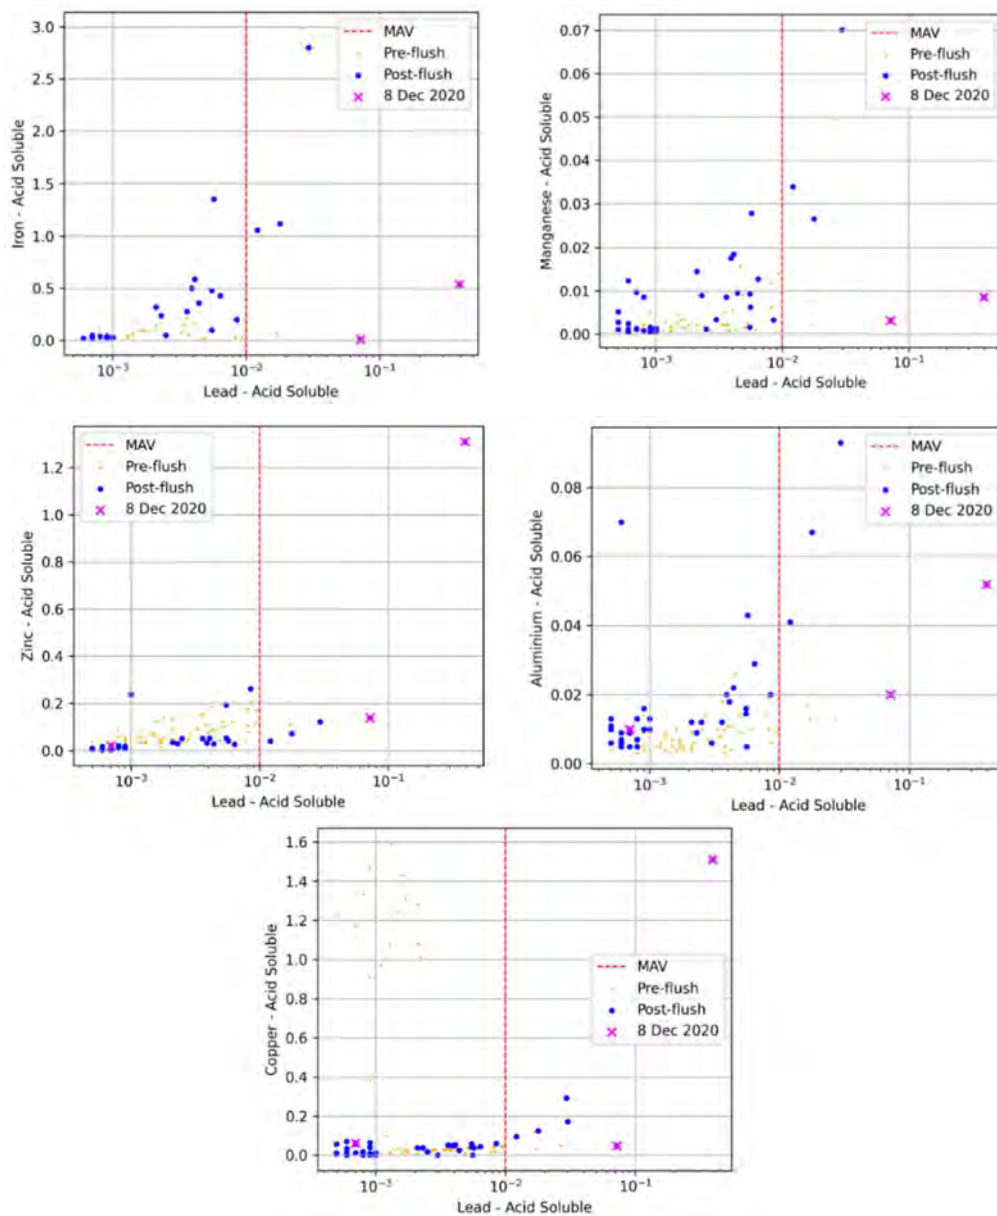
It appears that iron and manganese are particularly low on 8 December 2020 compared to other results as there is a weak positive correlation between lead and other metals. Aluminium appears to be low on 8 December 2020 compared to other post-flush samples, but may follow a similar trend to pre-flush samples. It is unclear whether zinc follows a trend without more detailed analysis.

Figure 16: Bivariate Plots of Iron, Manganese, Zinc, Aluminium, and Copper versus Lead

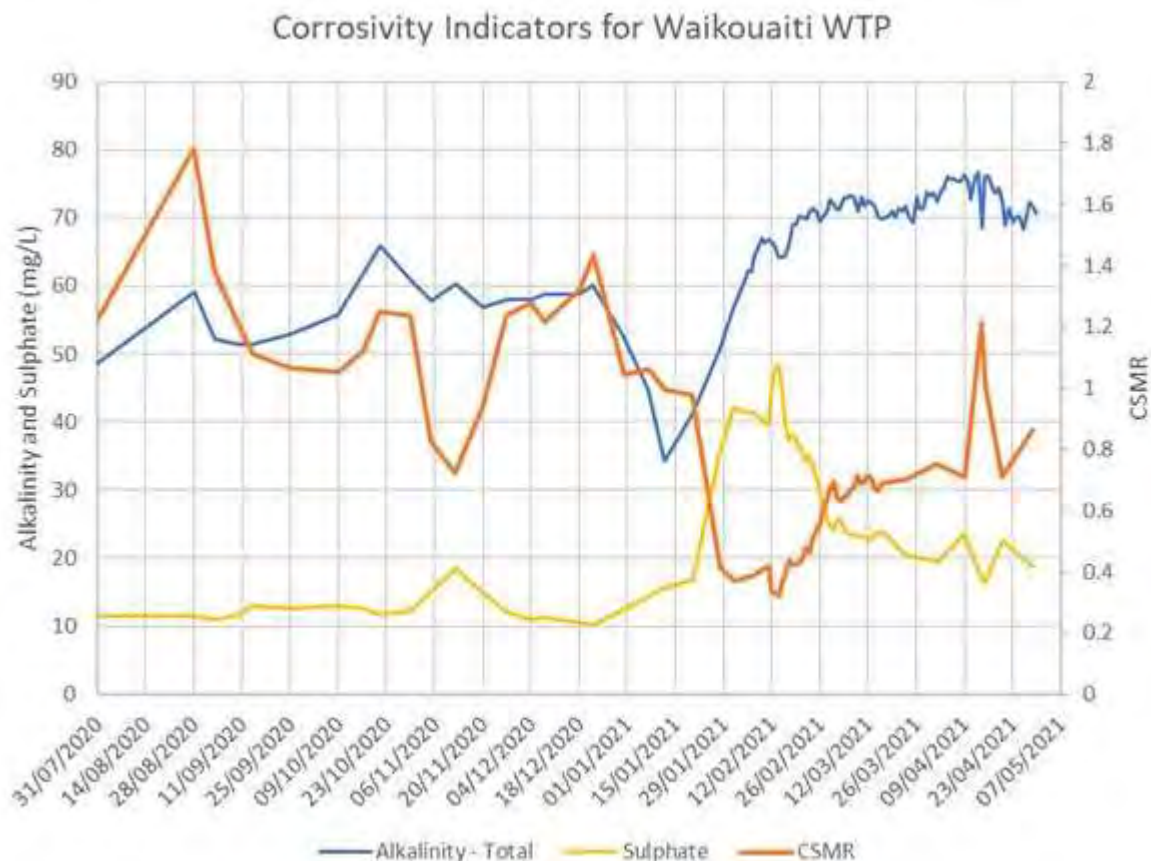
Figure 17 shows alkalinity and sulphate from samples taken at the Waikouaiti Golf Club. Changes in these parameters are mostly due to changes in source water rather than the treatment process.

Figure 17: Alkalinity, CSMR and Sulphate

Sulphate increased significantly in late January 2021, and a drop in alkalinity occurred at the start of January. A large rain event occurred in early January and the drop in alkalinity can be caused by rainfall and runoff (which have low alkalinity) diluting the river water. The sulphate (and therefore CSMR, because chloride is relatively stable) experienced a step change shortly after the rain event in early January. Data analysis indicates that changes in the sulphate level typically correlate with mining-related activities in the catchment and potentially including a discharge from Fraser's Pit (part of Oceana Gold Macraes facility) from 15 January 2021 until 21 January 2021. Lab results from this discharge on 15 January 2021 showed undetectable dissolved lead concentrations. Additionally, Oceana Gold indicated that waste rock piles in the upper catchment can absorb water during heavy rainfall and gradually leach sulphates into the ground water after the rain event as well. More evidence to support this is included in the CRA attached in Appendix G. Sulphate is not a public health concern in drinking water until it reaches very high levels. In general metals from waste rock are less mobile than sulphate, so an increase in sulphate does not directly indicate that increased metals occurred too.

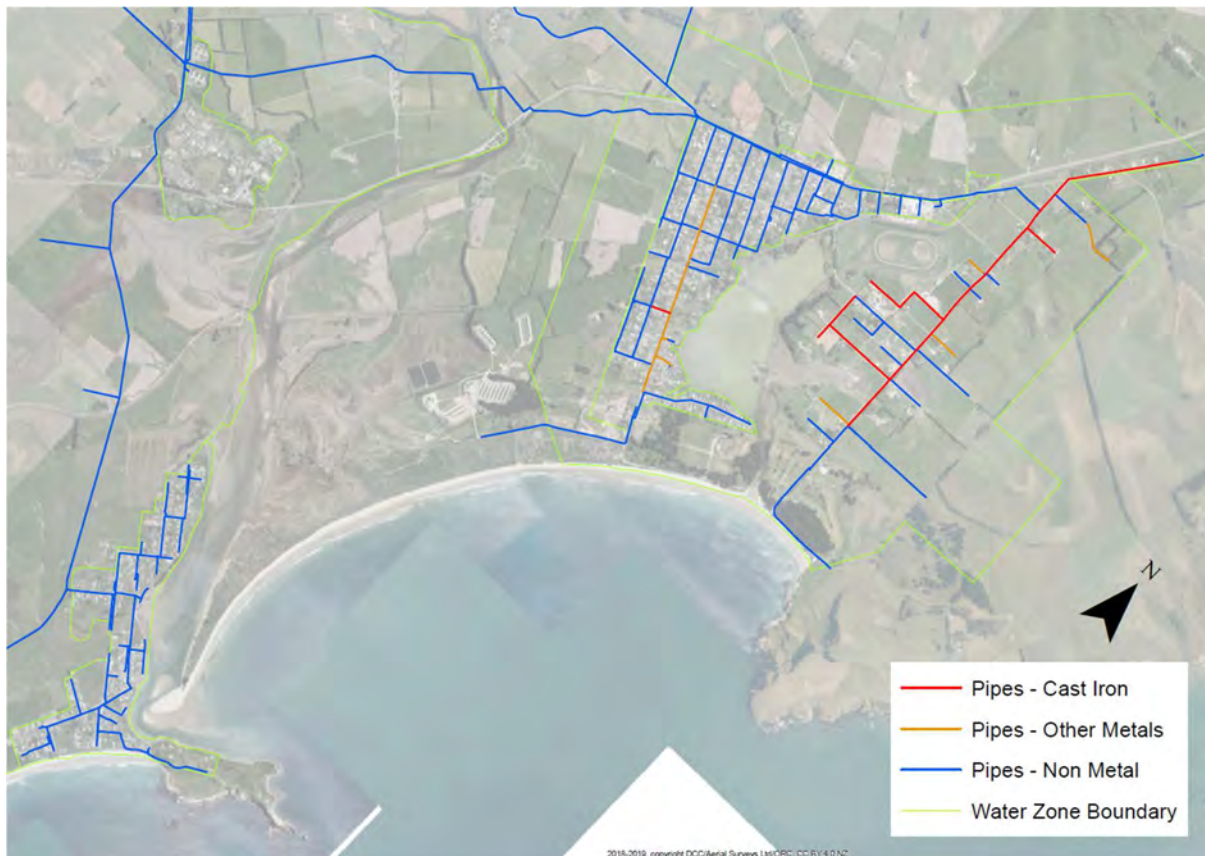
Figure 20 below shows the location of different pipe materials in the Waikouaiti, Karitane, and Hawksbury Village distribution network of relevance to this investigation. The majority of the pipework in the network is non-metallic, however, there are some areas with cast iron and other metals. Cast iron mains are limited to the Waikouaiti Upper Levels Zone (along Edinburgh Street to the right Figure 20) and a short section of cast iron in the Waikouaiti Lower Levels Zone (just above the centre of Figure 20). The Karitane zone (lower left of Figure 20) is not known to have any metallic pipes in the network.

Figure 20: Partial Map of Waikouaiti, Karitane, and Hawksbury Village Distribution Network.

While network lead leaching is a potential cause of high lead readings in samples taken from the Waikouaiti Golf Club on 8 December 2020, the Karitane Bowling Club result on the same day could not be explained by this mechanism because there is no known source of lead in the distribution pipework upstream of this location. Furthermore, the elevated levels at the raw water reservoir on 20 January 2021 would not be explained by this mechanism due to the absence of lead bearing pipework upstream of the raw water reservoir.

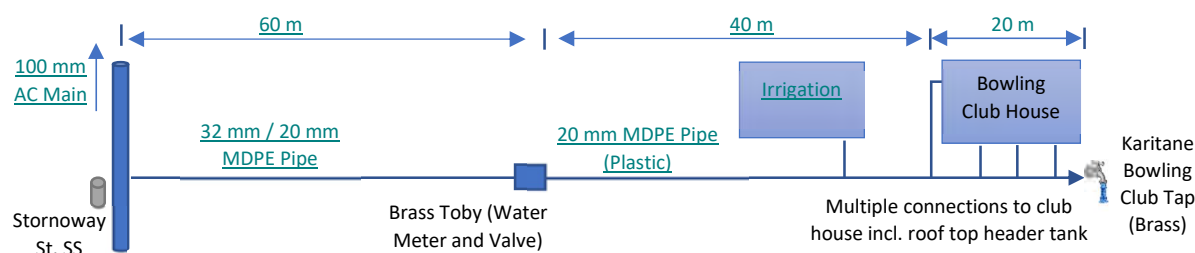
- A connection to an irrigation system connected at an unknown location.
- The time to fill a bucket was measured and based on this, the flow rate from the sample tap at the Karitane Bowling Club was estimated to be 0.1 L/s. The total volume in the supply line to the tap was estimated to be 25 L (based on pipe length and diameter) therefore the time to flush one volume of water out of the supply line is about four minutes, just under the five minute flushing protocol that was used by Eurofins. However, this could vary with changes in water pressure and interactions with other aspects of the customer pipework. Flushing is a necessary, but not sufficient condition to produce a sample representative of the main, as lead present in flushed samples may still originate from local plumbing.

Figure 23: Karitane Bowling Club Sample Tap Schematic (indicative and not to scale)

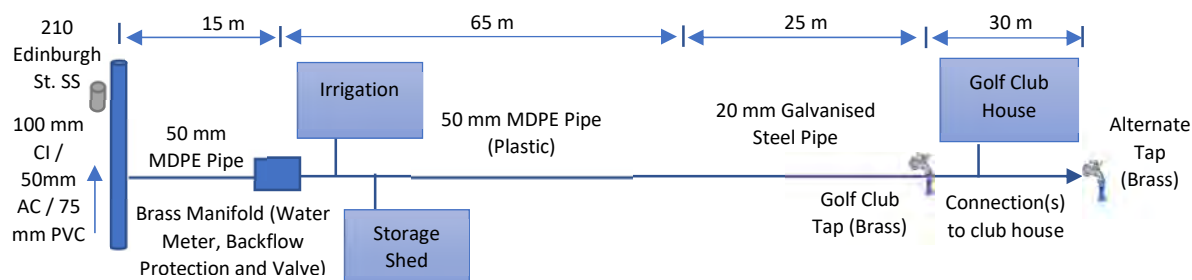
- The time to fill a 10-litre bucket was measured and based on this the flow rate from the sample tap at the Waikouaiti Golf Club was estimated to be 0.5 L/s. The total volume in the supply line to the tap was estimated to be 110 L and therefore the time to flush one volume of water out of the supply line is just under four minutes, which is under the five minute flushing protocol that was used by Eurofins. However, this could vary with changes in water pressure and interactions with other aspects of the customer pipework.

Figure 24: Waikouaiti Golf Club Sample Tap Schematic (indicative and not to scale)

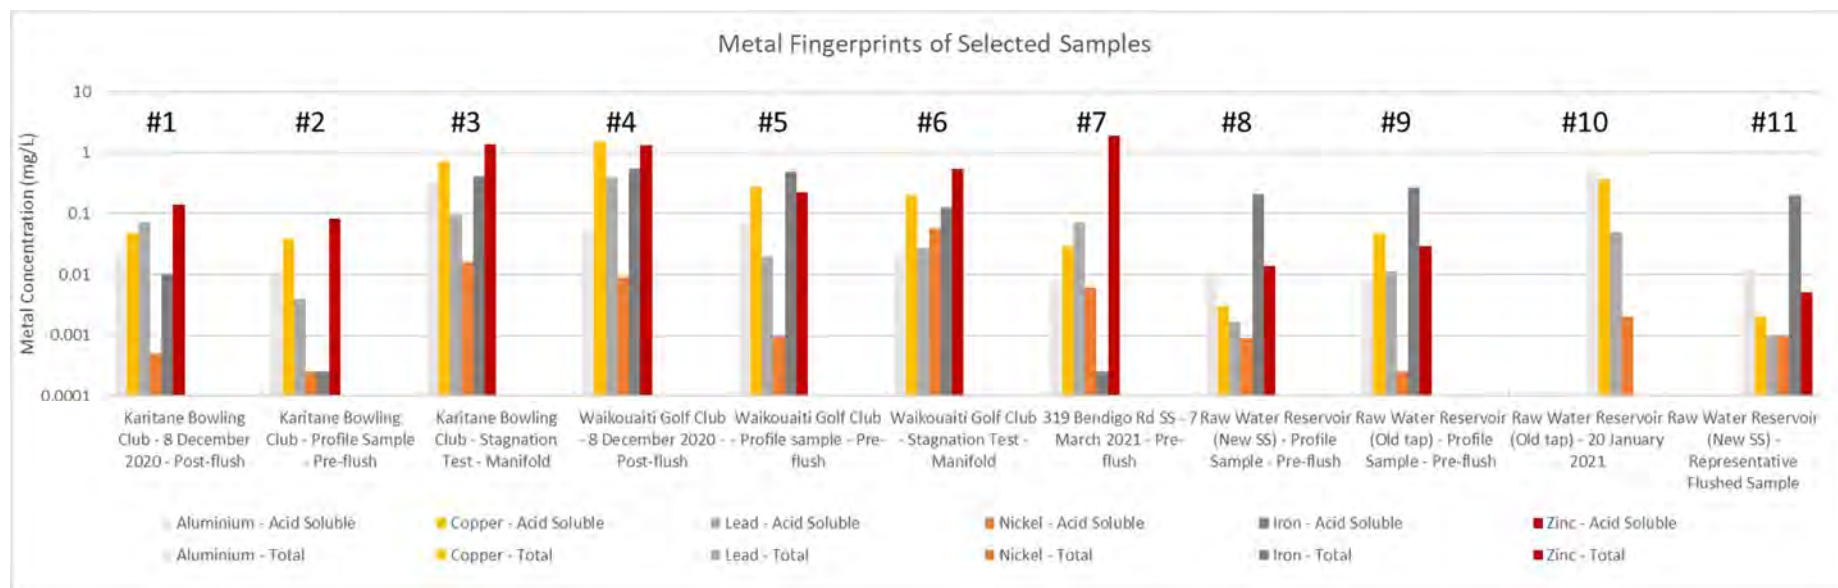
- The two exceptional results observed in post-flush samples taken on 8 December 2020 at the Karitane Bowling Club and the Waikouaiti Golf Club (#1 and #4 in Figure 33).
- The moderately elevated results observed in pre-flush profile samples (see section 5.6.3.1) taken on 22 April 2021 at the Karitane Bowling Club and the Waikouaiti Golf Club (#2 and #5).

- The results from 24-hour stagnation tests (see section 5.6.2) of manifolds from the Karitane Bowling Club and the Waikouaiti Golf Club (#3 and #6).
- The results of a pre-flush sample taken on 7 March 2021 from a recently installed, stainless steel dedicated SS at 319 Bendigo Road (#7).
- The results from pre-flush profile samples (see section 5.6.3.1) taken on 23 April 2021 from an old sample tap (#8) and a recently installed, stainless steel SS (#9) at the raw water reservoir.
- Finally, the results from a post-flush sample taken from the old sample tap at the raw water reservoir on 20 January 2021 (#10).

Figure 33: Metal Profile of Selected Samples

- Aluminium in sample #10 is higher than any other sample in Figure 33 and is present at a level which is uncommon in the Waikouaiti River water (typically <0.05). A potential cause of this high aluminium result and the associated lead result is discussed more in the section 5.7.5.

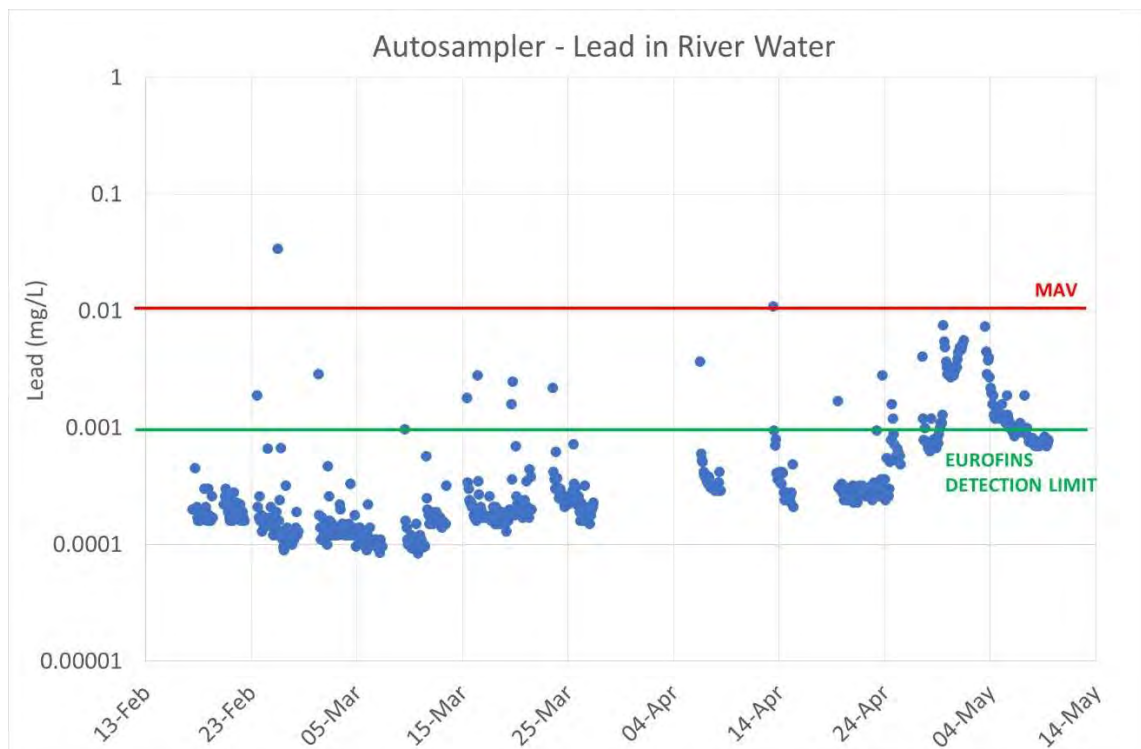
Of more than 500 river samples analysed, only two results were above MAV. The samples above MAV were 0.034 mg/L and 0.011 mg/L and were both from the first sample bottle in the autosampler. Samples from the first bottles tended to show significantly higher variation than any other sample bottles which indicates a potential systemic issue with one or more of the first sample bottles (four sets of bottles are used in rotation).

Figure 35: Autosampler – Lead in River Samples

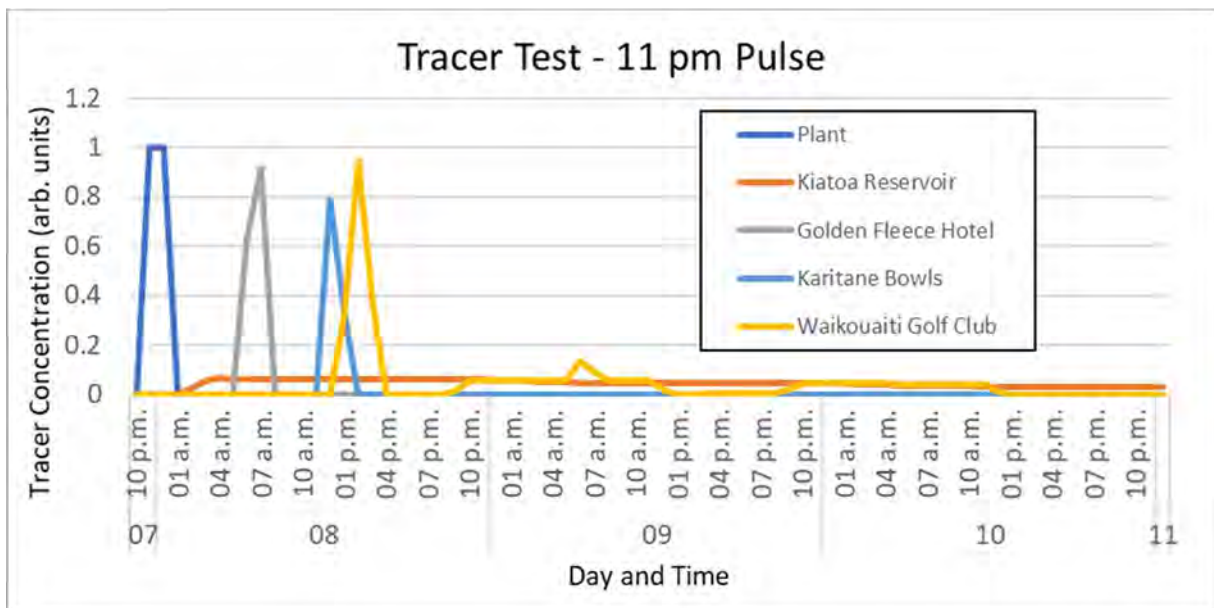
Figure 40: Tracer Test: 11 pm on 7 December 2020

- Pulse starts at 7pm on 7 December 2020 - McGrath Road pumps are not operating throughout this pulse and as such Waikouaiti Upper Levels Zone is supplied by water already pumped to Kiatoa Reservoir the previous day. This is shown in Figure 39.
- Pulse starts at 11pm on 7 December 2020 - McGrath Road pumps operate and the pulse reaches Kiatoa Reservoir where it is diluted prior to subsequent release. Some material bypasses Kiatoa Reservoir and is supplied direct to Waikouaiti High Levels. This is shown in Figure 40.
- Pulse starts at 3am on 8 December 2020 - McGrath Road pumps operate and the pulse reaches Kiatoa Reservoir where it is diluted prior to subsequent release. Some material bypasses Kiatoa Reservoir and is supplied direct to Waikouaiti High Levels. This is shown in Figure 41.

These pulses all arrive at the Waikouaiti Golden Fleece Hotel first, followed by the Karitane Bowling Club approximately 5-6 hours later. If the McGrath Road pumps were running during the pulse, then the Waikouaiti Golf Club would receive the pulse a further 2-3 hours after the Karitane Bowling Club. There are subsequent lower level pulses in the Waikouaiti Golf Club which are due to the pulse contaminating Kiatoa Reservoir and being supplied across a number of days (the level is lower due to dilution in the reservoir).

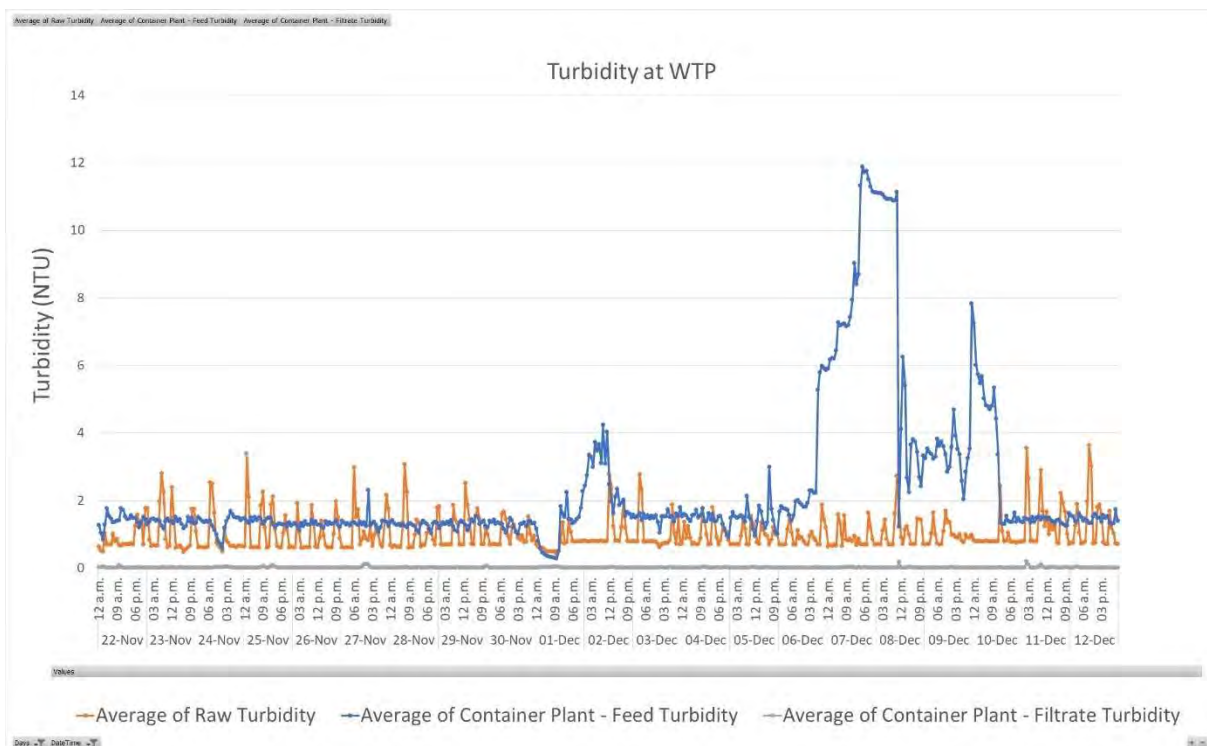
Figure 43: Raw Turbidity, Feed Turbidity, and Filtrate Turbidity

Figure 43 shows Raw Turbidity, Feed Turbidity, and Filtrate Turbidity. Raw Turbidity is measured at the raw water pump station and measures river water turbidity. The Feed Turbidity monitor is positioned after the flocc tank (downstream of a return stream from the tube settler).

Figure 43 shows the feed turbidity rises on 7 December 2020 while raw water turbidity remained at a consistent level. Generally, the turbidity from the raw to the feed will increase due to floc forming and this can be seen in the baseline levels of both the raw and feed turbidity. However, the increase in turbidity on 7 December 2020 is significantly higher than typically observed. This could be caused by the carry over of solids from the tube settler (see section 5.8.2 for further discussion of the operation of this process unit). Turbidity caused by the carry over of solids from the tube settler would inherently be particulate material which should be removed by the downstream membrane process. It would not be expected to cause elevated lead levels in treated water. The dosed water in the floc tank does have slightly reduced pH (typically between 6.5 and 7). However, this is not expected to cause dissolution of lead.

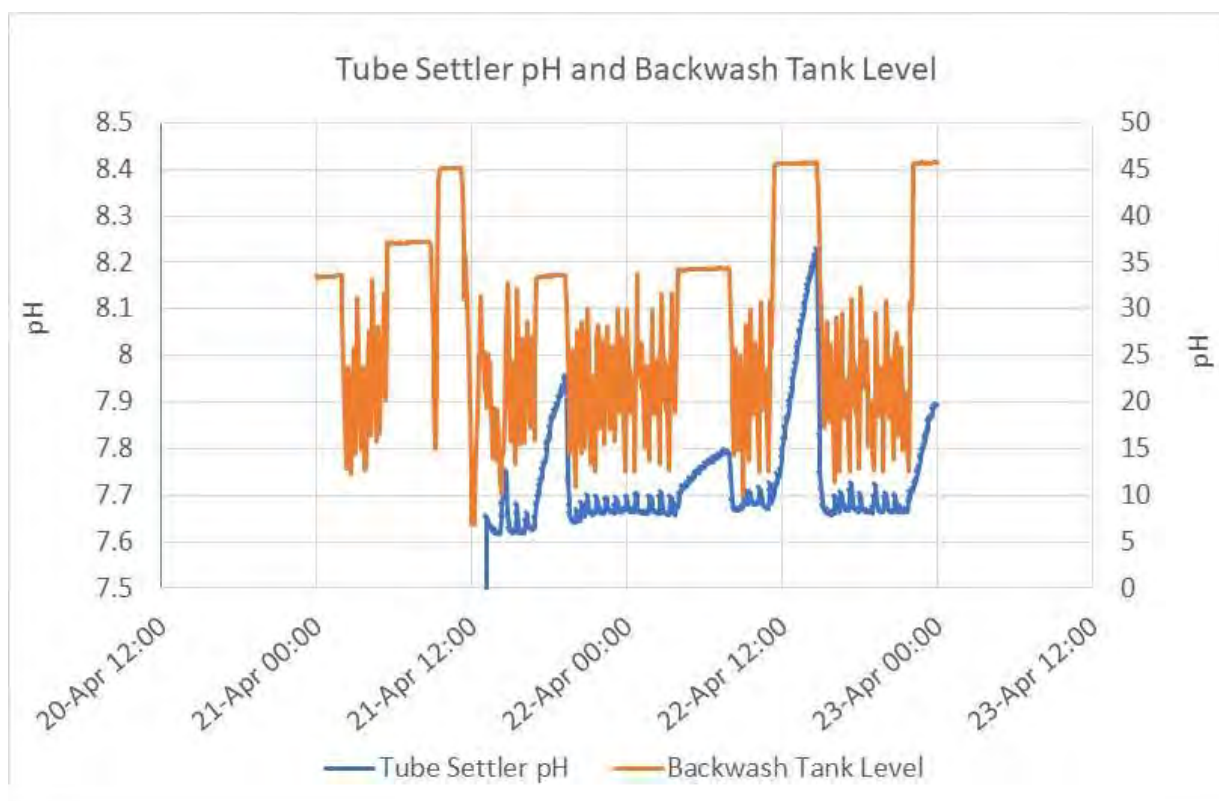
Figure 44: Tube Settler pH and Backwash Tank Level

To understand if it is feasible for low pH material to be present in the tube settler the supernatant and post clean flush water pH were monitored during chemical cleans. Three samples were taken, and the pH of the water in these samples were all greater than 7.5. The pH of the tube settler supernatant did not drop below 7.6. Continuous pH monitoring of the tube settler supernatant was set up from 21 April 2021 and shows a stable pH between 7.6 and 7.8 when the backwash pumps are running as shown in Figure 44.

Figure 44 shows a periodic increase in pH. The rises are almost certainly an artefact caused by the position of the pH probe in the tube settler and not representative of the actual pH in the tube settler. At these times the backwash tank level is flat meaning the WTP is not producing water. The backwash tanks pump intermittently and small pH rises can be seen in between backwash pump runs. As expected, there is no significant elevation of pH in the tube settler during acid cleans. It is very unlikely that this could be the cause of the elevated lead levels on 8 December 2020, unless there was some unidentified abnormal operation at the time which caused unusual changes in pH.

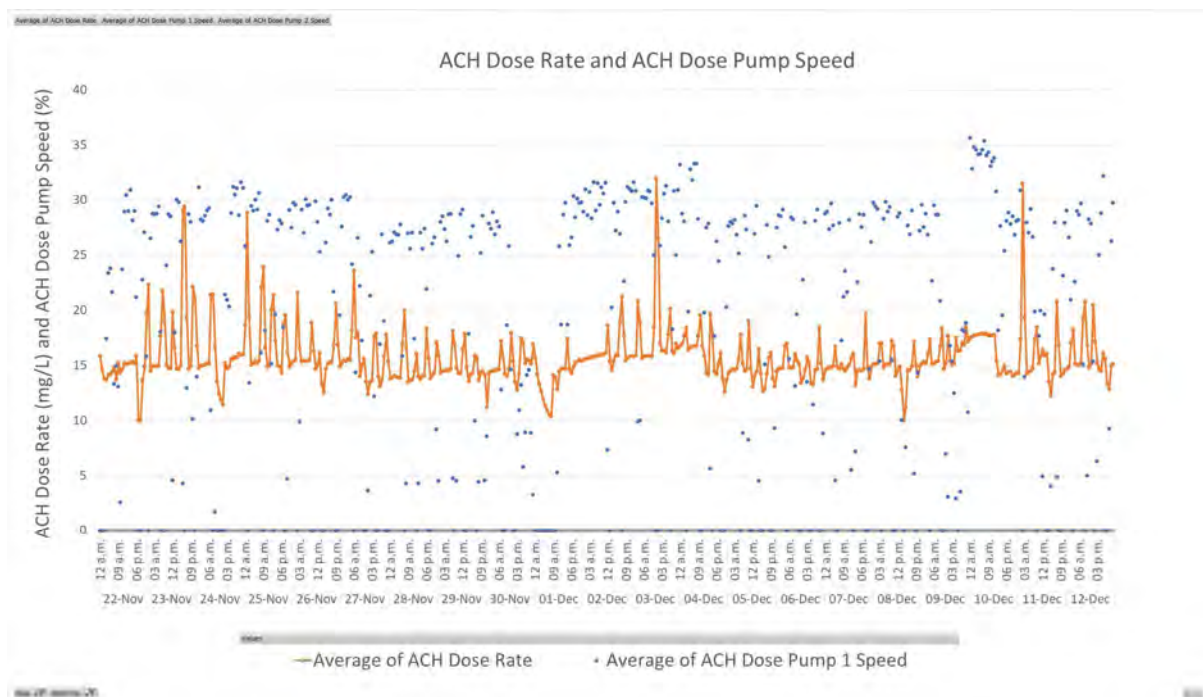
Figure 45: ACH Dose Rate and Pump Speed (22 November 2020 to 12 December 2020)

Figure 45 shows the ACH dose rate which was within normal operating conditions up to 8 December 2020. The dose rate is directly linked to the colour of the raw water. A dose factor (not shown) is also entered manually by the operator to fine tune the coagulation step to reduce the filtered colour. The Dose Pump Speed is also shown, and the pump has been operating within the normal range.

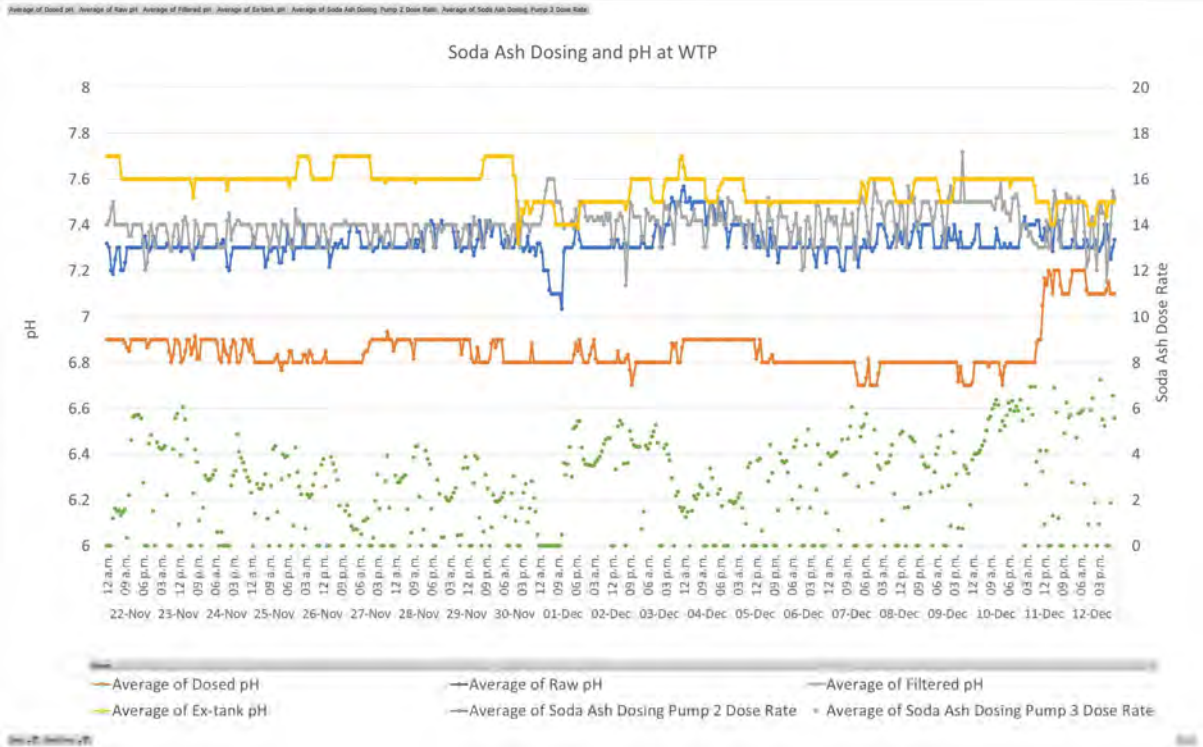
Figure 46 shows soda ash dosing parameters. In the weeks preceding and days immediately after 8 December 2020, soda ash dosing is normal. The plant runs intermittently, so the dose rate is zero when the plant is not running. This is confirmed by ex-tank pH usually being higher than the filtered pH. Soda ash is added after filtration (filtered pH) and increases the pH of treated water (ex-tank pH). All pH trends are within normal range. A calibration was performed on November 30 2020 on the ex-tank pH meter.

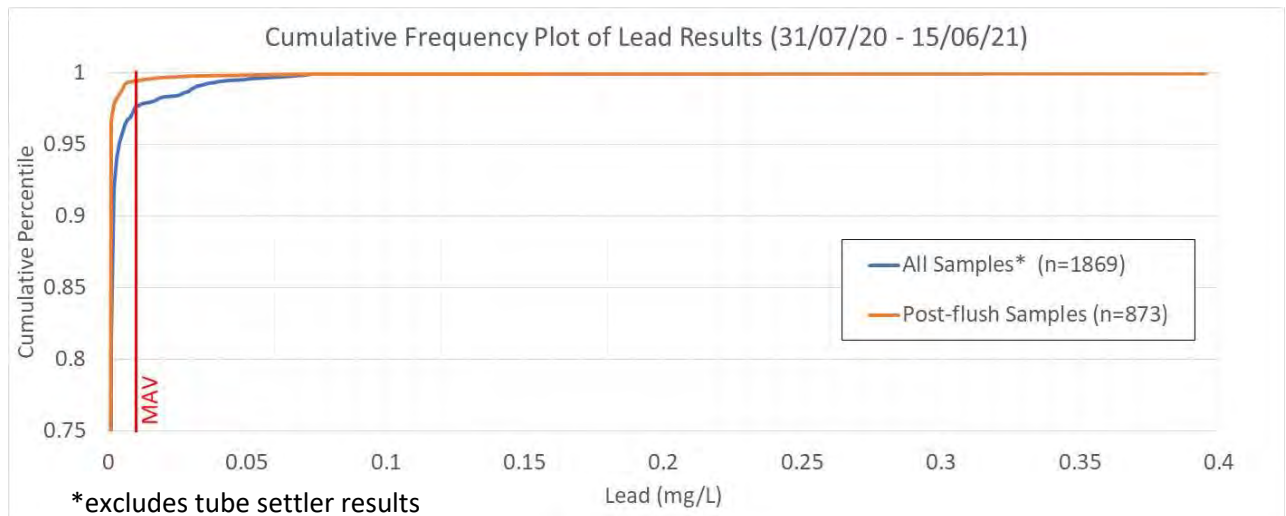
Figure 48: Cumulative frequency plot of lead results (31/07/20 – 15/06/21)

Figure 48 presents a cumulative frequency plot of all of the samples. This demonstrates that more than 99% of post flush samples were less than the MAV and more than 95% of all samples (including preflush) are less than MAV.
