# Lead Source Investigation Update

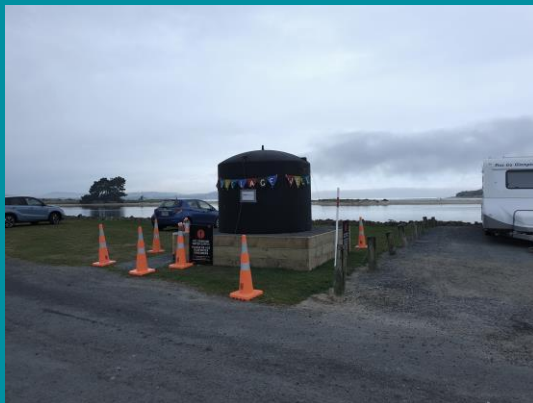
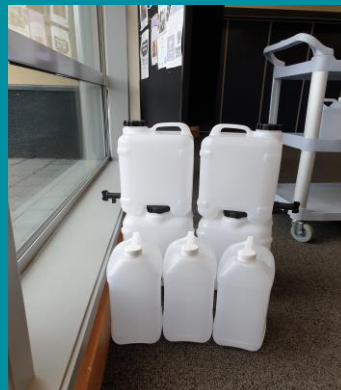
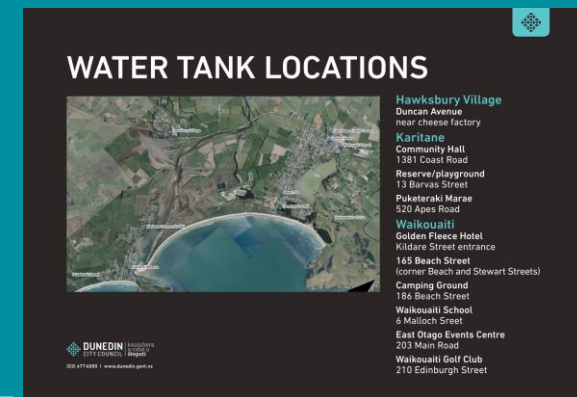
- Local liaison through community board
- Water tanks provided
- Containers provided for water collection
- Home water deliveries where needed
