# Arboricultural Report

# LUC-2024-297 - Request for comment

Prepared by: Roberts Consulting Ltd

Date: September 9, 2024

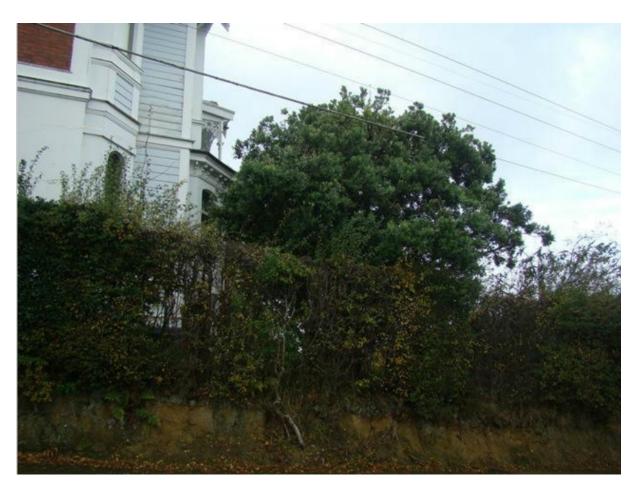
In addition to the above, the only other record relating to the scheduled tree is a '2GP audit', which simply contains a photograph of the tree from outside of the property and its entry into Council's records dates to 6<sup>th</sup> May 2013. This photograph is copied here:
