# Memorandum

**SUBJECT:** LUC-2019-380 – 5 FERNTREE DRIVE – APPLICATION TO REMOVE A SCHEDULED TREE

An application to remove a Scheduled Tree (T444) from DCC road reserve at 5 Ferntree Drive states:

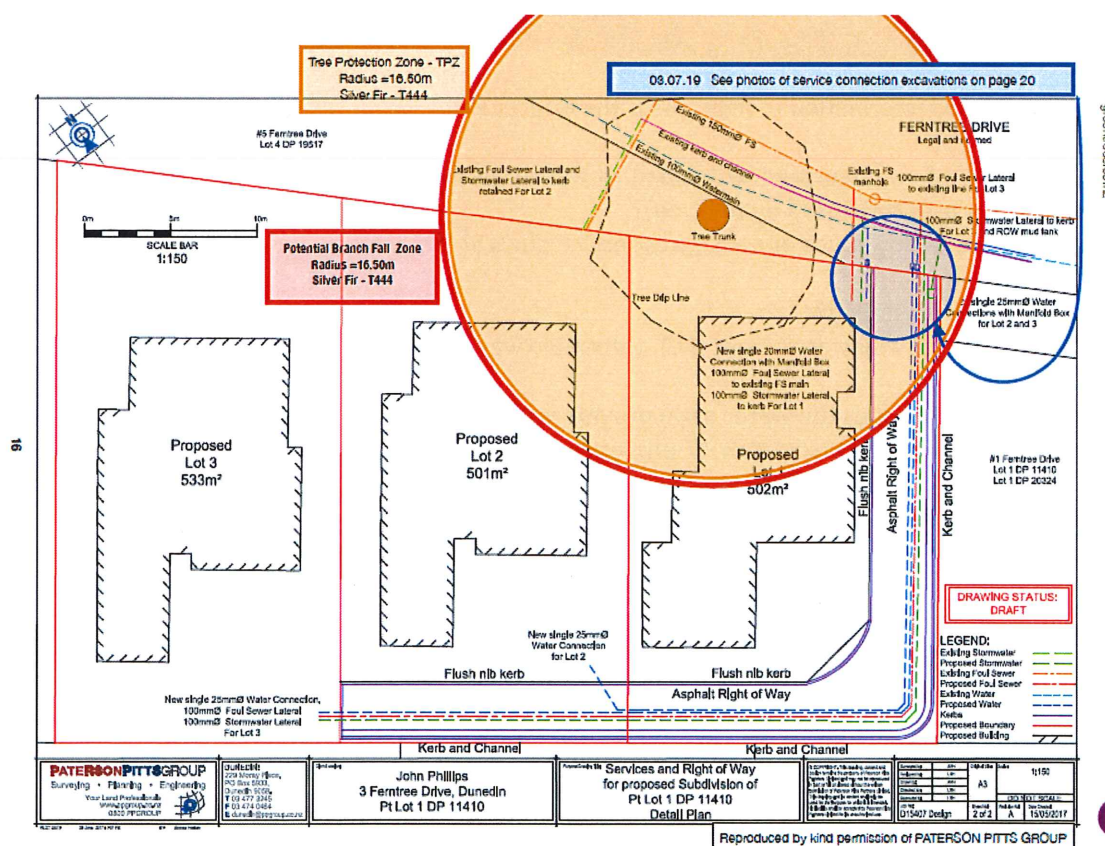
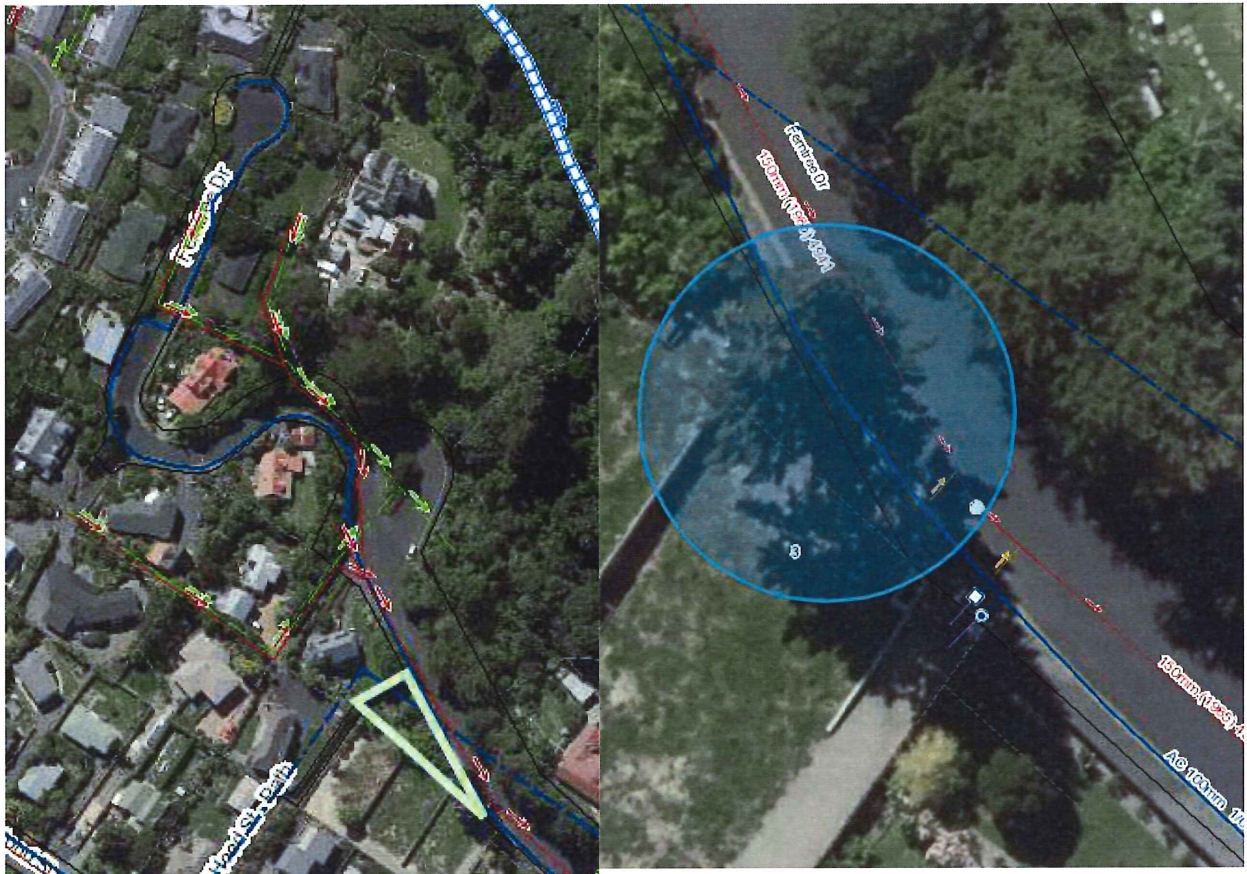
*The tree currently sits very close to a 100mm water-main that supplies a large number of Dunedin homes. This is shown on the attached 'subdivision construction plans' prepared by Patterson Pitts Surveyors. This plan also shows other services that have been installed extensively around the base of the tree. These services were installed some years ago before the tree became listed when it was common practice to cut tree roots during trenching. As outlined in the arborist's report, cutting of these roots over successive years of ground work calls into question the stability of the tree.*

**Is Council aware of any issues with/damage to this watermain or services pipes shown in the survey plan below (that may be caused by the tree)?**

The 100mm diameter asbestos cement (AC) watermain was installed in 1986.

The watermain services approximately 17 properties upgradient of the tree location.
