# Geotechnical Investigations Report

143-193 Moray Place, Dunedin

**November 2016**

**GeoSolve Ref: 160658**

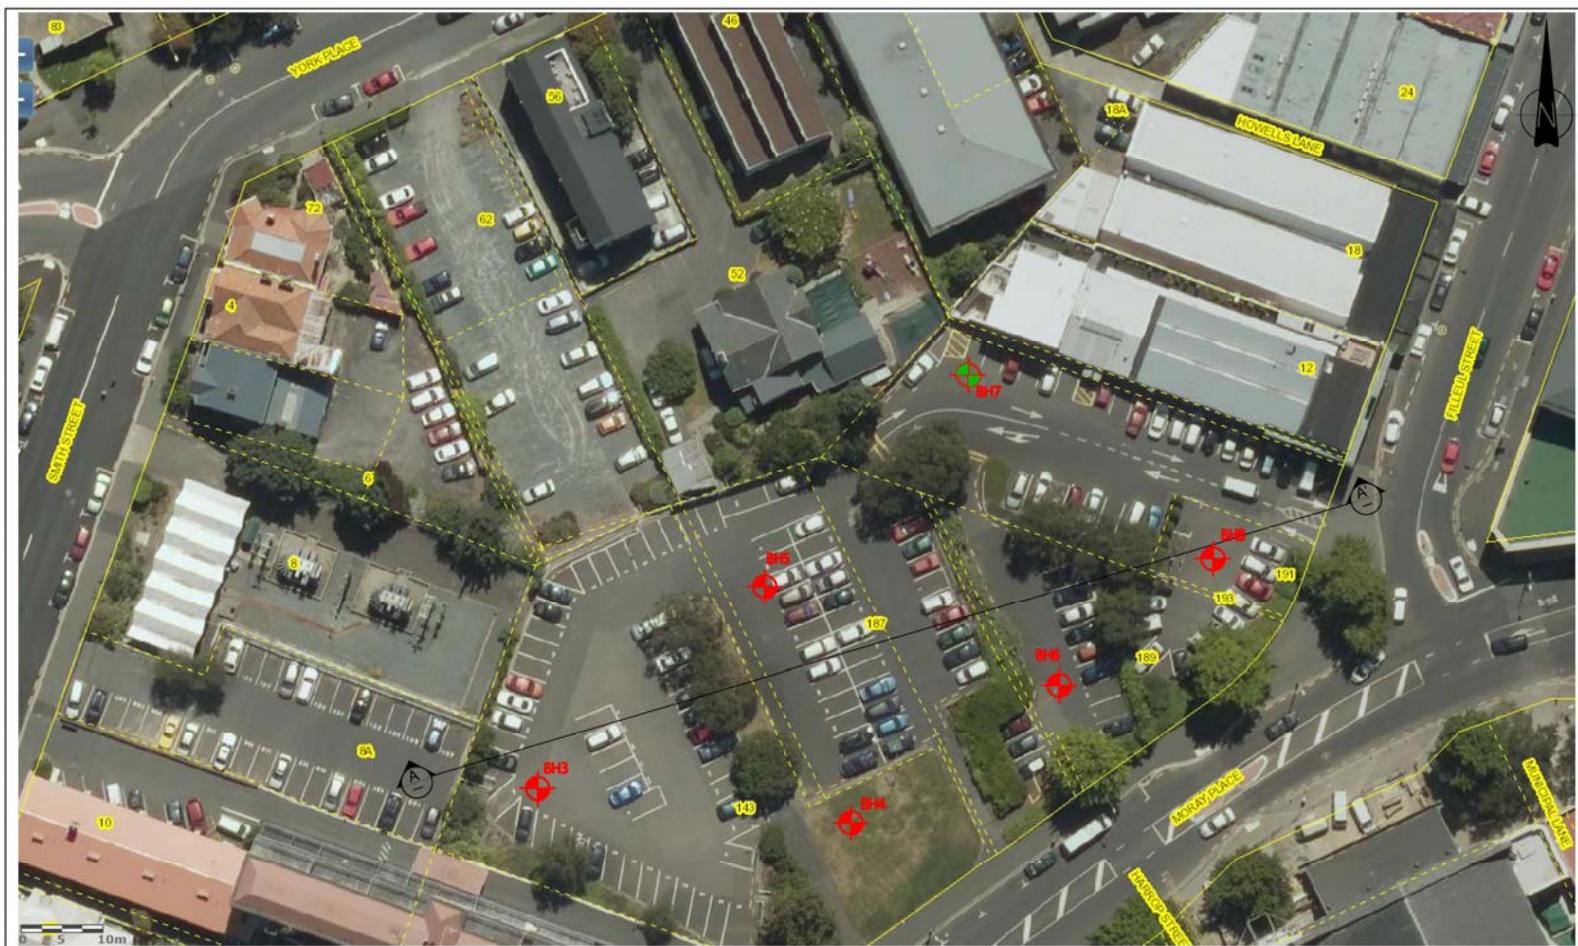
FIG No: Appendix A - Figure 1

Bore hole location

The local water table was observed at approximately 4.00-4.15 m below ground level in BH3 and BH6 and was not observed in any other BHs.
