**BEFORE THE COMMISSIONERS ON  
BEHALF OF DUNEDIN CITY COUNCIL**

**BY** **NZ HORIZON HOSPITALITY  
GROUP LIMITED**

**LUC 2017-48 and SUB 2017-26**

**SUPPLEMENTARY STATEMENT ON BEHALF OF ANTONI FACEY**

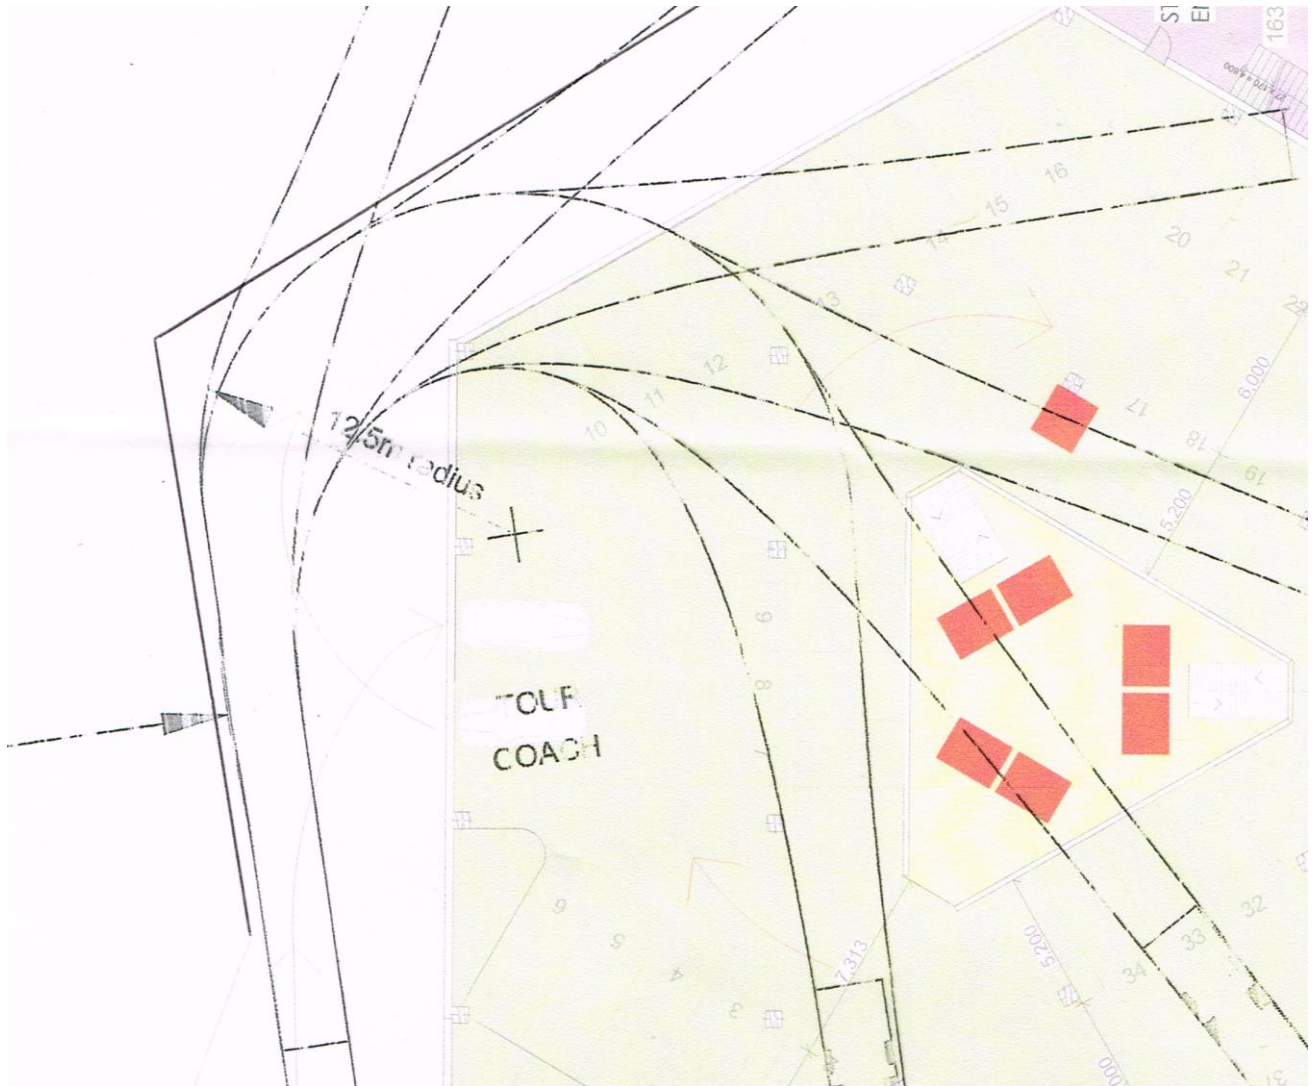
21. Mr Carr has made much of the inability of a coach to negotiate a horizontal curve on the ramp when a coach is parked in the western coach parking space on the ramp to Filleul Street.
22. It is clear from the turning path templates in RTS 18 that a coach can negotiate the curve when there are no coaches present on the ramp. See below.

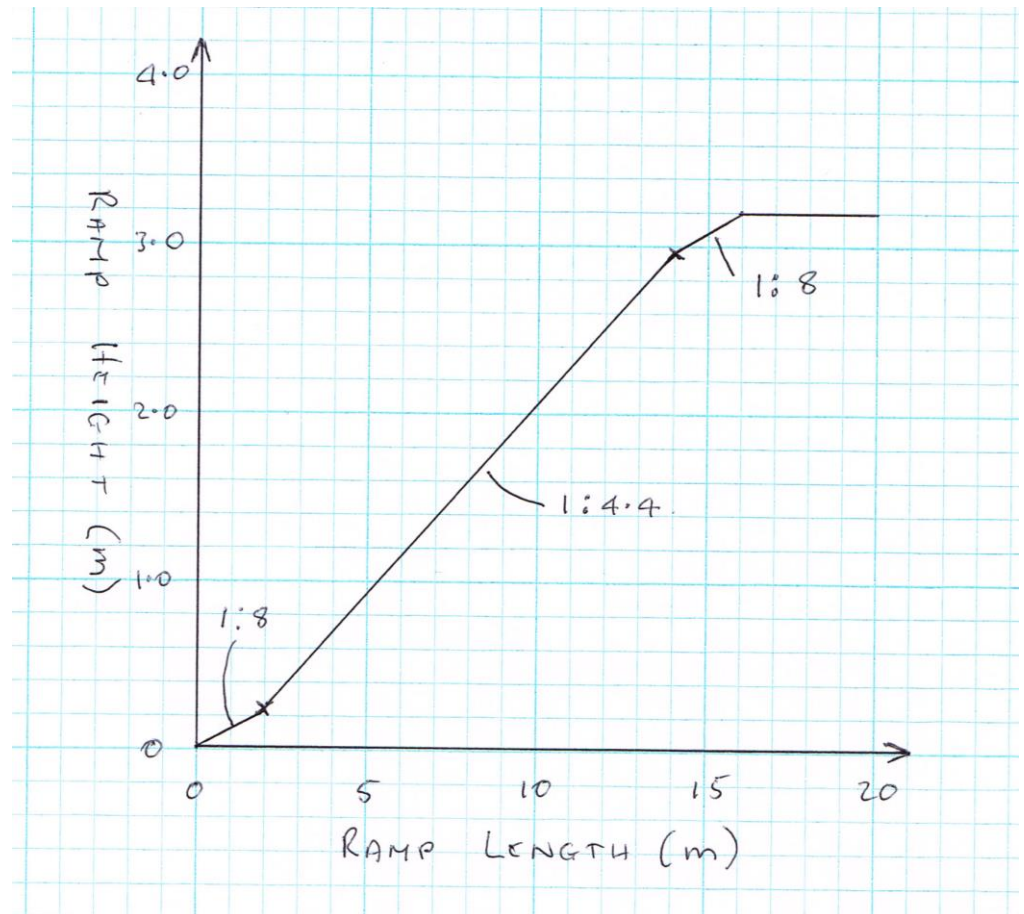
28. Since the car park will be operated by valets, it is considered as a private car park. ASNZS2890.1-2004 "Parking Facilities-Off Street Car Parking" allows a gradient on the ramps of up to 1:4 (25%) in these situations if the length of ramp is less than 20 metres. The critical ramp is the inside radius of the uphill ramp where the measured length of the ramp is 16 metres. The difference in floor levels is currently proposed to be 3.2 metres. Allowing for transition ramps of 1:8 (12.5%) at each end of the ramp, the steepest part of the ramp would be 22.5%. This is within the requirements of AS2890.1. The downhill ramp is longer but will have a shallower gradient as a result of the increased length.

29. Given that it is unlikely that the difference in levels between floors will be as great as 3.2 metres in final design, the gradients calculated above can be considered as maximum or worst case.

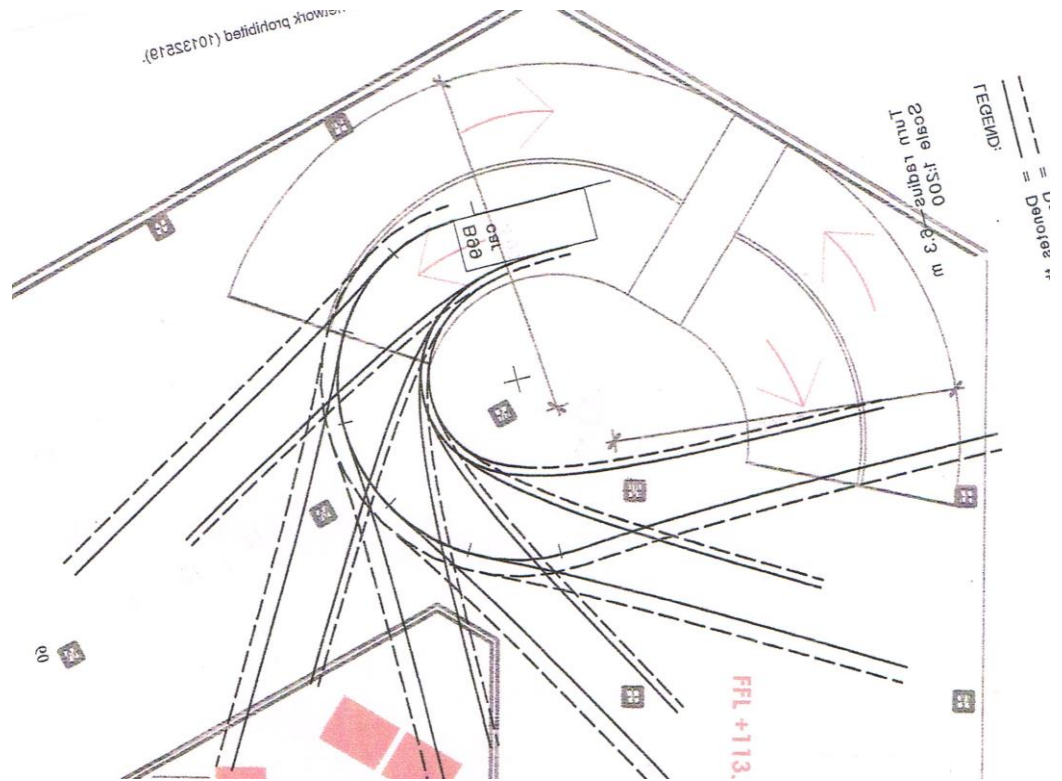
### Swept path on internal car park ramp

30. The internal car park ramps have been redesigned to demonstrate that they can operate as a two lane, two way ramp with generous width. The swept paths on the internal car park ramp have been checked and it is demonstrated that the cars can easily negotiate the curves on the ramp and the entry and exit to the ramp. The most critical case is shown below using the B99 car swept path from AS2890.1.

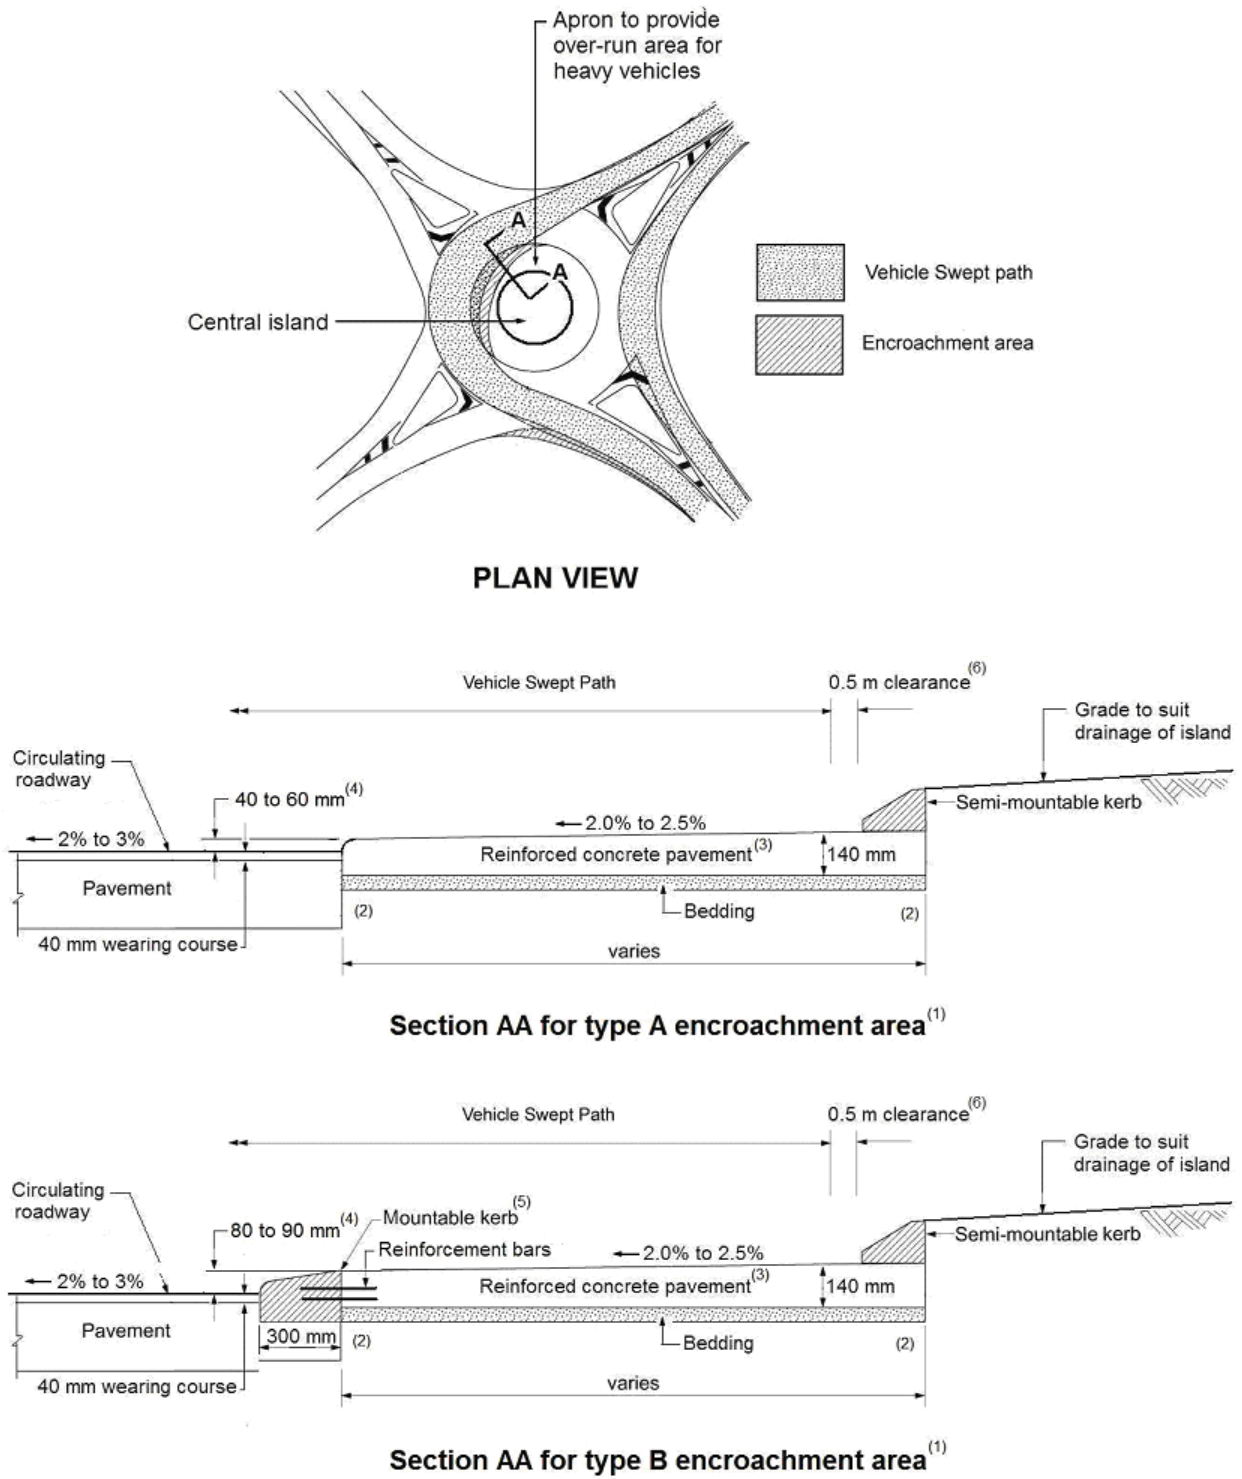
47. The plan to date shows only the extreme internal circulating island to accommodate a turning coach. A concentric circular roundabout ring of 8 metres radius is proposed around the central circulating island at a lower level to provide a split level roundabout. This outer ring will be fully mountable for trucks and coaches to use to complete their turns safely while cars would be discouraged from using this area to manoeuvre. Hence, deflection is developed and maintained for all vehicles to ensure that the roundabout operates at a low speed. Allowing encroachment like this is a standard method of roundabout design as shown in Figure 4.11 of AUSTROADS "Guide to Road Design part 4B-Roundabouts" reproduced below. The encroachable concentric area is considered to be the radius of the roundabout and the radius is therefore 8 metres.

Figure 4.11 from AUSTROADS - Typical encroachment area detail at a roundabout
