Submission – Jason and Lisa Breen, 161 Dukes Road South, Mosgiel April 6th 2023

This is an objection submission to the Otago Regional Council's (ORC for ease of reference in this submission) appeal against the proposed Second Generation District Plan (2GP) in relation to the Gordon Road Floodway.

Re: Morphological changes in Silver Stream and implication on scheme operation – Gordon Road Spillway

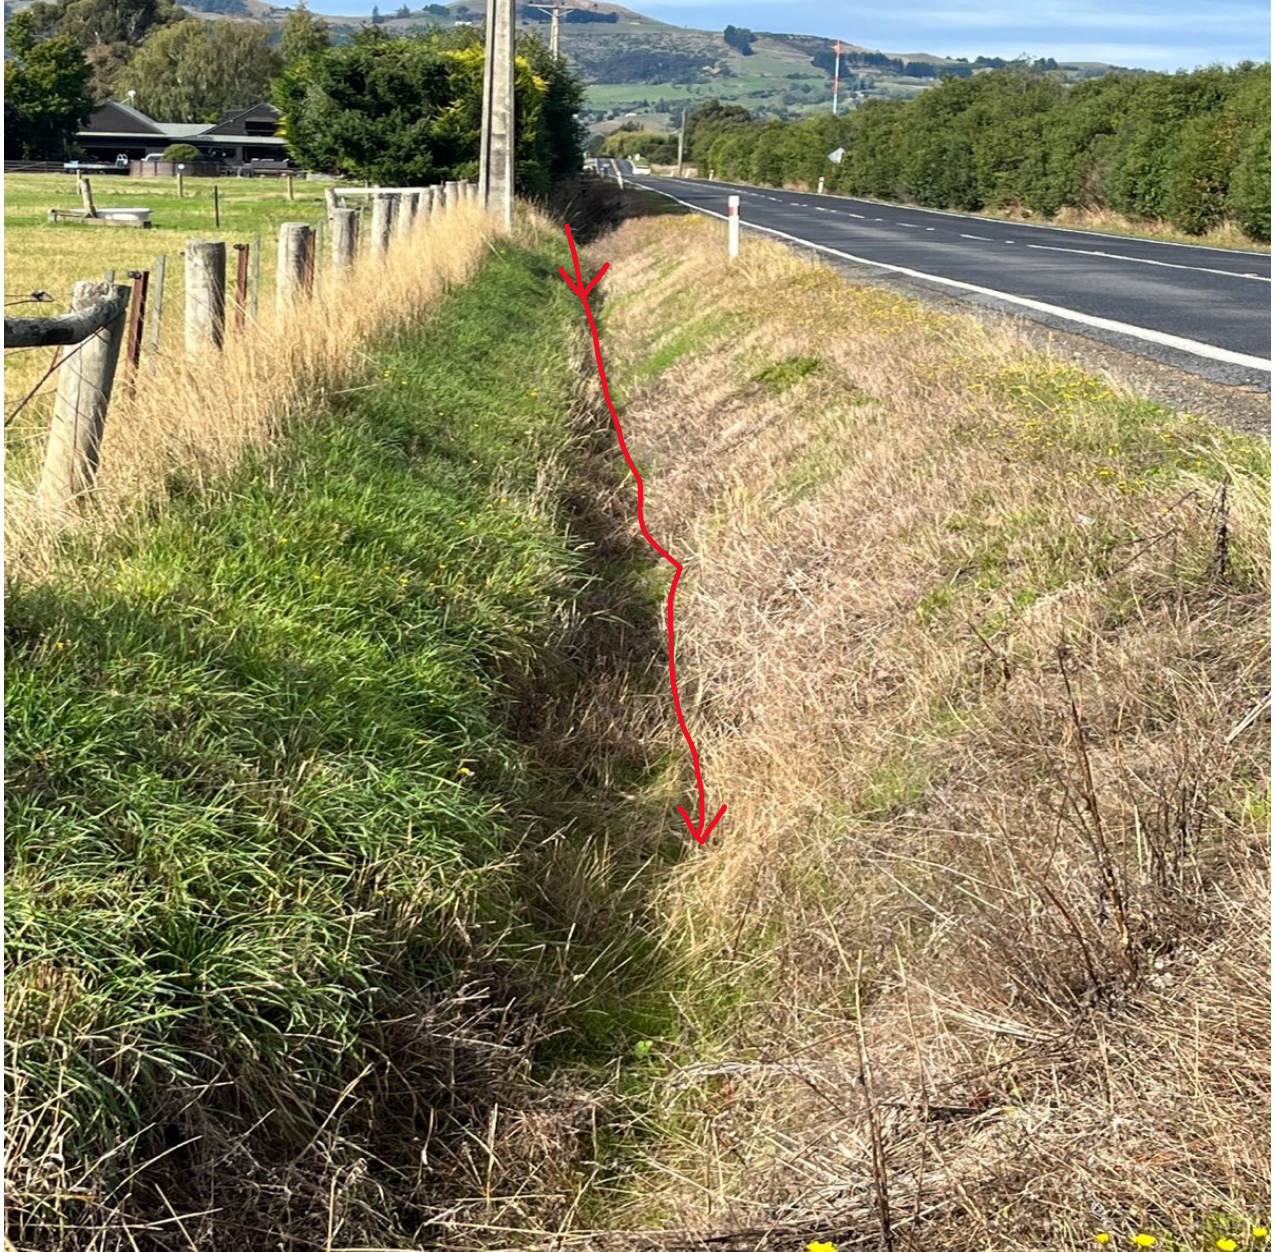
Exhibit A – Riccarton Road M4 drain looking toward Silverstream Bridge. Bottom of photo is where the M4 culvert meets the M3 at the corner of Dukes Road South.

You will see from the below photographs (exhibits A, B, C, D) the lack of maintenance and substandard size and design of culverts and M3 and M4 drains that form part of the drainage in the Lower Taieri Flood protection scheme. (Photographs were taken on April 1st 2023). We believe these photos to well contradict the above statement.

Exhibit E shows inundation levels across the floodway area. Note similar inundation levels not in the mapped area. The area highlighted with a purple edge is the area shown in exhibits A-D. Water becomes trapped and backed up at the meeting of the M3 and M4 drains at the corner of Riccarton Road and Dukes Road South in a heavy rainfall event. Lack of drain capacity to move water under Riccarton Road towards the upper ponding area causes backup of water to the properties shown in the highlighted area. The road acts as a dam until water levels become high enough to spill over the road.

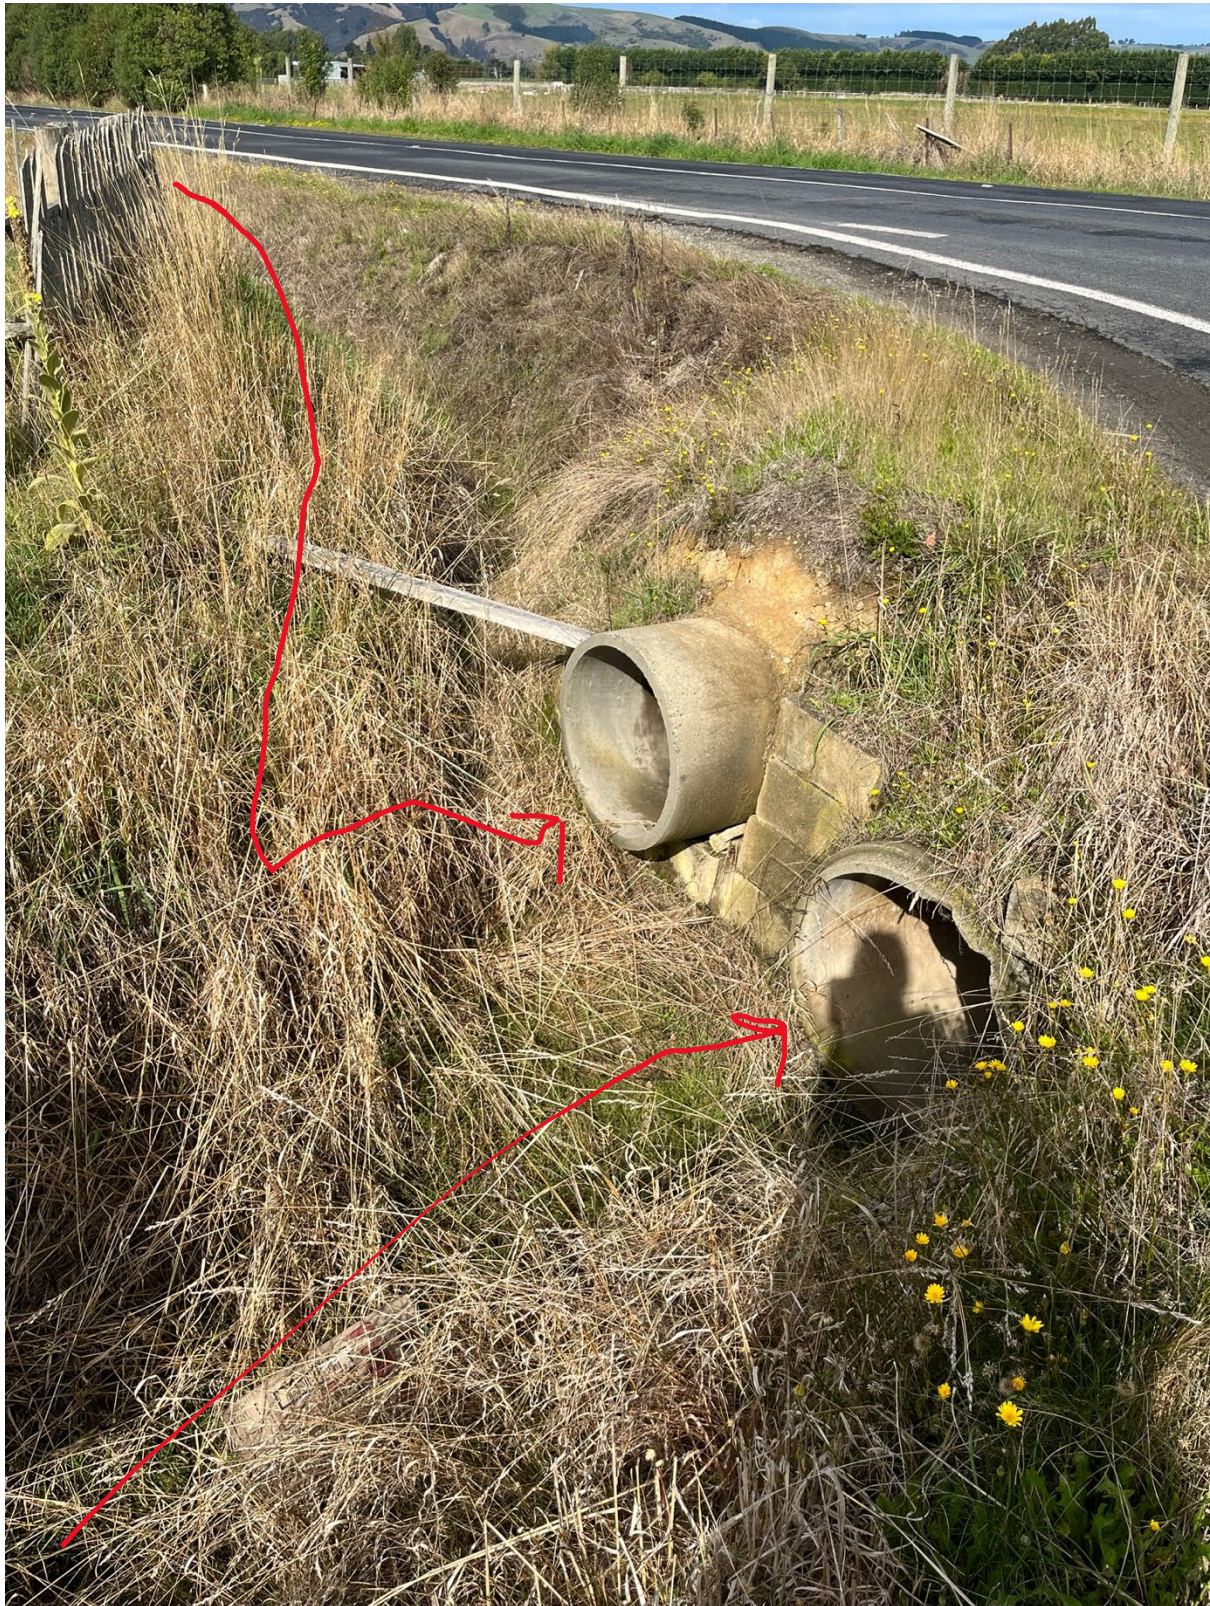
Exhibit B – Drains at Riccarton Road and Dukes Road South corner where M4 meets M3 and takes water under the road to continue on down Dukes Road South towards the Upper Pond.

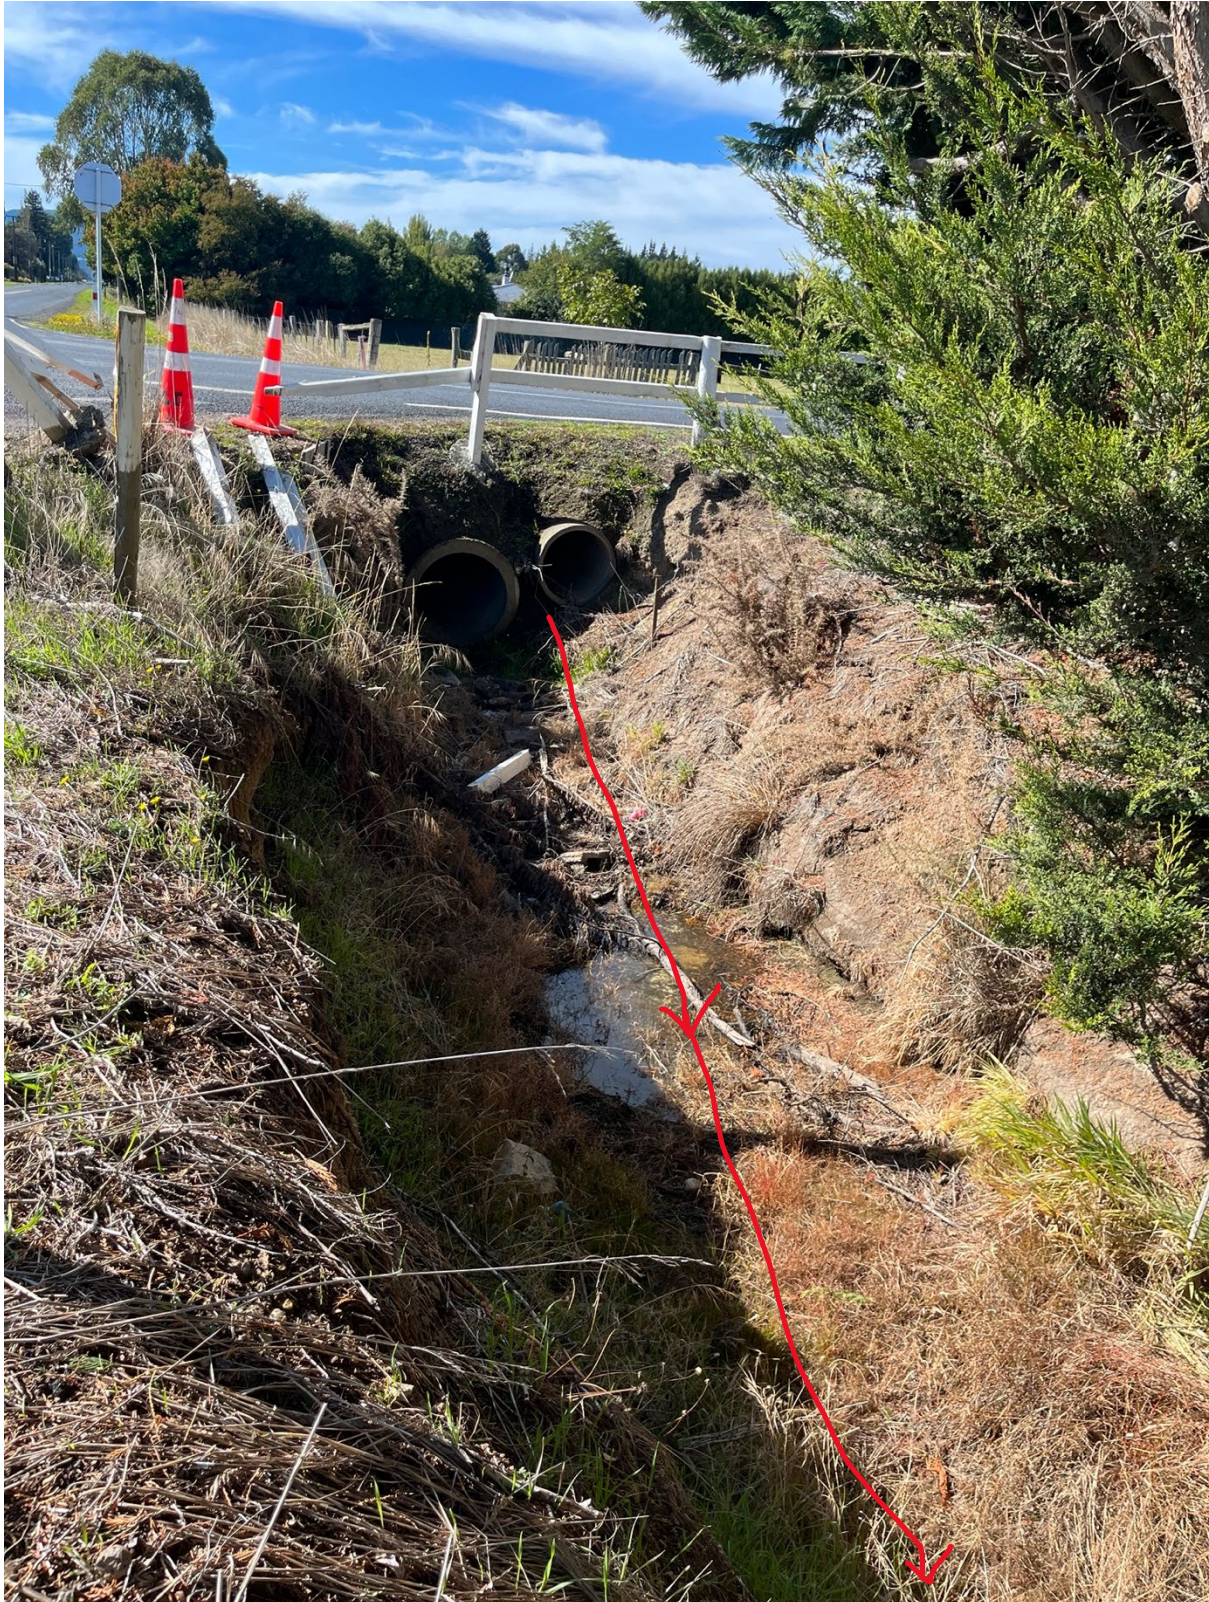
Exhibit C – M3 drain and culvert on Dukes Road South on the south side of Riccarton Road.

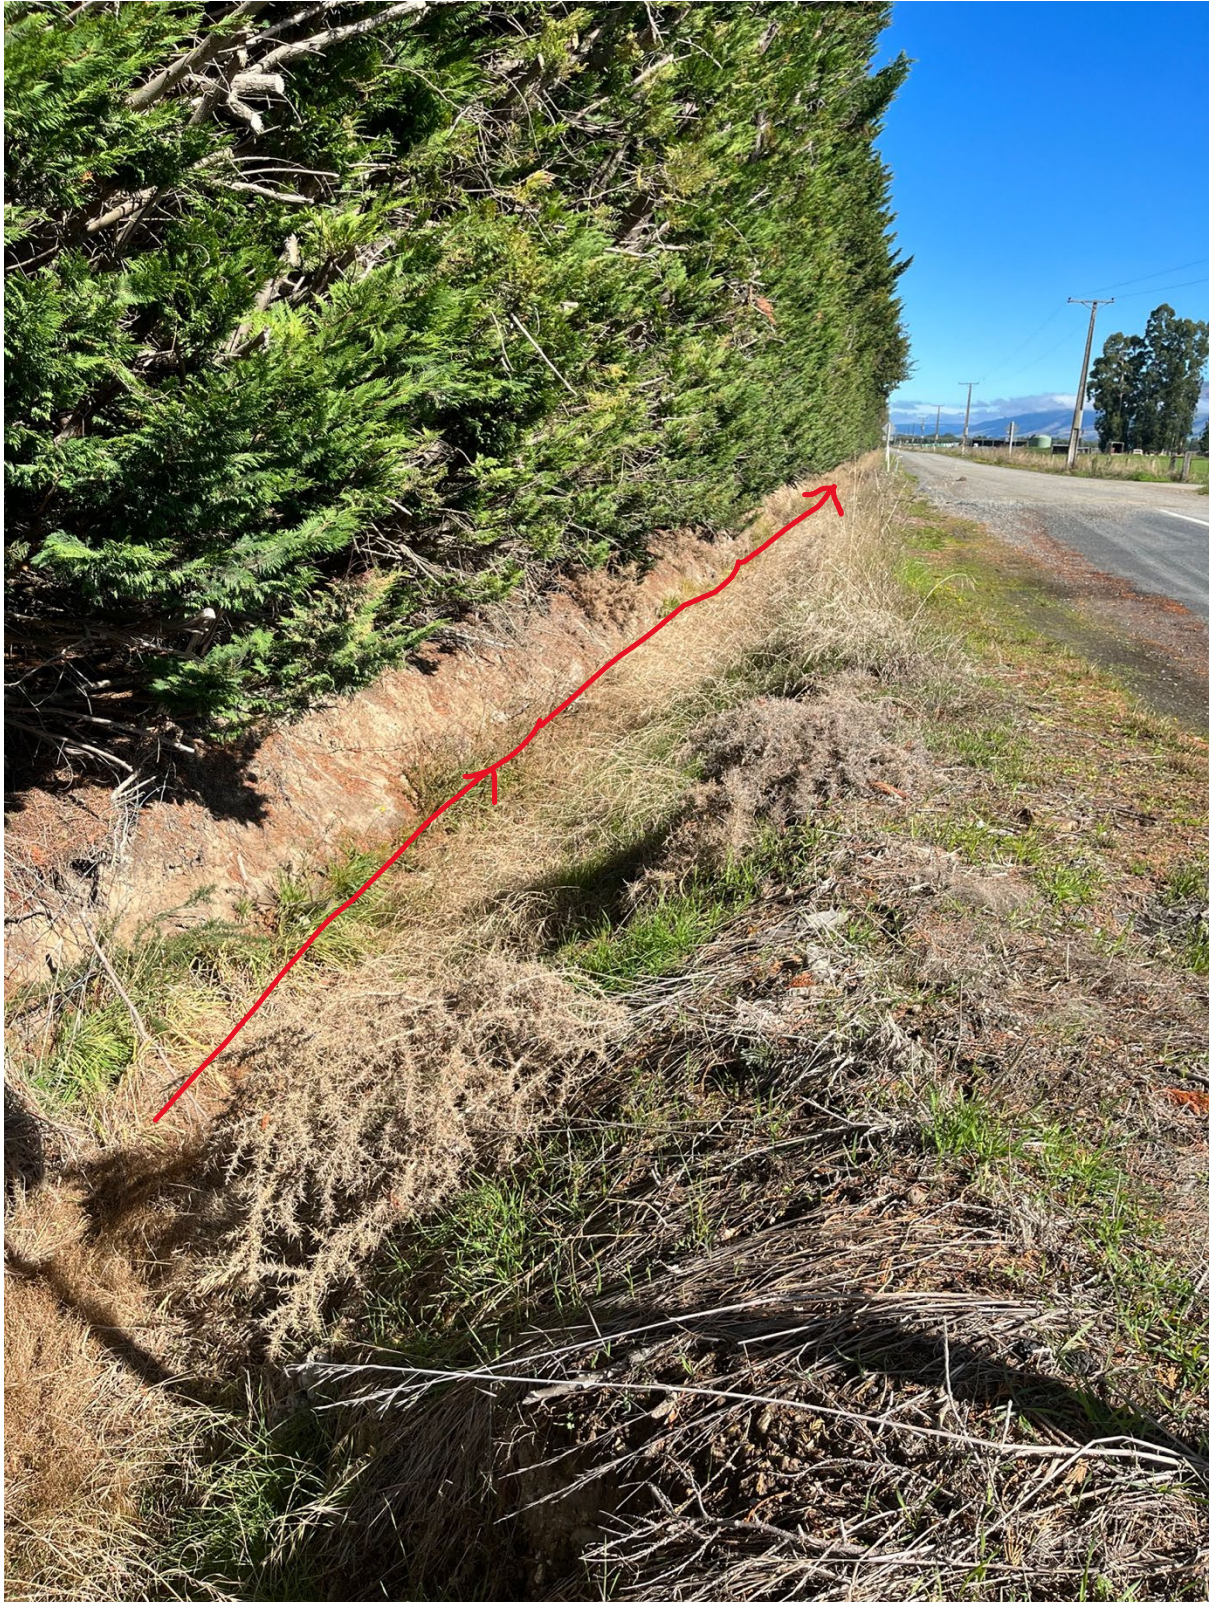
Exhibit D – M3 culvert on lower Dukes Road South heading towards the Upper ponding area.

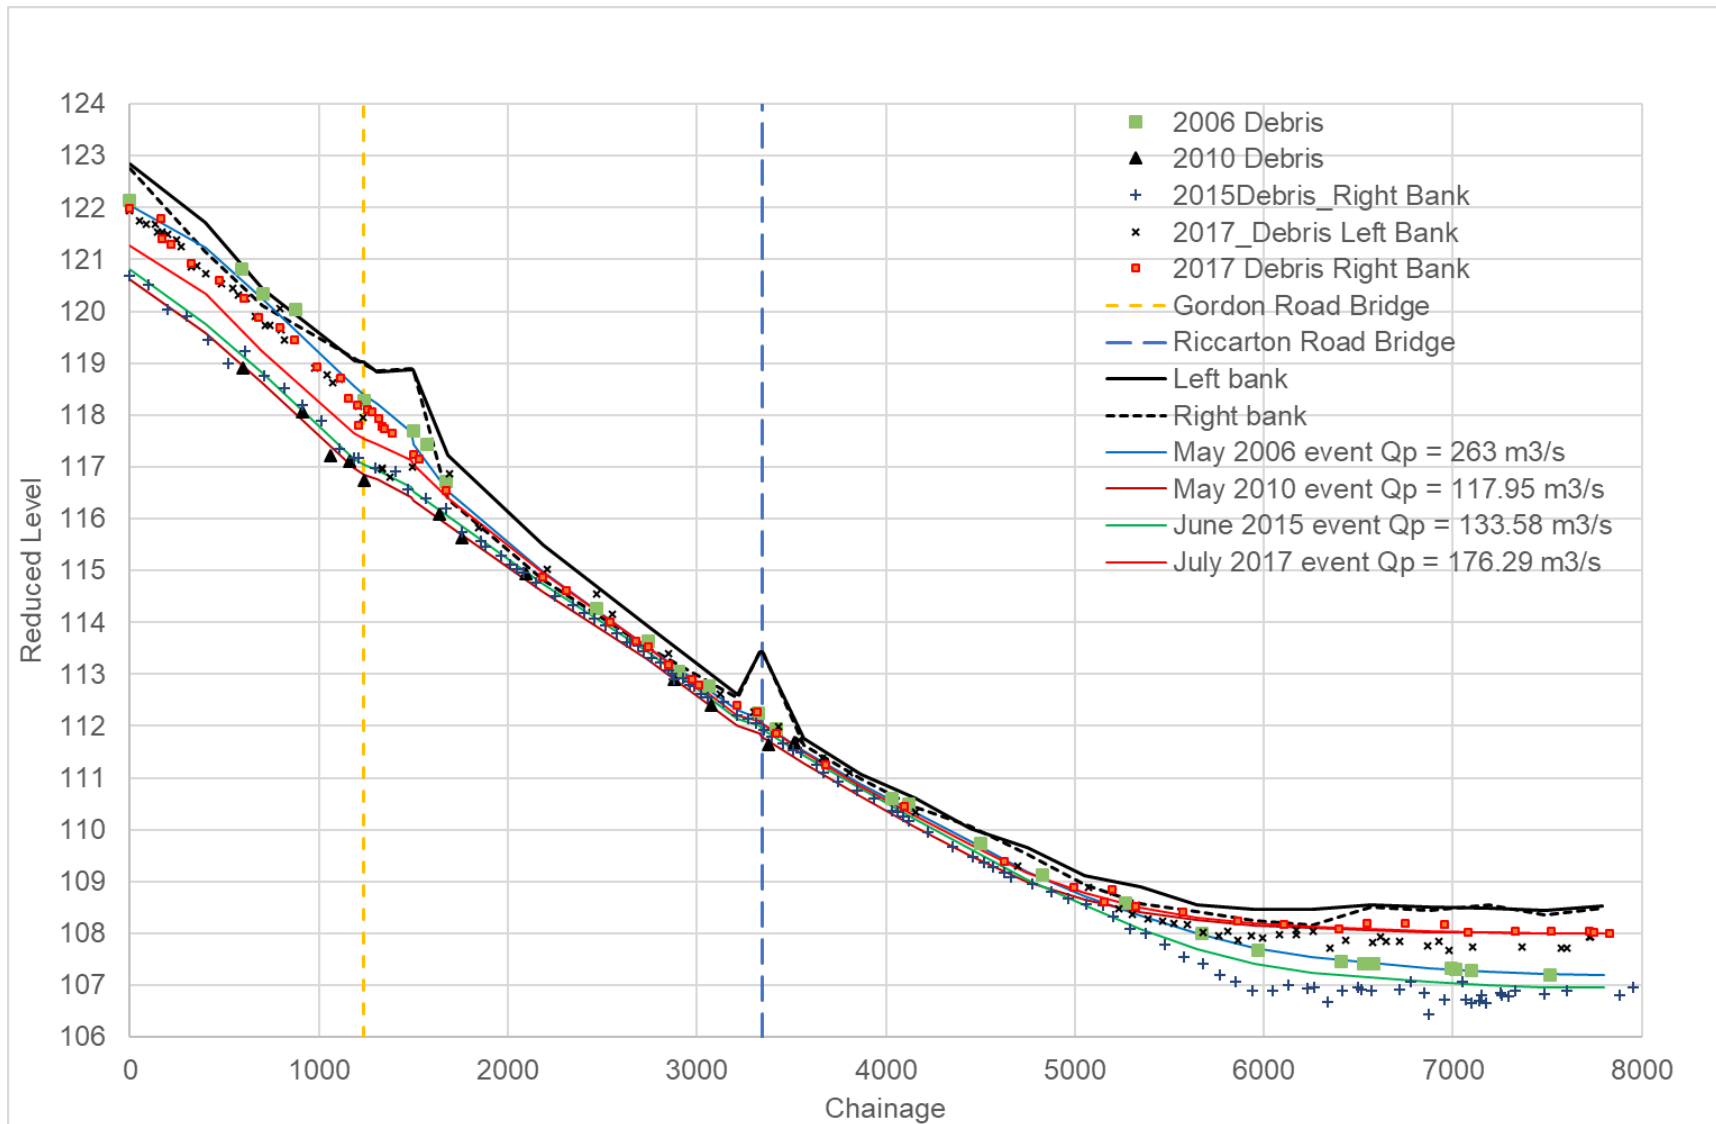
Figure 4. Comparison of observed high water level against simulated water levels.

The Natural Hazards Team at ORC carried out an assessment of the implication of morphological changes of the Silver Stream on the performance of the Gordon Road spillway and recommend possible measures to reduce the impact. To achieve the scope of the investigation a 1Dimensioniional / 2Dimensional hydraulic model was developed for the Silver Stream. HEC-RAS 5.03 was the hydraulic model used for this investigation. The model has been calibrated for June 2015 event and validated for May 2006, 2010 and July 2017 events (as presented in Figure 4).

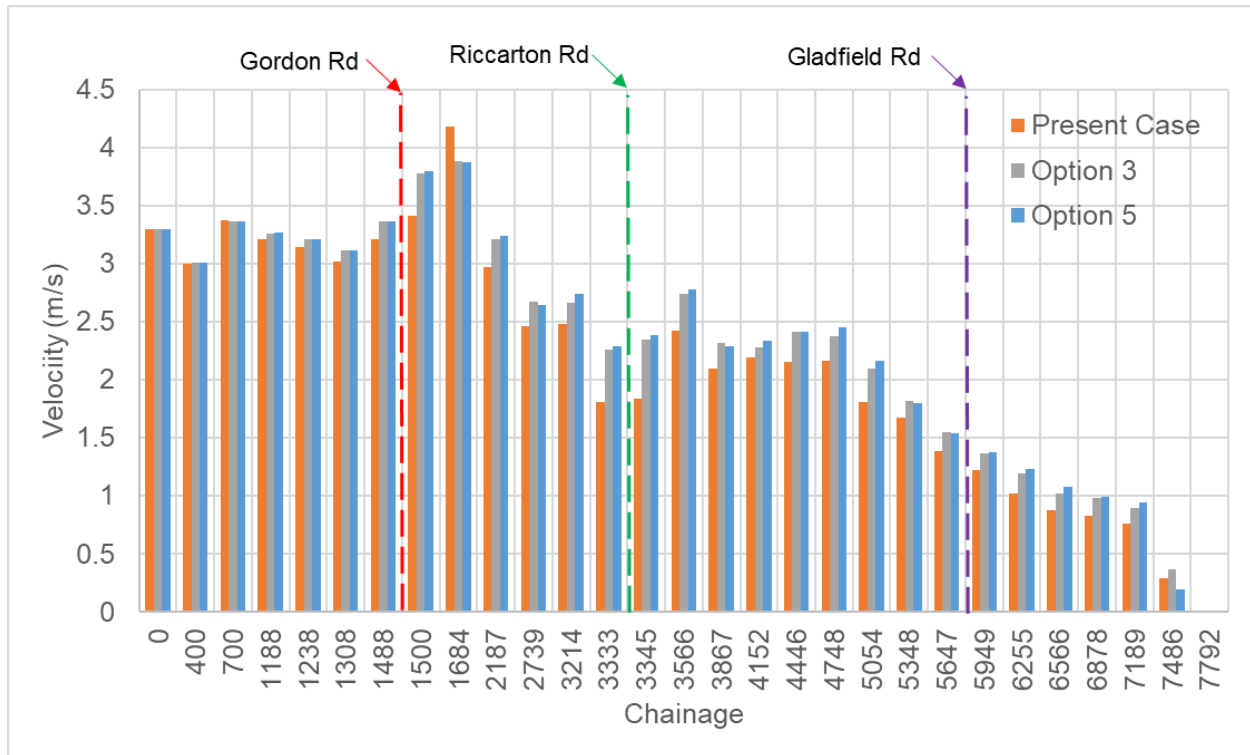
Figure 10. Mean velocity along the channel.

The model result suggests that in majority of reach the mean channel velocity will not drop as result of channel widening (Figure 10) under high flood conditions. The result shows reach upstream of Gordon Road bridge and some sections between Riccarton Road and Gordon Road with velocity higher than 2.4 m/s, which is higher than the maximum permissible mean channel velocities for grass-line earth channel (USDA, 2007) such as the Silver Stream. Hence, in these sections of the Silver Stream rock lining may be necessary. Although high flow velocities of up to 4 m/s have been identified in some reaches under flood condition, yet the flow conditions are subcritical (Froude value < 1).
