**BEFORE THE VARIATION 2 HEARING PANEL**

Variation 2 to the proposed  
Second Generation Dunedin City  
District Plan (2GP)

**STANTEC NEW ZEALAND – RESPONSE TO SUBMITTER EVIDENCE**

**Dated 31 August 2022**

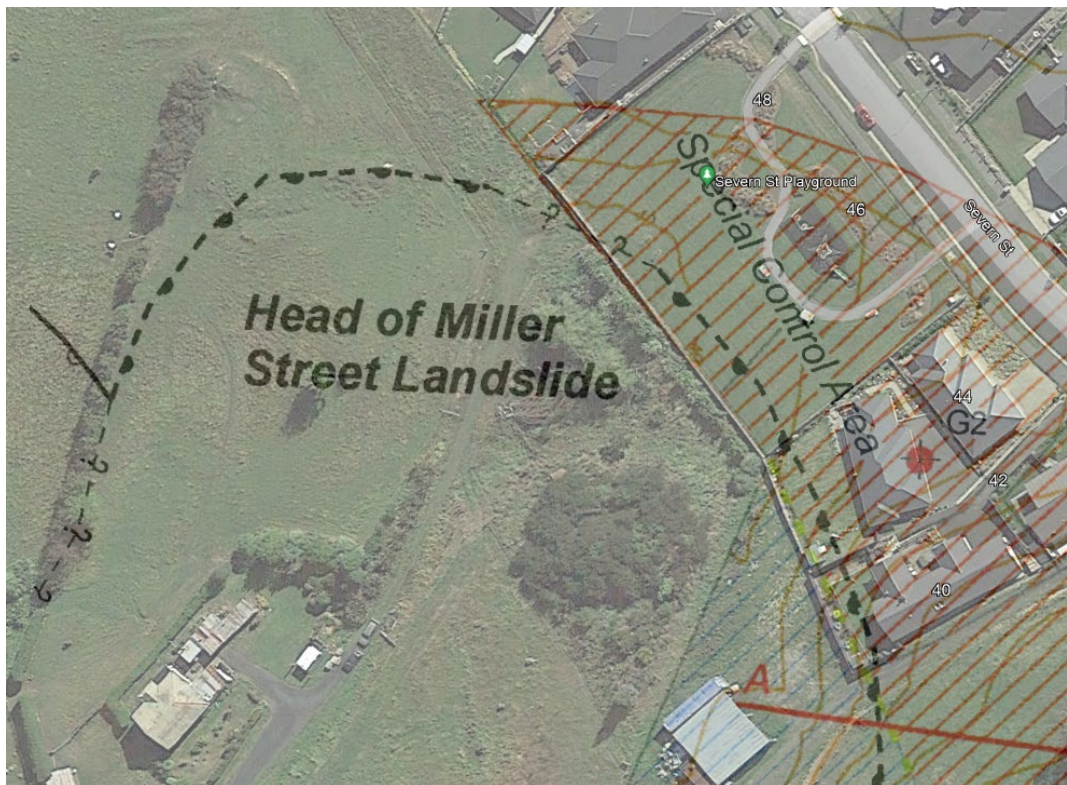
43. The area that Geosolve refers to as precedent for development which contains 20 dwellings (GNS "likely" landslide area) is the old "special control area" which has since been revised by Golder. None of the houses in the Grandvista subdivision are constructed within the revised Miller Street landslide exclusion zones recommended in Golder's report. An example of this can be seen in 44 Severn Street where a dwelling is constructed on an angle to allow for the recommended 10m offset from the headscarp of the Miller Street landslide.

42. **Review of Golder's report:** The "1970s scarp" was the original reasoning behind a "special control area" imposed over part of the Grandvista subdivision area. It was formerly assumed that the 1970s scarp was part of the Miller Street rotational landslide complex up until 2009. To contest this assumption, in 2009, Golder Associates conducted an investigation and assessment of the area which concluded that the 1970s scarp was actually an erosional feature and is not part of the Miller Street rotational slide complex. The recommendations in Golder's report was that the "special control area" within the Grandvista subdivision is no longer correct, given their findings. They provided a number of constraints and offsets from the Miller Street landslide in lieu of the special control area. The net result of this was reducing the area of the no build zone.
