Dunedin City Council

Waste Futures - Smooth Hill Landfill  
Geotechnical Interpretive Report

August 2020

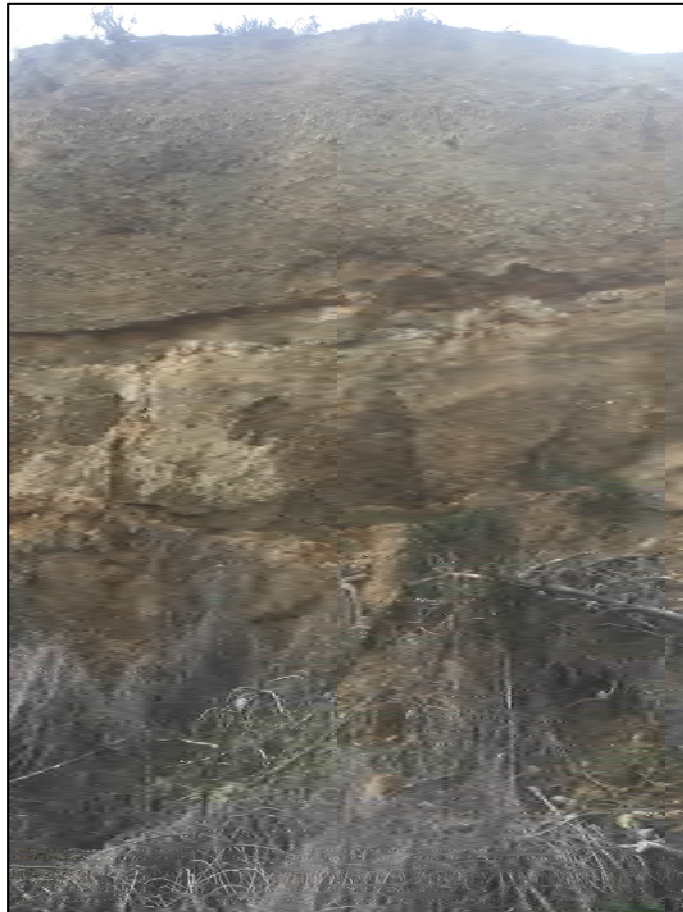
Figure 5 - Taratu Formation outcrop near the northwest extent of the site

Although not indicated by published geology as outcropping on the site, the Taratu Formation was mapped on site in a single outcrop (adjacent to the northwest boundary of the site) and encountered in boreholes (BH09, BH209 & BH10). A photograph of the outcrop is presented in Figure 5 below. Bedding is most evident in the interface between the sandstone and conglomerate beds, and appears to display cross-bedding in the sandstone beds. The bedding observed in the outcrop is consistent with that indicated in the published geological map.

The conglomerate layers were typically massive, with moderately thick bedding noted in BH203 and in the outcrop. The sandstone and siltstone layers were typically laminated to moderately thickly bedded. The interbedded layers do not appear to be contiguous across the site.

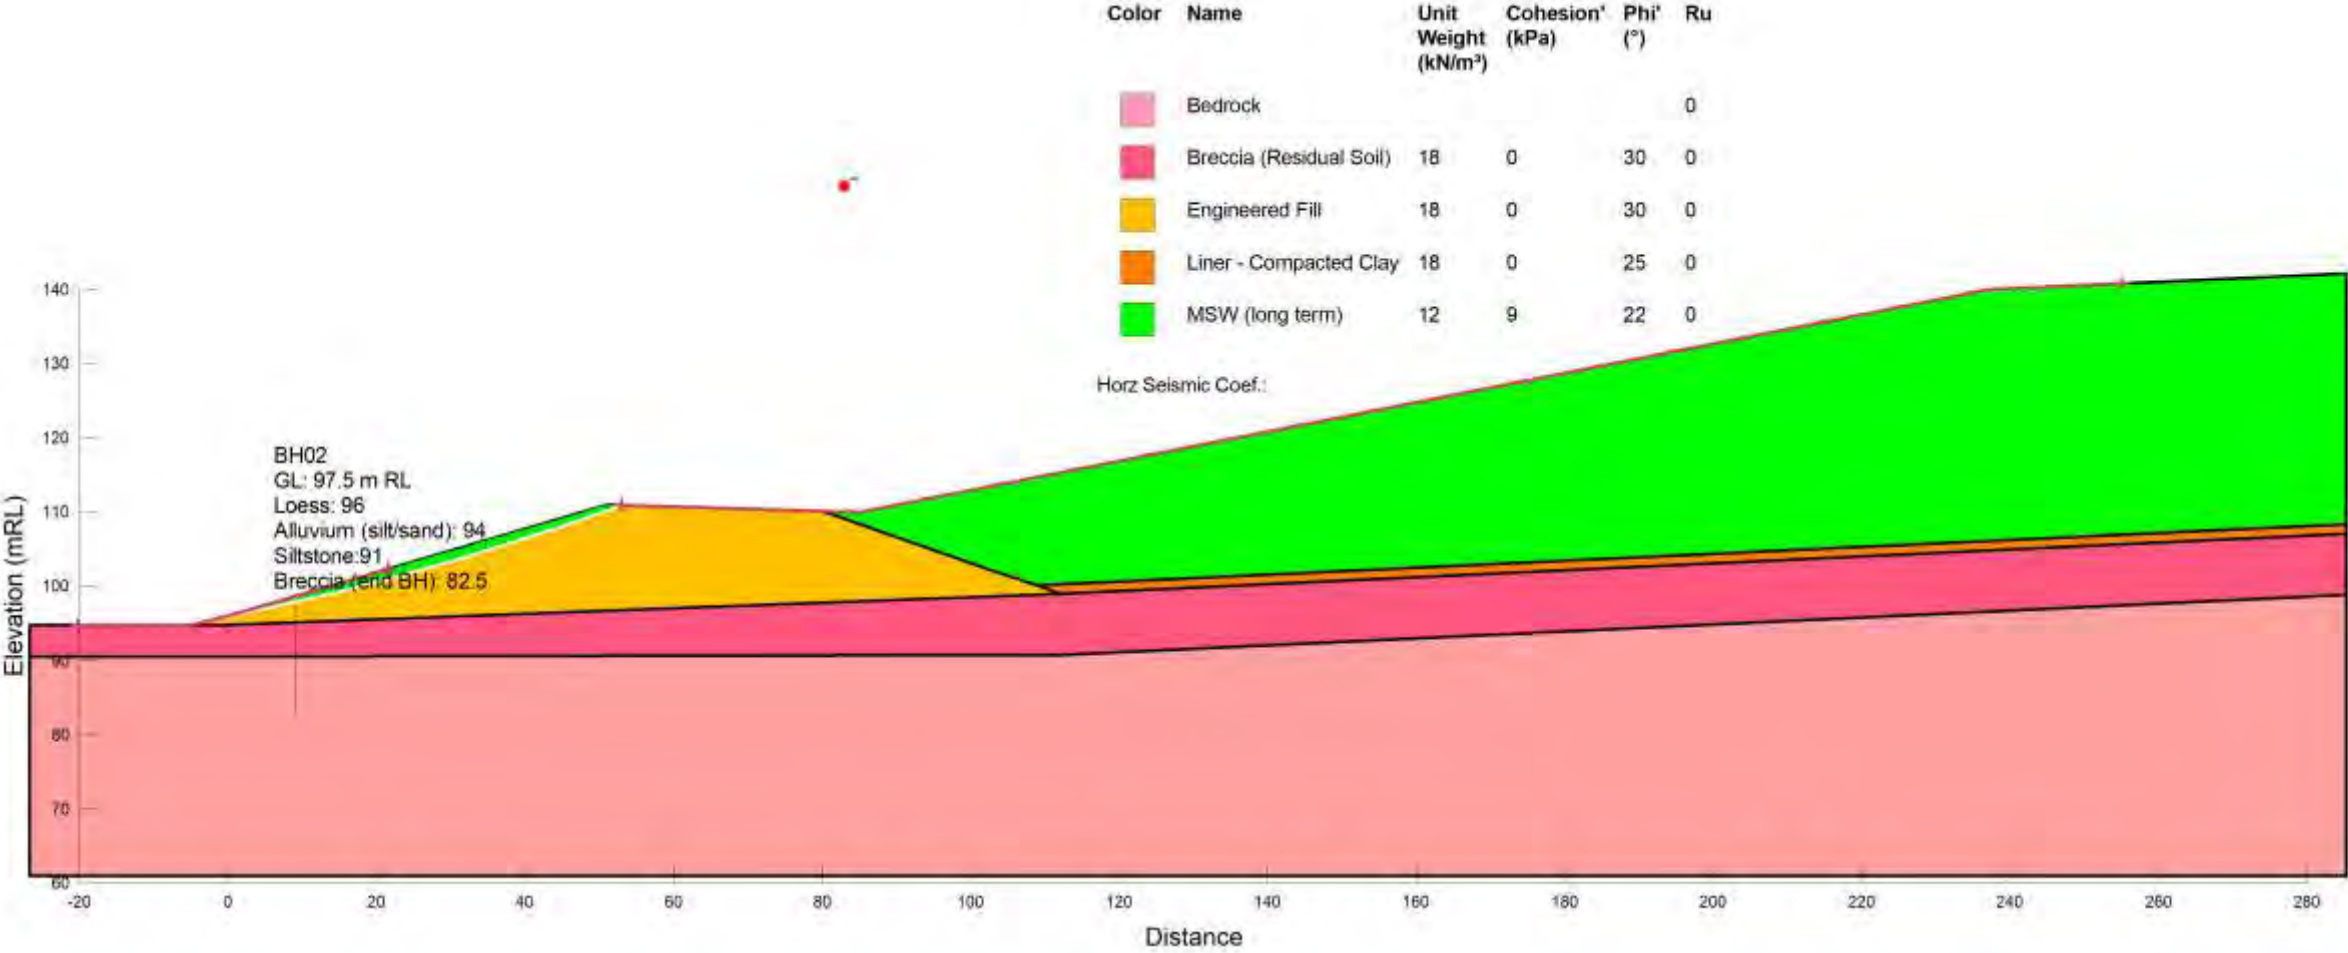
Section D - Toe Bund Stability

Internal Bund Stability  
Analysis

Critical factor of Safety = 2.0
