Geotechnical Investigations Report

143-193 Moray Place, Dunedin

Dunedin City Council

GeoSolve Ltd

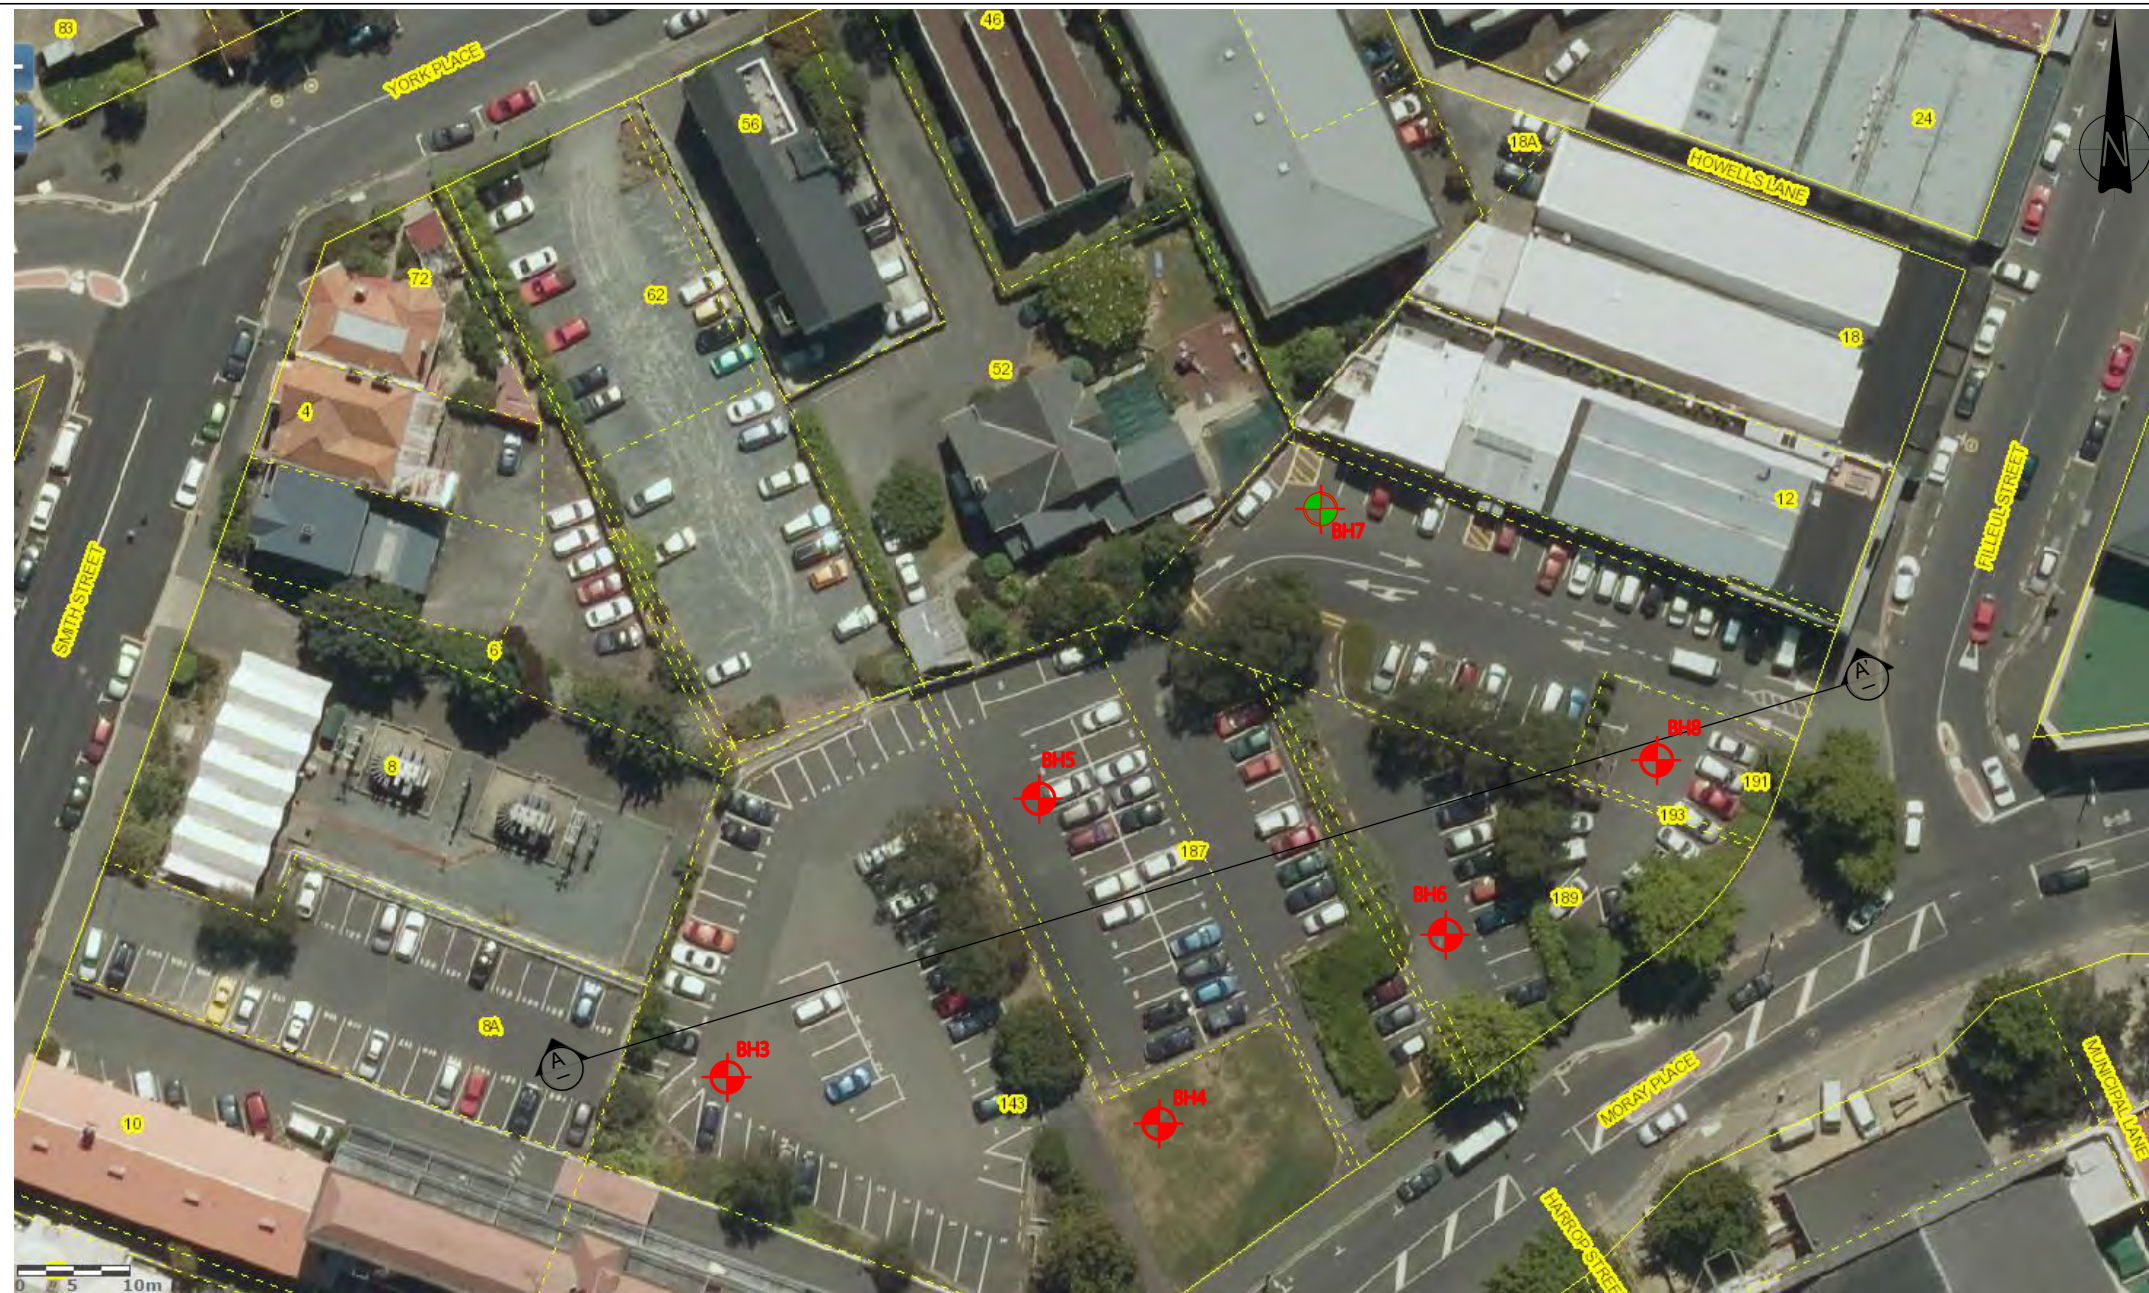
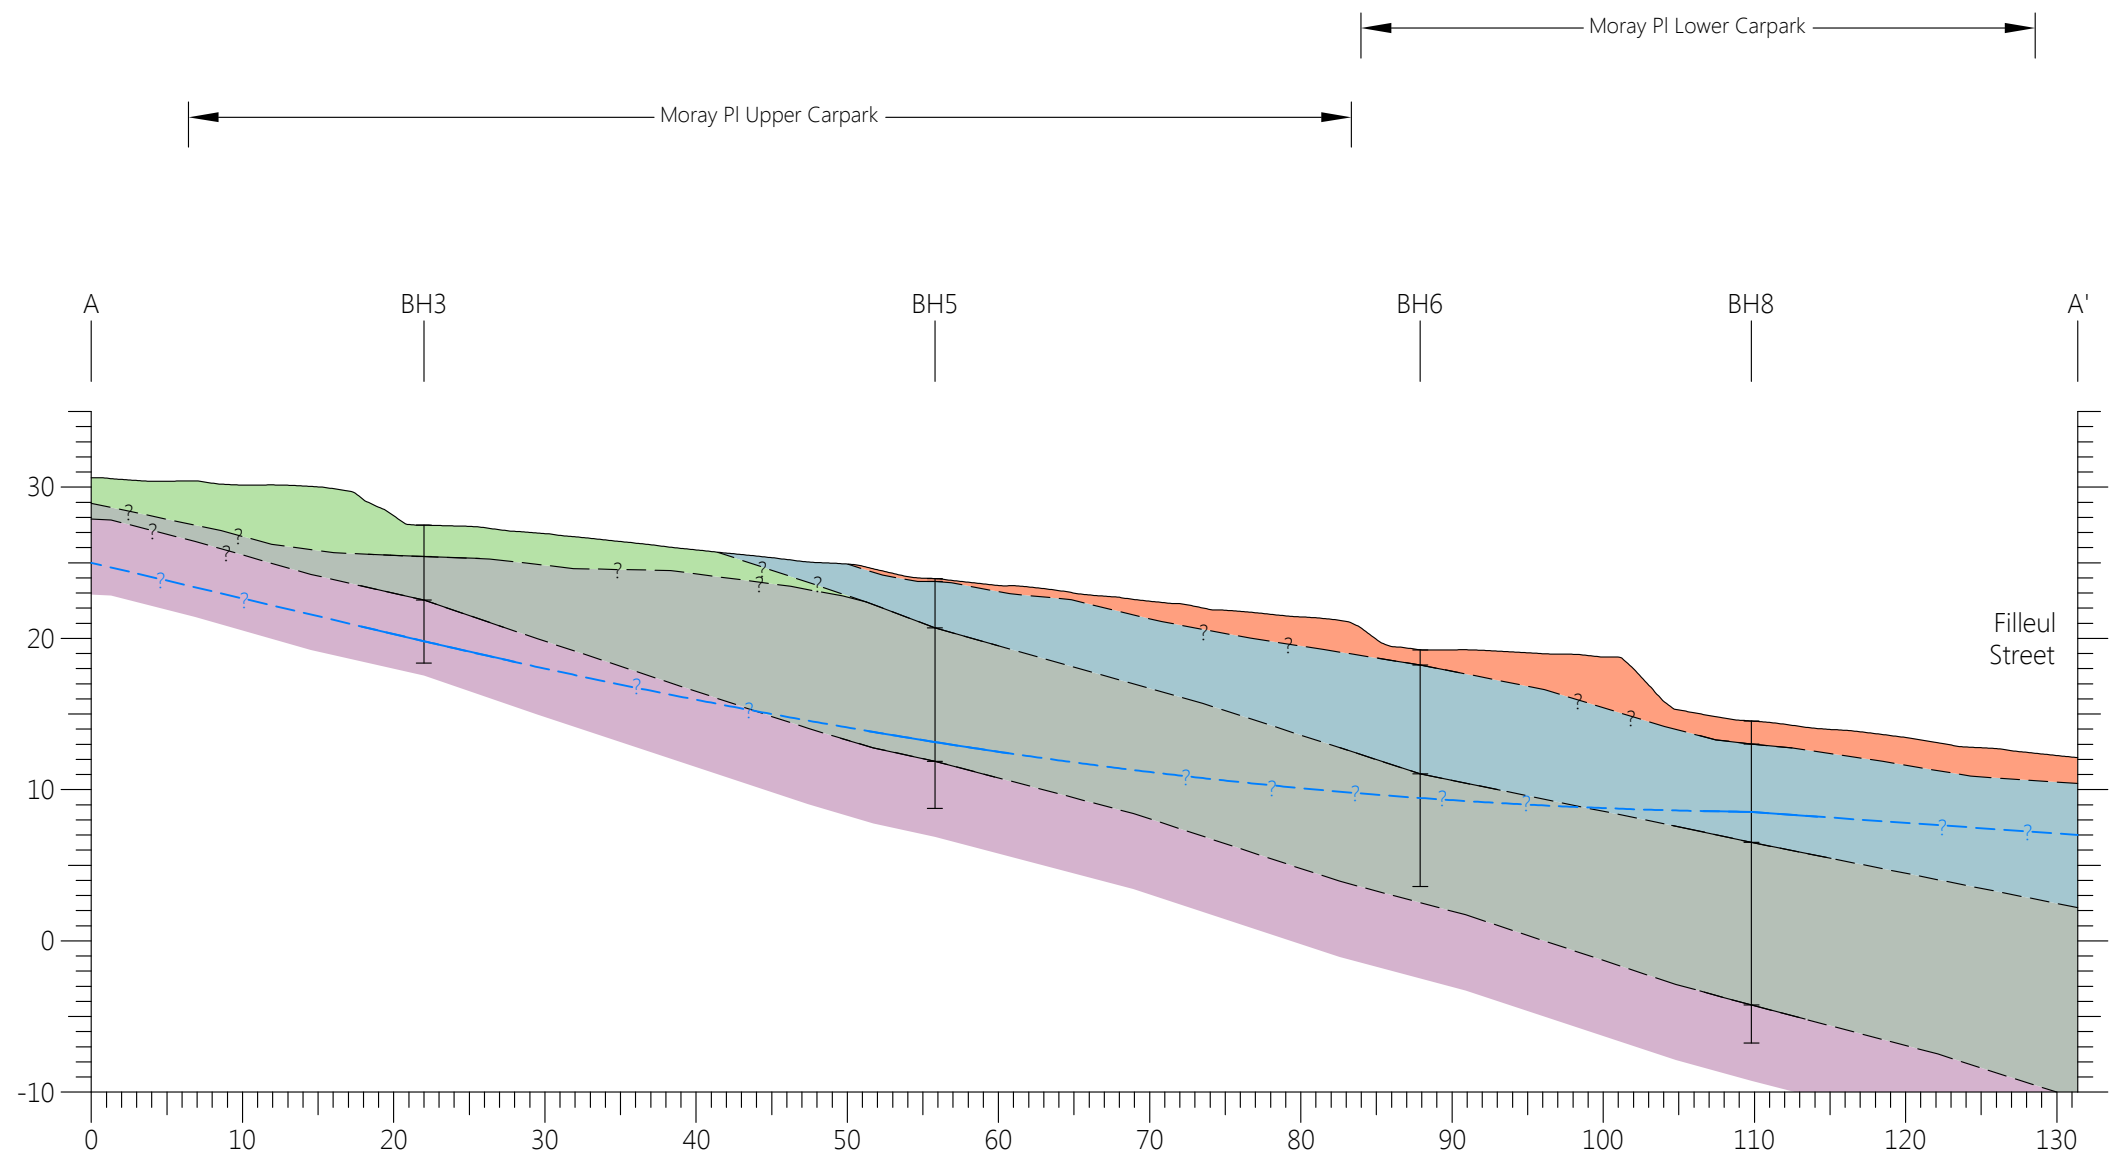
Appendix A: Site Plan & Cross-sections

Bore hole location (not drilled)

SCALE 1:500
0 5 10 15 20 25 (m)
