**PRESENTATION MATERIAL FOR PLAN CHANGE 1 SUBMISSION**  
**Patersons on behalf of Blue Sky Property 45 Beach Limited**

The DCC Heritage Assessment for the building at 45 Beach Street recommended that the entire external building envelope, excluding the carport and garage on Albert Street, was recommended for protection.

Patersons, on behalf of BlueSky, requests that the Scheduled Heritage Building BX046 feature, referring to the main building at 45 Beach Street be removed from PC1. This includes from the planning maps.

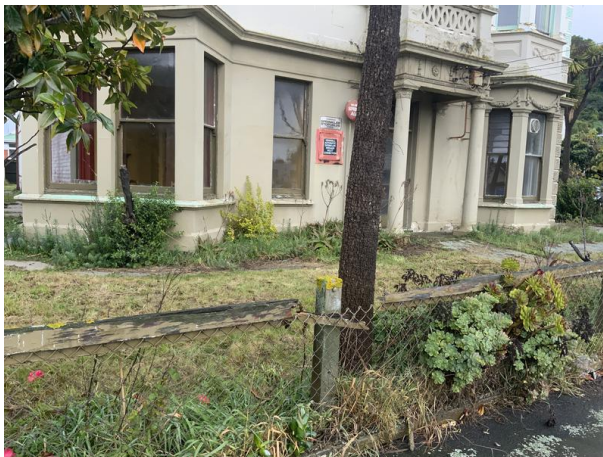
Photo 3

East aspect foundation

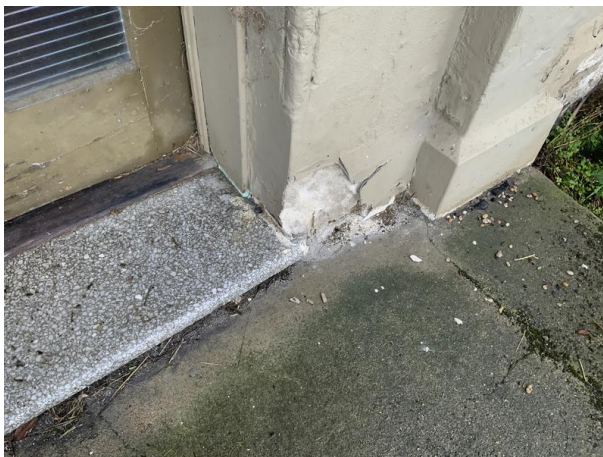
Photo 4

Cracking detected to East aspect foundation. Advise a structural engineer investigate the structural viability of the material as it presents as chalky and possibly beyond it's serviceable life.

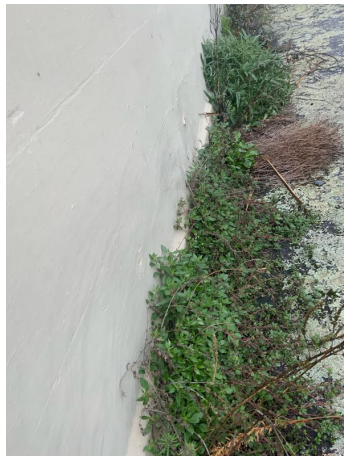
Photo 7

Vegetation against North aspect foundation. Removal advised

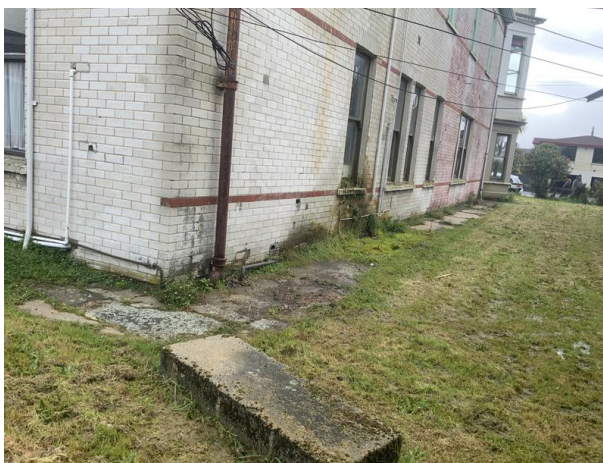
Photo 9

South aspect foundation

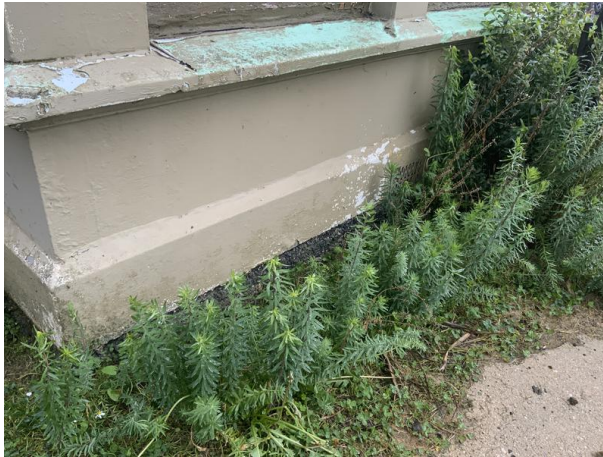
Photo 11

Vegetation against West aspect foundation & vents. Removal advised

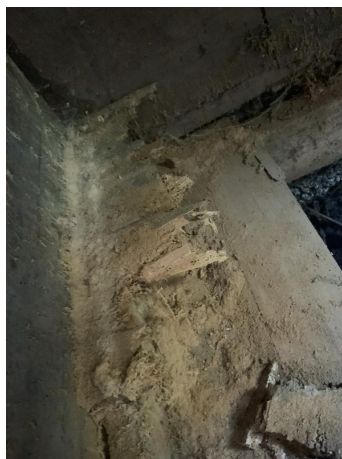
Photo 13

Borer dust detected throughout the subfloor area to a matter of structural degree. Further investigation is required to the amount of borer damage to the subfloor structure

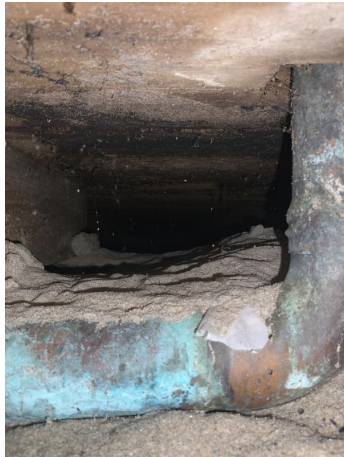
Photo 14

View of subfloor with deterioration of timber flooring visible. Replacement of flooring advised

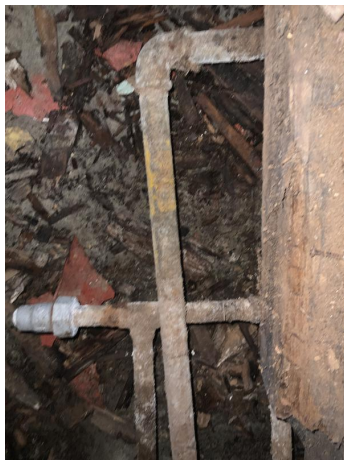
Photo 15

Plumbing pipe viewed throughout the subfloor area unsupported. Support where necessary

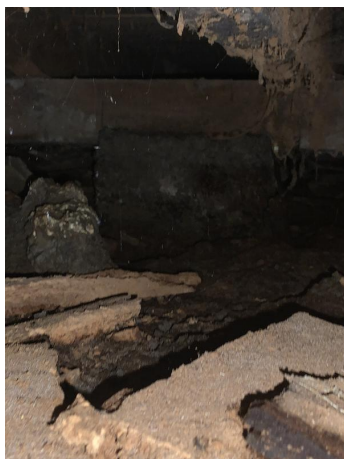
Photo 16

Concrete pile detected in the subfloor area with connections not visible. Further investigation is required into the subfloor structure

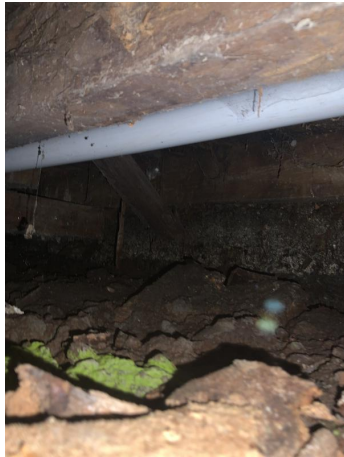
Photo 17

Rotting timbers detected throughout the subfloor area. Removal advised

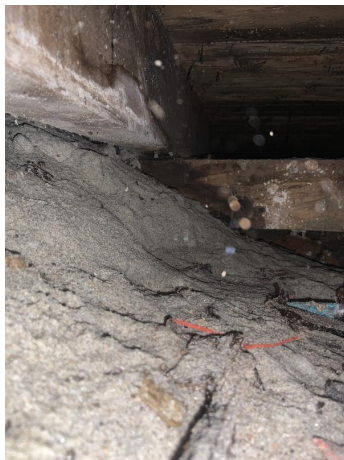
Photo 18

Inground bearer detected to the subfloor area. Further investigation is required to the structural system of the subfloor area

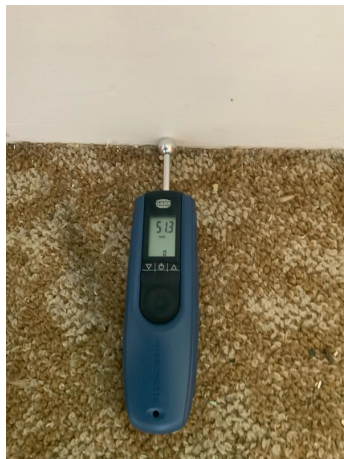
Photo 19

Internal moisture to bedroom  
23 South external wall reading  
low/medium moisture levels

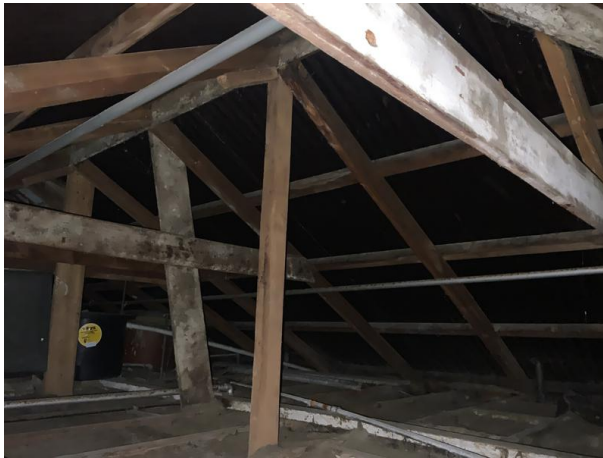
Photo 20

Roof space purlins, rafters, collar ties and strutting

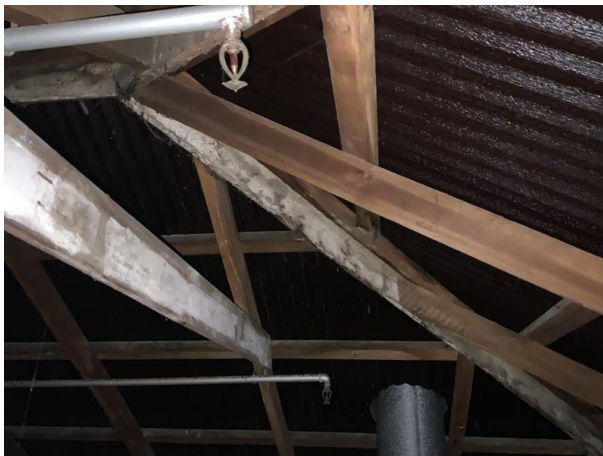
Photo 21

No roofing underlay detected throughout the roof space area. Installation of roofing underlay advised

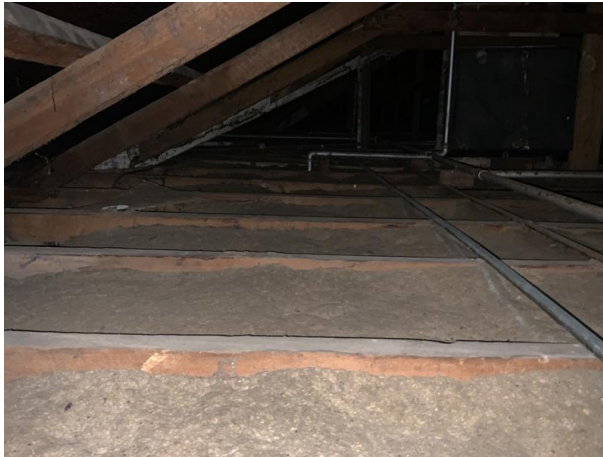
Photo 22

Insulation viewed throughout the roof space

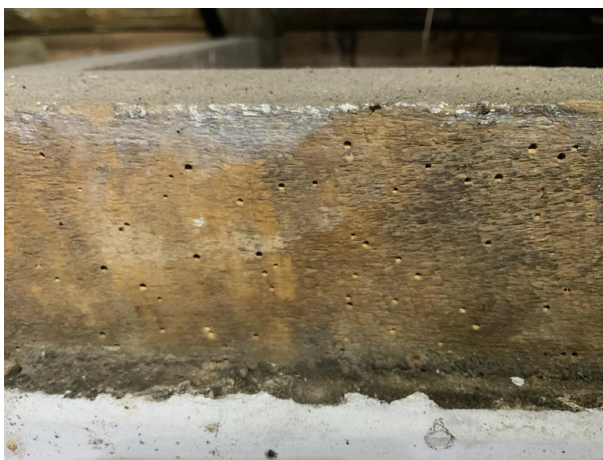
Photo 23

Borer detected throughout the roof space to a matter of structural degree. Further investigation is required

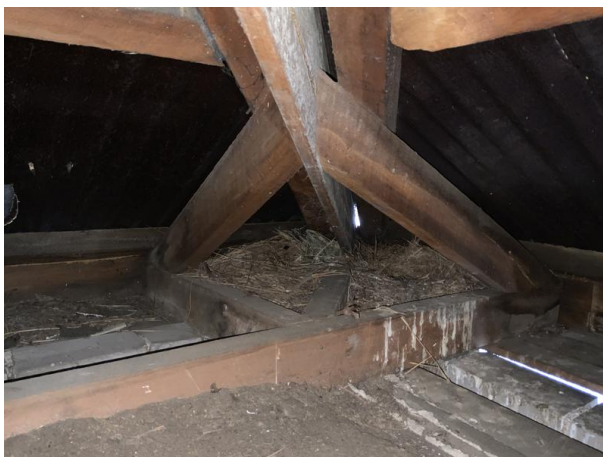
Photo 24

Bird nesting detected throughout the roof space. Advise are pest specialists for eradication

Remove bird nesting and seal visible gaps to deter birds.

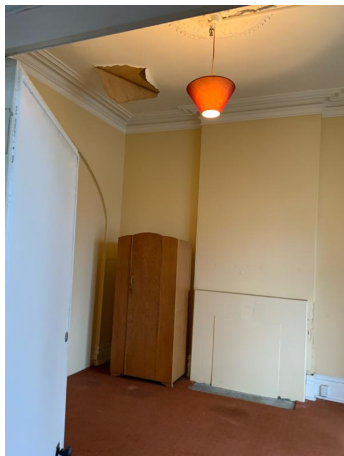
Photo 27

Bedroom one

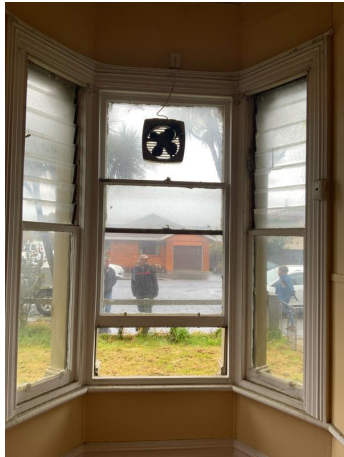
Photo 28

Bedroom one window set with only one opening window. Maintenance required to open 2 x windows

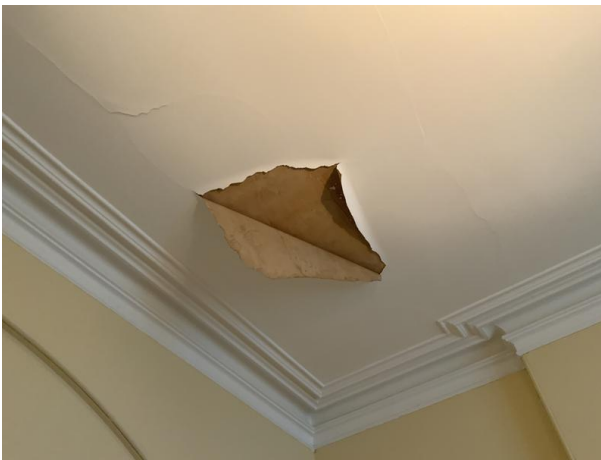
Photo 29

Cracking and deterioration of paint detected to bedroom one ceiling. Advise installing a new ceiling

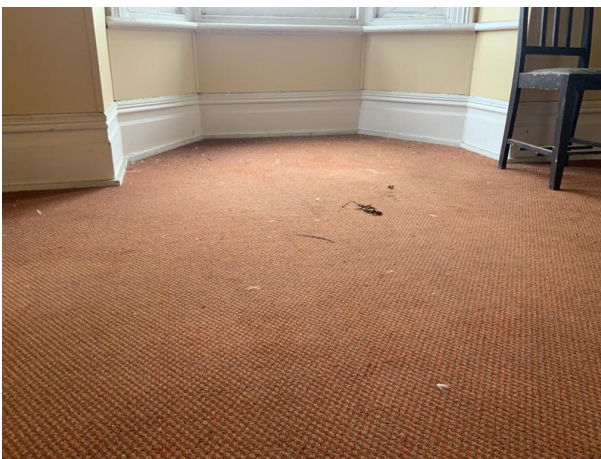
Photo 30

Bedroom one floors + - 20mm out of level

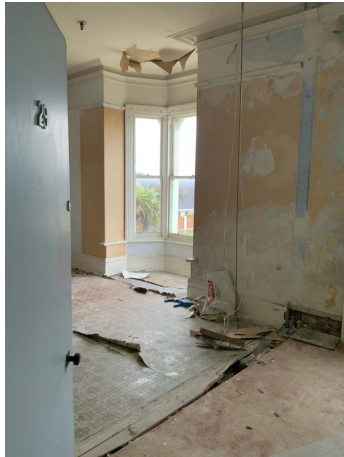
Photo 31

Bedroom 29 and 30

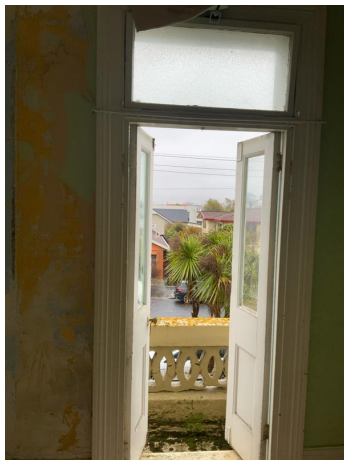
Photo 32

Bedroom 29 doors to balcony

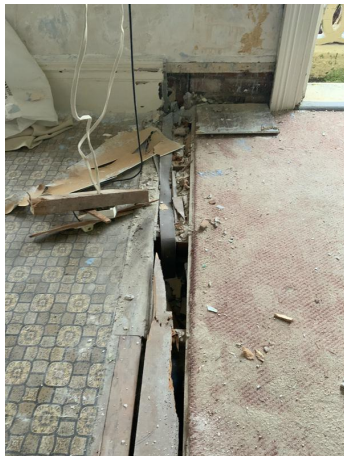
Photo 33

Removed wall detected between room 29 and 30. Structural integrity of floors has been compromised also.

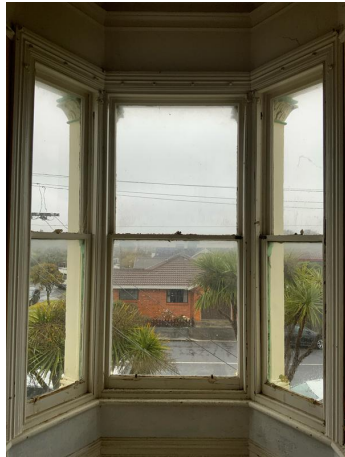
Photo 34

Bedroom 30 bay window with no opening windows. Maintenance required for windows to open

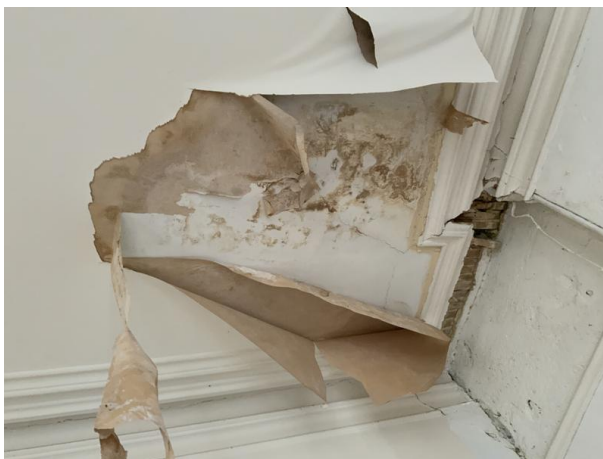
Photo 36

Moisture damage detected to room 30 ceiling. Installation of new ceiling advised

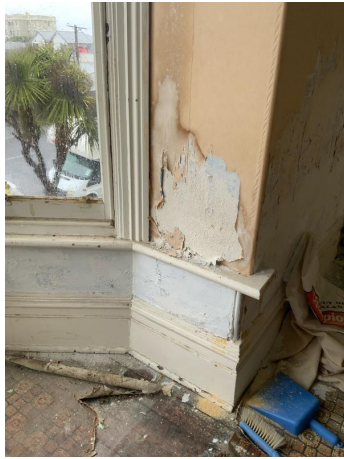
Photo 37

Damage detected to bedroom 29 wall linings. Re-lining advised

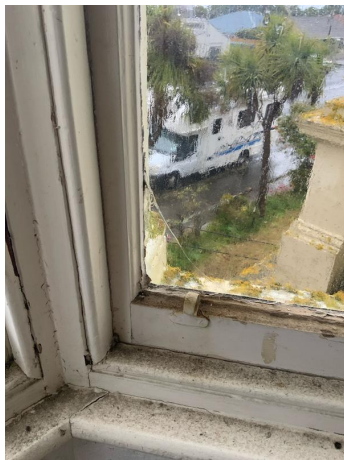
Photo 38

Cracked glass detected to bedroom 30 window. Replacement of glass advised

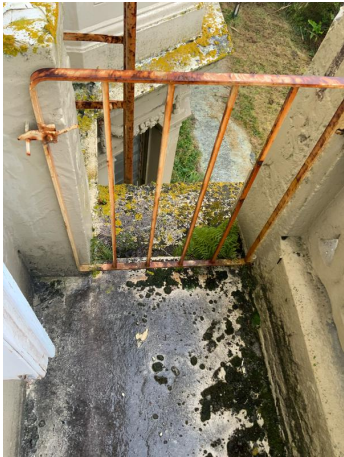
| <p>Photo 40</p> | <p>Corrosion detected to room 29 balcony gate. Replacement advised with code compliant safety gate</p> |

Although the balustrade would have complied at the time of construction, in the interest of safety, it is recommended to be upgraded/replaced with a current code-compliant version.

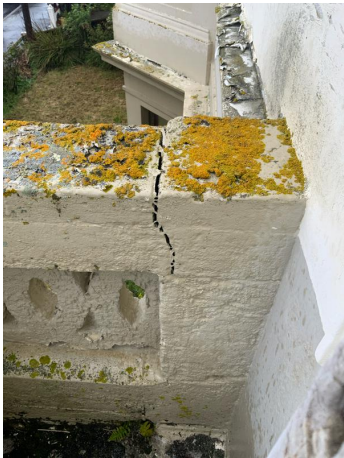
| <p>Photo 41</p> | <p>Cracking &amp; lichen detected to masonry balustrade. Structural integrity has been compromised to this balcony and should be investigated further by a structural engineer</p> |

Advise a structural engineer for further investigation into the balcony's structural integrity due to visible cracking.

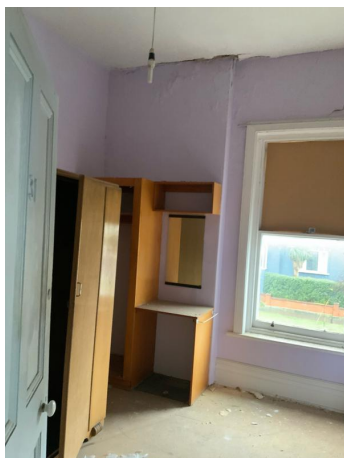
Photo 42

Bedroom 31

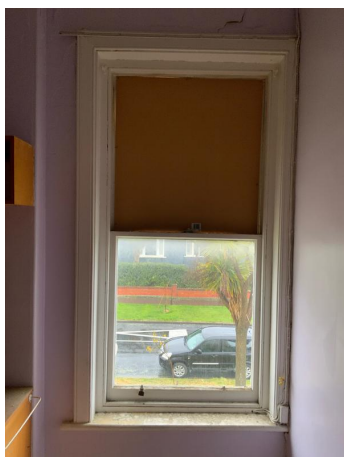
Photo 43

Bedroom 31 window not opening and missing glass. Replacement of window advised

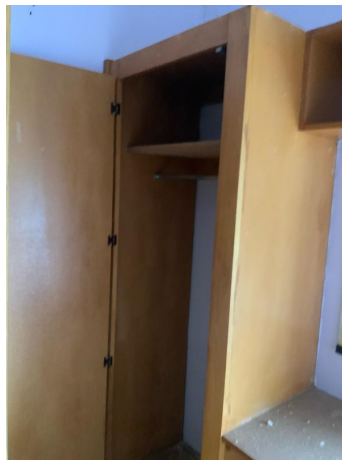
Photo 45

Bedroom 31 storage

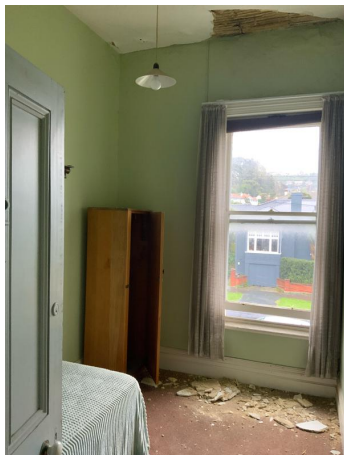
Photo 46

Bedroom 32

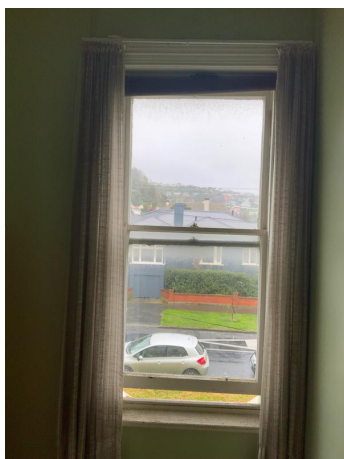
Photo 47

Bedroom 32 window

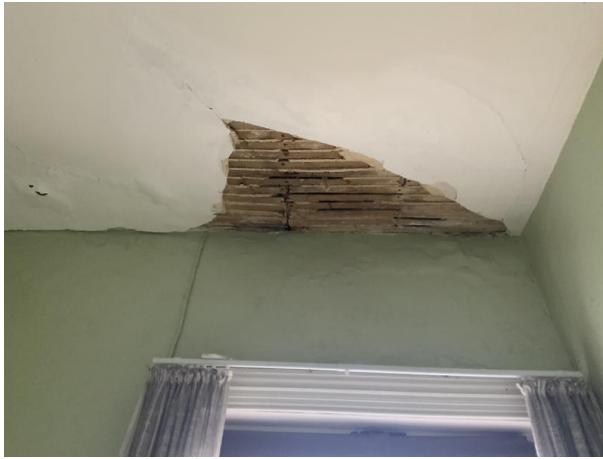
Photo 48

Damage and cracking detected to bedroom 32 ceiling. Installation of a new ceiling advised

Advise installation of a new ceiling to bedroom 32.  
Inspection of flooring and sub-floor framing is advised due to moisture damage.

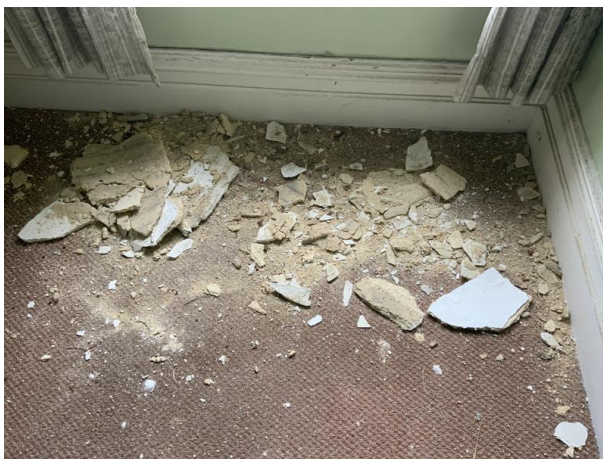
Photo 49

Moisture and mould detected to bedroom 32 carpet. Invasive inspection of timber flooring and floor framing advised

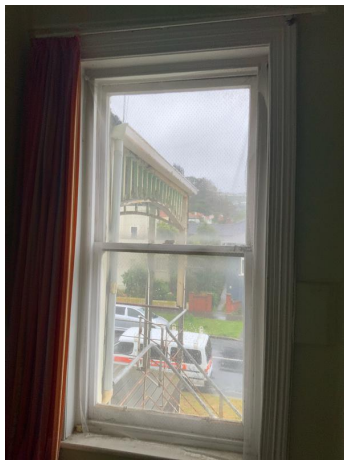
Photo 53

Bedroom 33 window non-opening. Maintenance required to open

Windows requires replacement due to rot & non-functional.

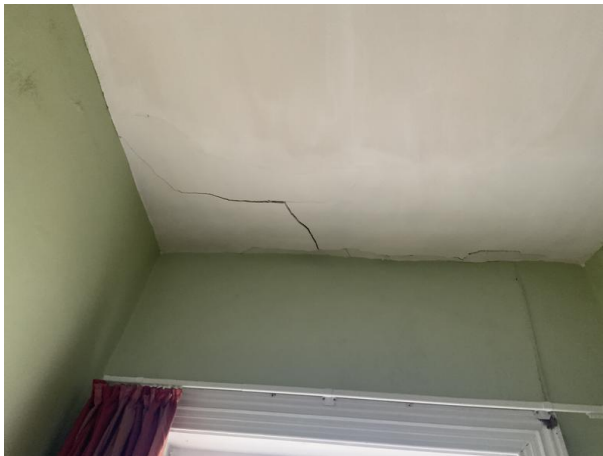
Photo 54

Cracking detected to bedroom 33 ceiling. Advise installation of a new ceiling

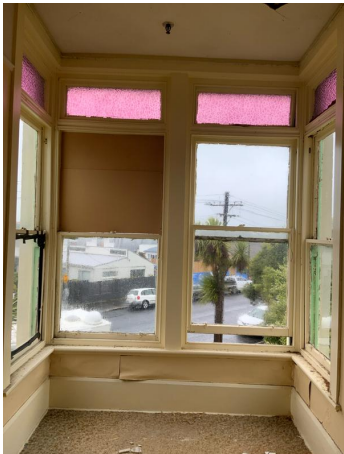
| <p>Photo 58</p> | <p>Bedroom 28 window set with only one opening window. Maintenance required to open other windows</p> |

A complete fit-out is required for bedroom 28.  
 Windows requires replacement due to rot, broken glass & non-functionality.

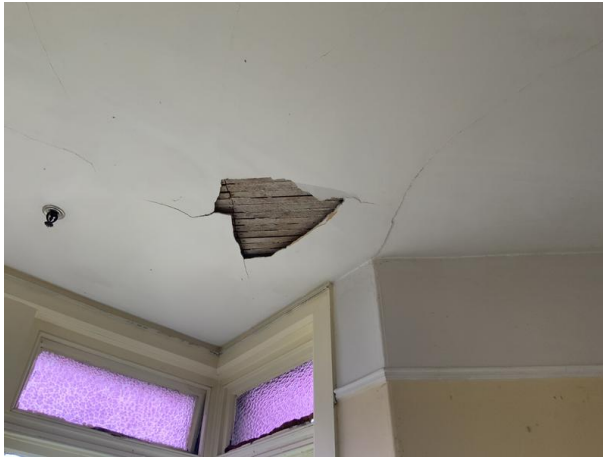
Photo 59

Major cracking and damage detected to bedroom 28 ceiling. Installation of a new ceiling advised

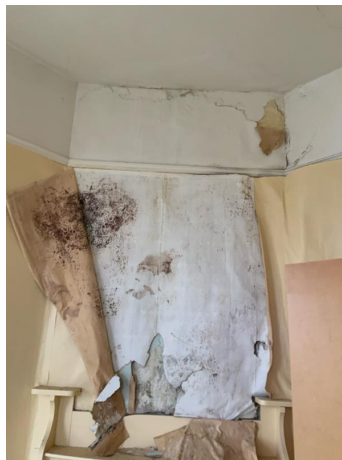
Photo 60

Moisture damage detected to bedroom 28 wall linings. Replastering of wall linings advised

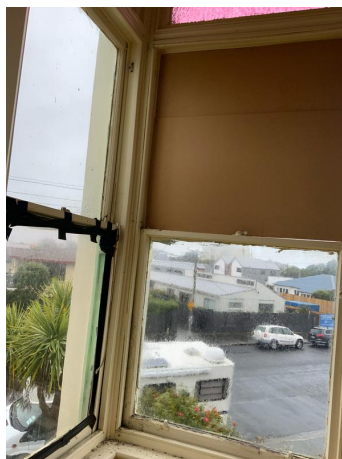
Photo 61

Replacement of windows advised to bedroom 28

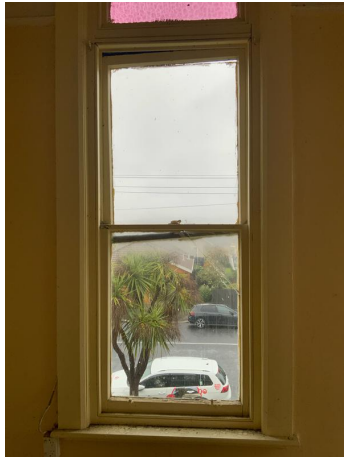
Photo 62

Bedroom 28 window two non-opening. Replacement required

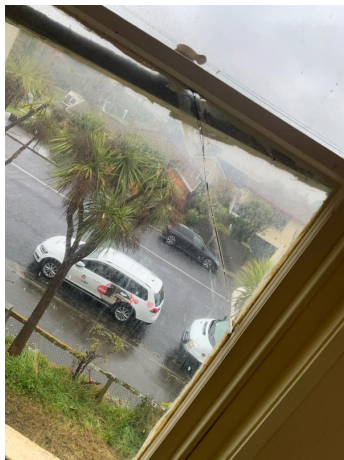
Photo 63

Replacement of windows advised

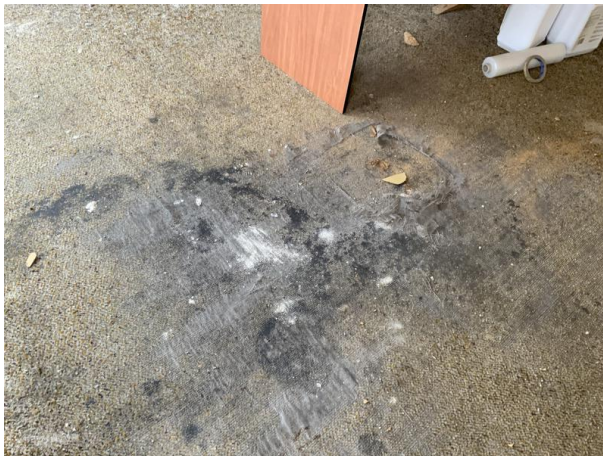
Photo 64

Moisture and mould detected to bedroom 28 carpet. Further investigation to the flooring and sub-floor timbers advised

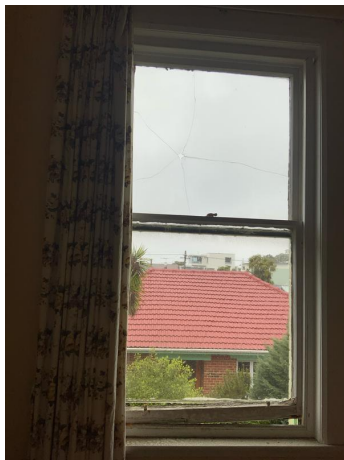
Photo 67

Bedroom 27 non-opening window damaged. Replacement of window advised

Windows requires replacement due to rot, broken glass & non-functional.

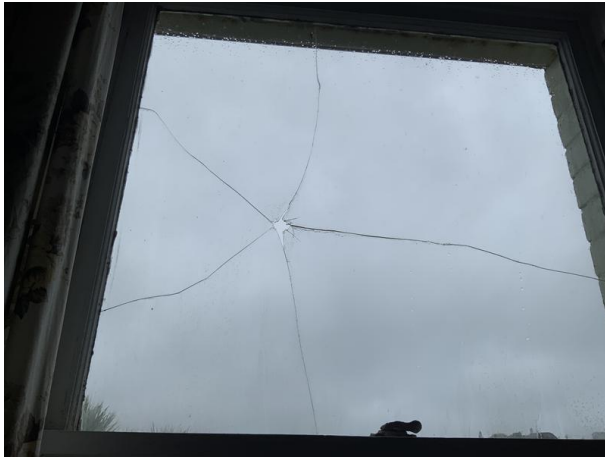
Photo 69

Cracked glass detected to bedroom 27 window. Replacement of window advised immediately for safety reasons of bystanders below

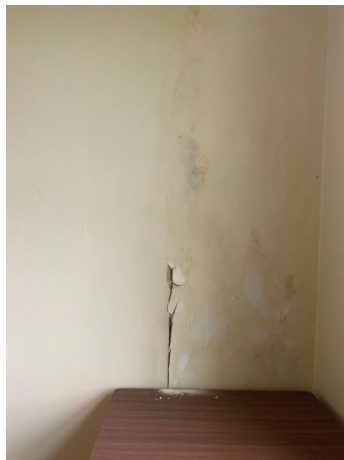
Photo 70

Moisture damage detected to bedrooms 27 wall linings. Re-lining of wall linings advised

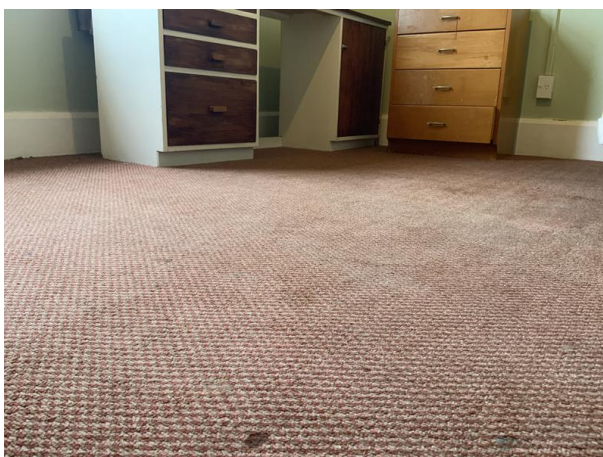
Photo 73

Bedroom 26 floors out of level  
+ - 30mm. Further investigation  
to the flooring and sub-floor  
timbers is required

Investigations of the sub-floor timber are required.

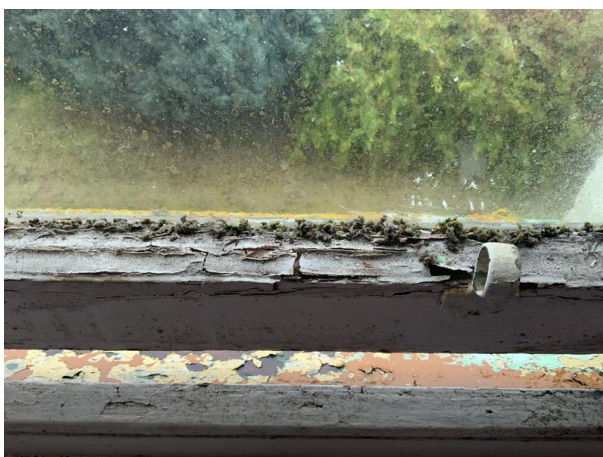
Photo 82

Mould & growth detected to bedroom 25 window. Replacement of window advised

Replace bedroom twenty five window due to visible mould and fungal growth.

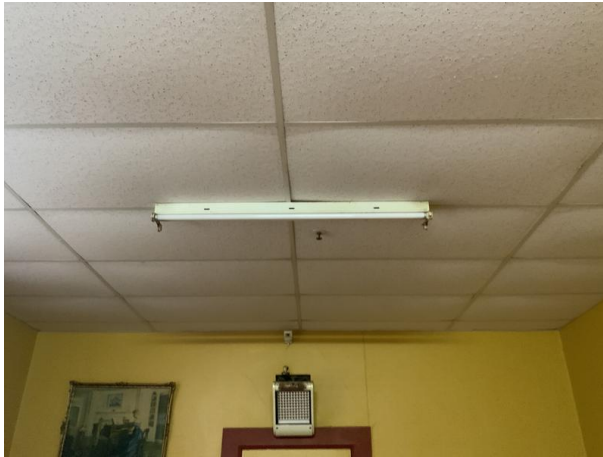
Photo 84

Lounge ceiling tiles damaged and sagging. Installation of a new ceiling advised

Replacement is required to the lounge ceiling due to sagging and damage.

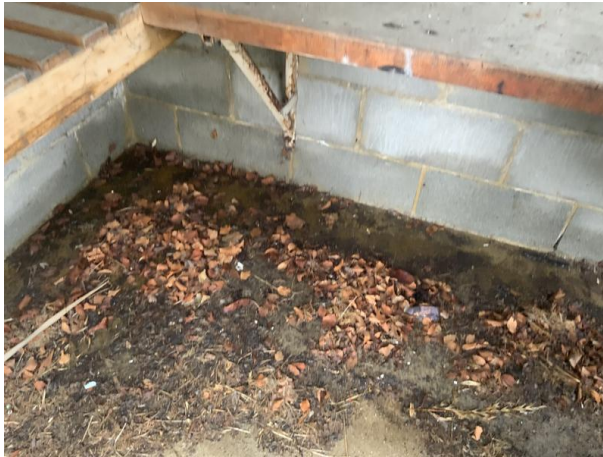
Photo 88

Moisture detected throughout laundry floor subject to leaking roof. Further investigation is required

A structural engineer needs to investigate further the structural integrity of the laundry dwelling due to moisture damage.

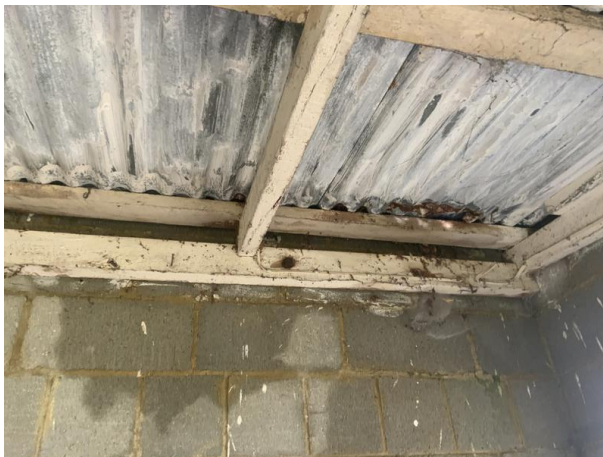
Photo 89

Moisture detected throughout the laundry walls. Replacement of roof advised

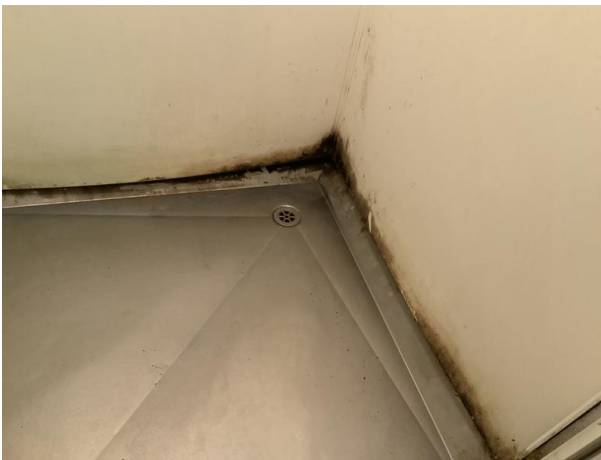
Photo 93

Mould and caving in of floor detected to level one bathroom shower tray. Further investigation is required to the amount of wet rot damage

Remove/replace shower due to extensive wet rot.

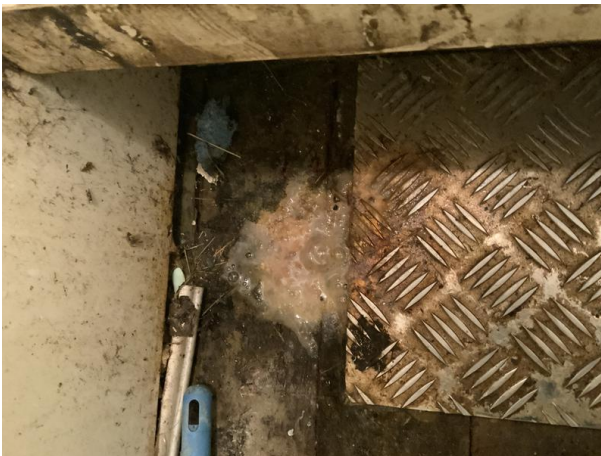
Photo 94

Rot detected to the bathroom floor boards. Installation of a new floor and further investigation to the sub-floor advised

Replace bathroom flooring due to rot.

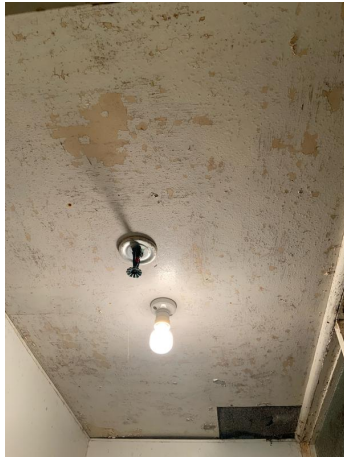
Photo 95

Bathroom ceiling cracking & harboring mould also deterioration of paint detected. Replacement of the ceiling advised

Replace bathroom ceiling due to deterioration, mould and cracking.

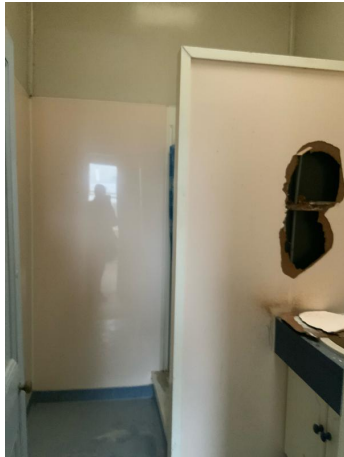
Photo 96

Upstairs bathroom two

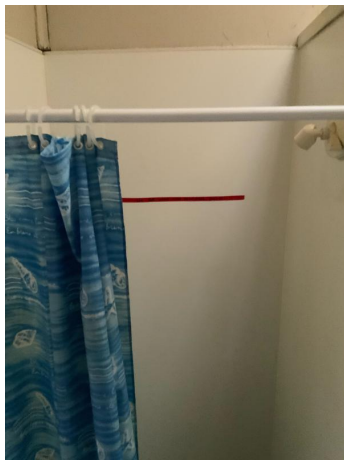
Photo 97

Bathroom shower enclosure

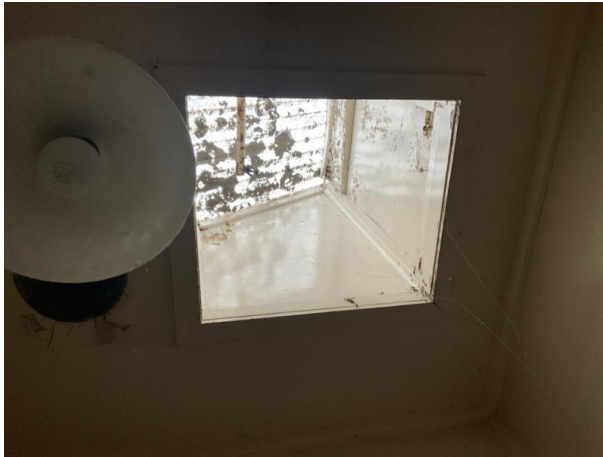
Photo 99

Bathroom skylight with moss detected to skylight glass. Cleaning advised

Bathroom requires complete makeover due to damage to ceilings and walls.  
Treatment/replacement required to bathroom skylight for mould.

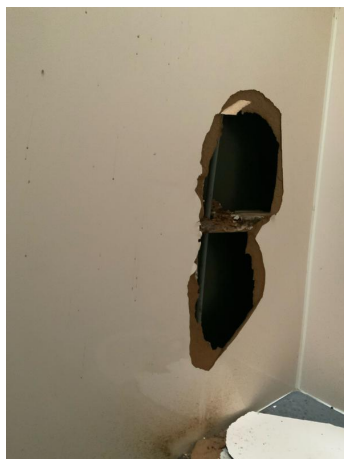
Photo 101

Damage detected to wall linings of bathroom two. Replacement of wall linings advised

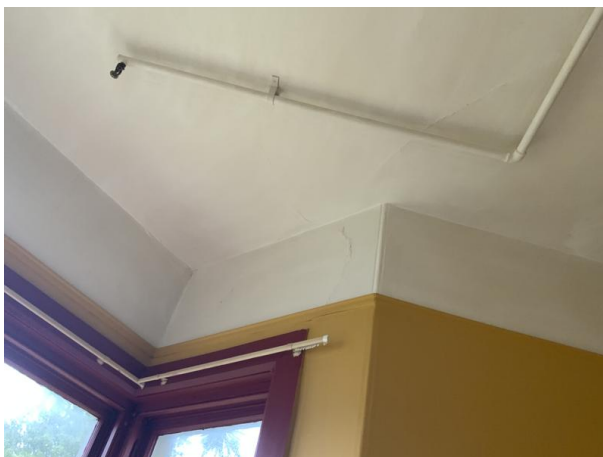
Photo 158

Cracking detected to office ceiling. Advise installation of a new ceiling due to vast cracking

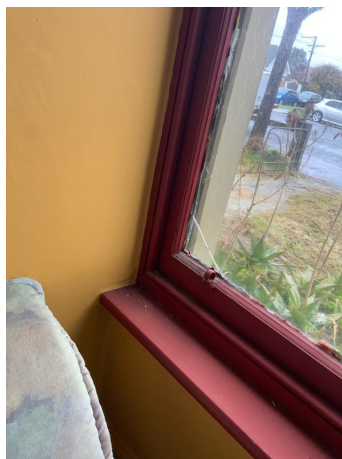
Photo 161

Office window two non-openable and is glass cracked.  
Advise replacing glass and maintenance required for window to open

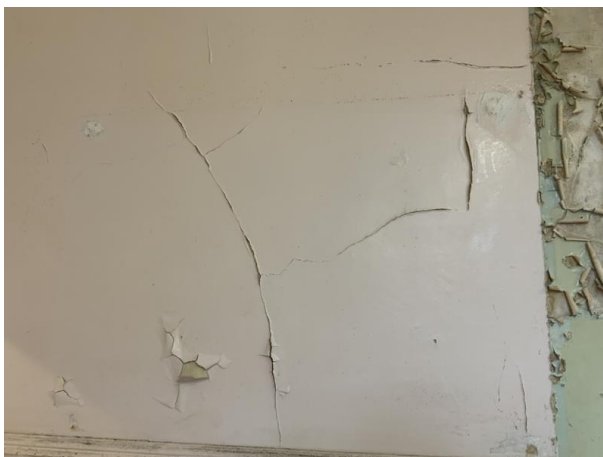
Photo 168

Damage detected to dining room wall linings. Re-lining advised

A complete fit-out is required in the dining and kitchen areas due to vast cracking in the ceilings, damage to the wall linings, and missing flooring due to rot.

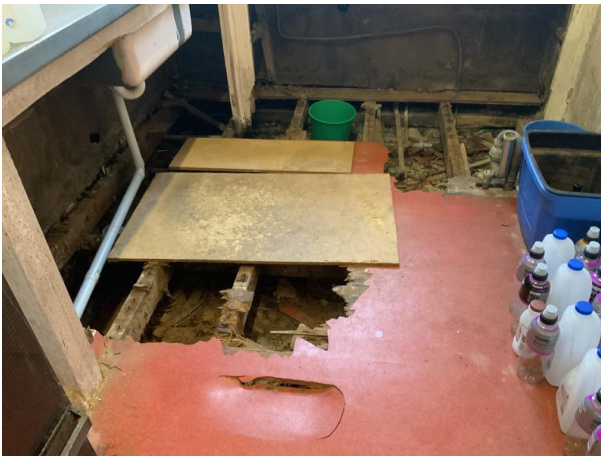
Photo 171

Kitchen flooring missing and damaged flooring structure. Installation of a new flooring system and flooring advised

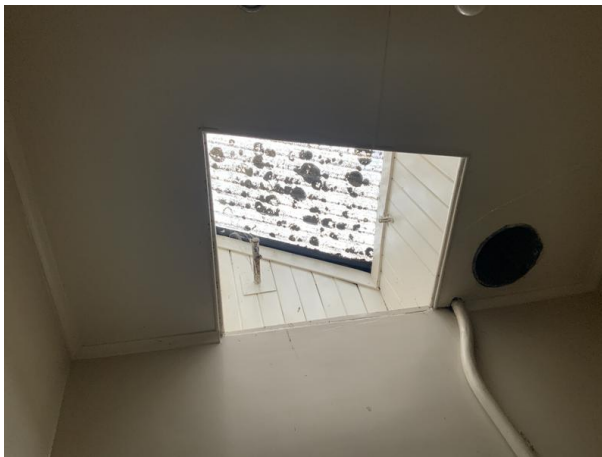
Photo 173

Bathroom skylight with lichen detected to the surface. Cleaning and treatment advised

Treatment/replacement required to bathroom skylight for lichen.

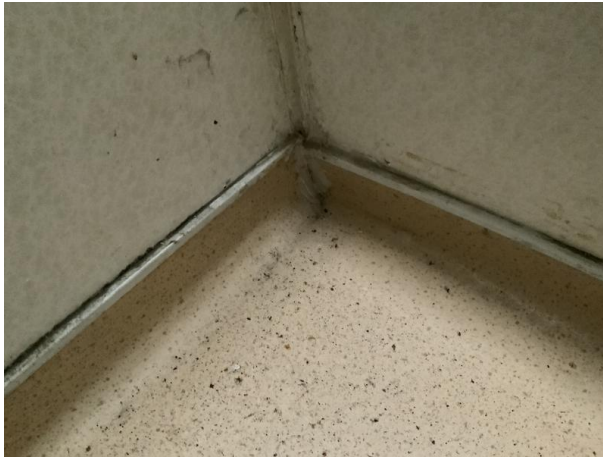
Photo 175

Damage detected to wall linings below bath. Removal advised to investigate further moisture damage

Further investigation is required behind the wall linings below the bath due to moisture damage detected.

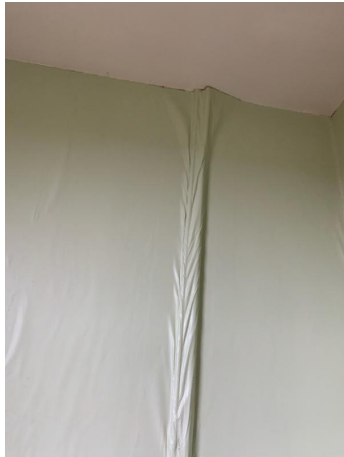
Photo 179

Cosmetic damage detected to bedroom 24 wall linings. Re-lining advised

Relining of walls required due to cosmetic damage.  
 Further investigation is required above the ceiling due to moisture damage detected. Replacement of ceiling advised respectively.

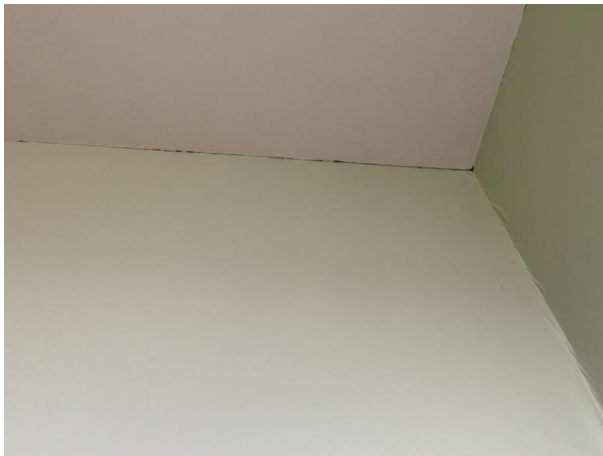
Photo 181

Moisture damage detected to bedroom 24 ceiling at wall junction. Further investigation is required to behind the scenes for moisture damage to structural timbers

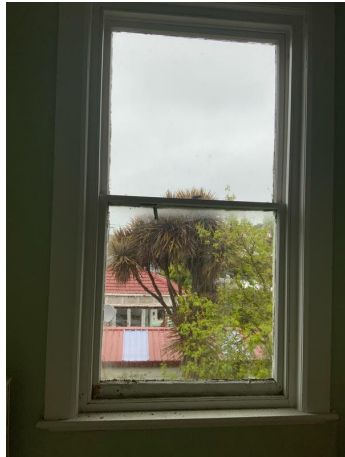
Photo 183

Bedroom 23 window not opening & rot detected to frame. Replacement advised

Replacement of window advised due to non-opening and damage detected to framing.

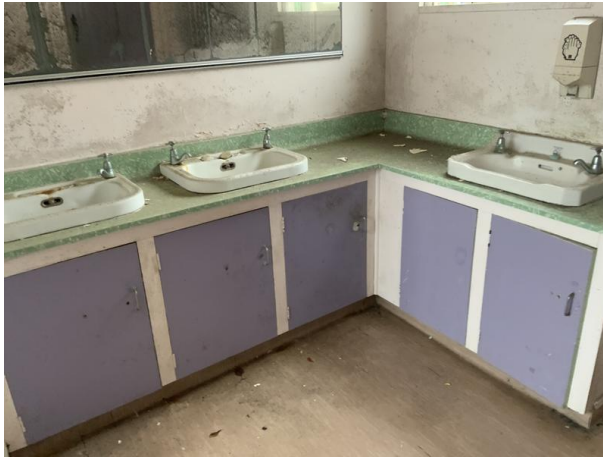
Photo 187

Bathroom 22 vanity sink units with middle left door non-openable.

Complete read fit out of toilet block advise due to deterioration, mould and decay.

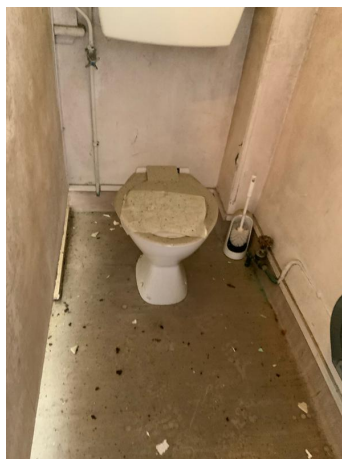
Photo 189

Bathroom toilet two non-functional

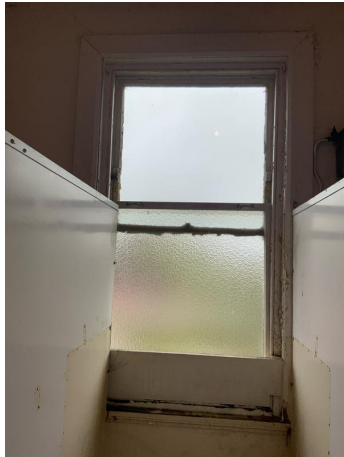
Photo 190

Bathroom window non-operable. Maintenance required to open

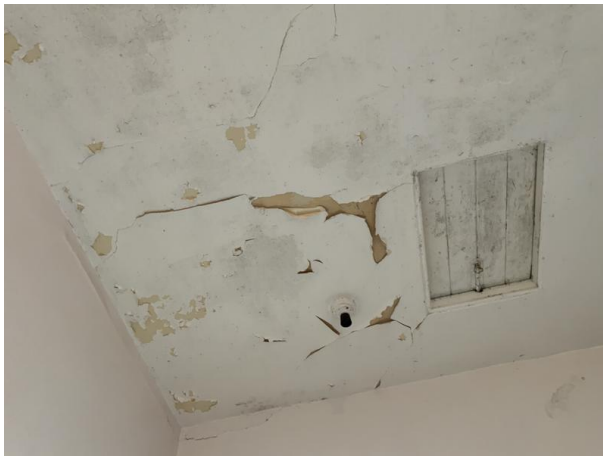
Photo 192

Moisture damage detected to bathroom ceiling. Further investigation is required into the roof systems and integrity before works to installation of a new ceiling

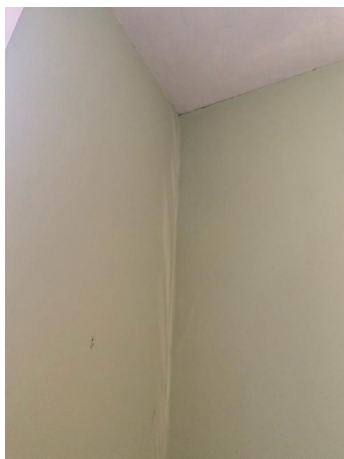
Photo 196

Cosmetic issues detected to internal corner of bedroom three. Prep and paint required

Prep and paint required to bedroom three wall linings due to cosmetic issues.

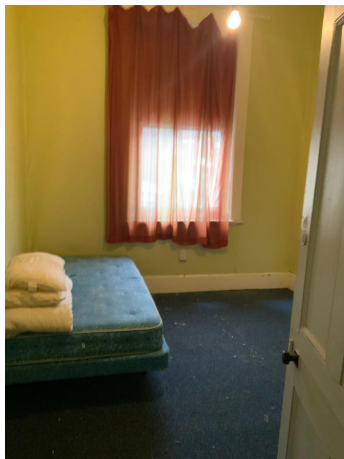
Photo 197

Bedroom 35

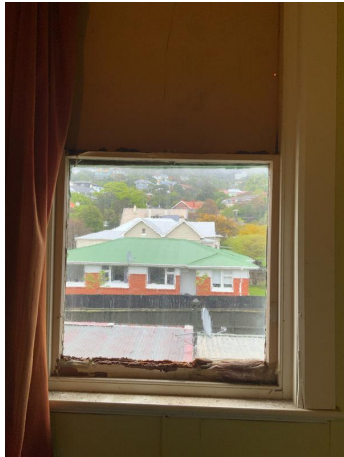
Photo 198

Bedroom 35 window

Replace bedroom 35 window due to broken glass & visible rot and mould.

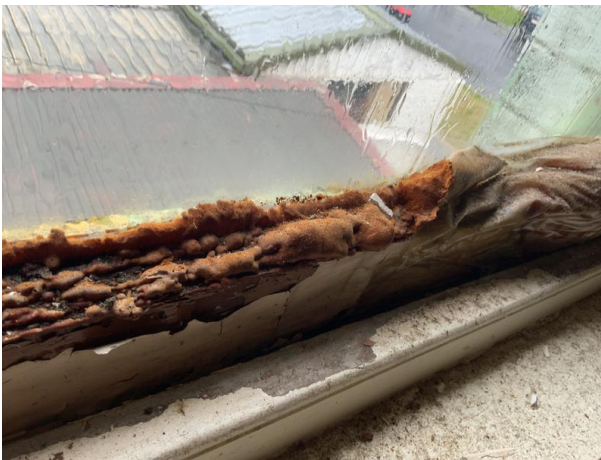
Photo 199

Mould and rot detected to bedroom 35 window. Replacement advised

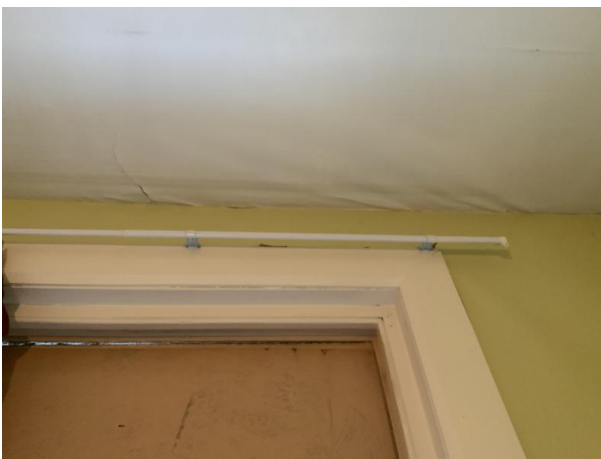
Photo 200

Moisture damage detected to bedroom 35 ceiling. Installation of a new ceiling advised

Replace bedroom 35 ceiling due to moisture damage.

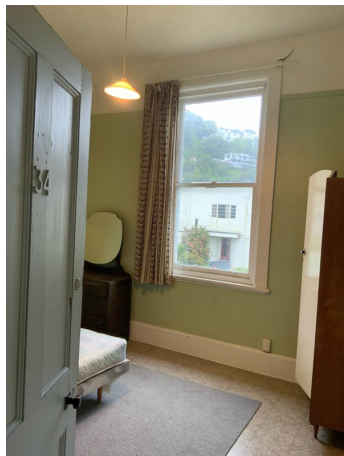
Photo 201

Bedroom 34

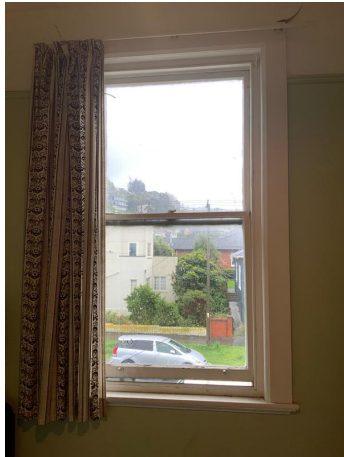
Photo 202

Bedroom 34 window

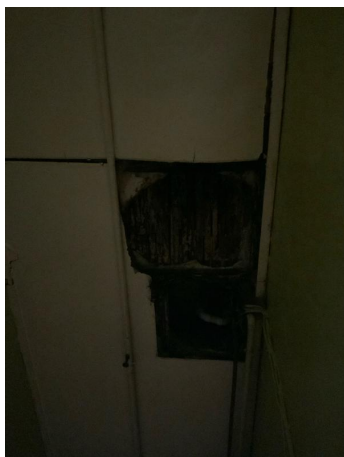
Photo 207

Damage detected to hallway ceilings. Replacement advised

Complete fit-out required to hallway ceilings and wall linings due to cracking, cosmetic issues and damage.

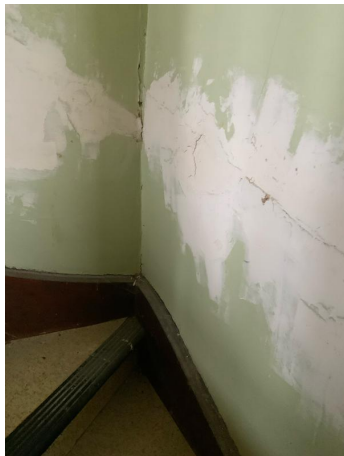
Photo 210

Cosmetic issues detected to stairway wall linings. Re-lining advised

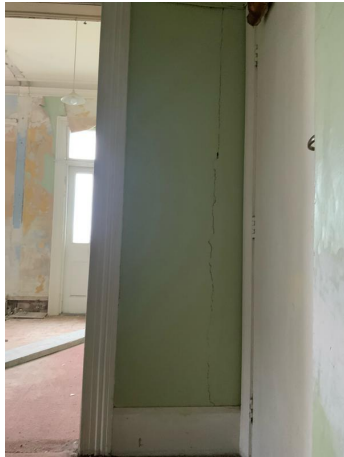
Photo 211

Cracking detected to wall linings to level two hallway. Re-lining of level two hallway advised

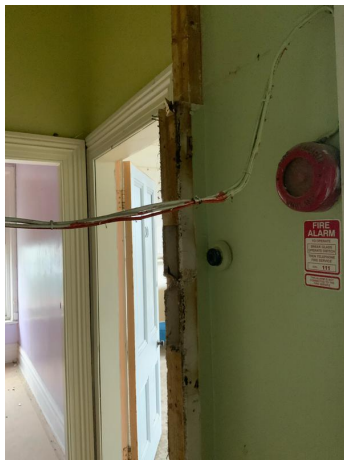
Photo 212

Dangerous overhanging detected in level two hallway. Advise an electrician to divert

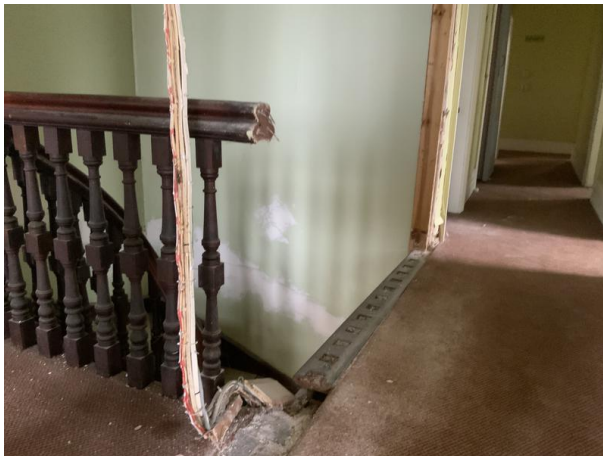
Photo 213

Missing balustrade detected to level two hallway. Installation of a new balustrade advised immediately, due to falling from heights requirements, DANGEROUS!

Replace missing balustrade immediately due to safety from falling requirements.

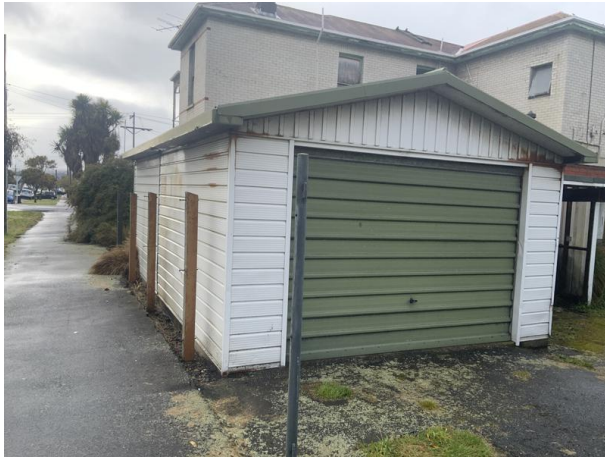
Photo 232

Garage located Northwest aspect on property

Removal of carport and garage advised due to deterioration, corrosion, leaking and decay.

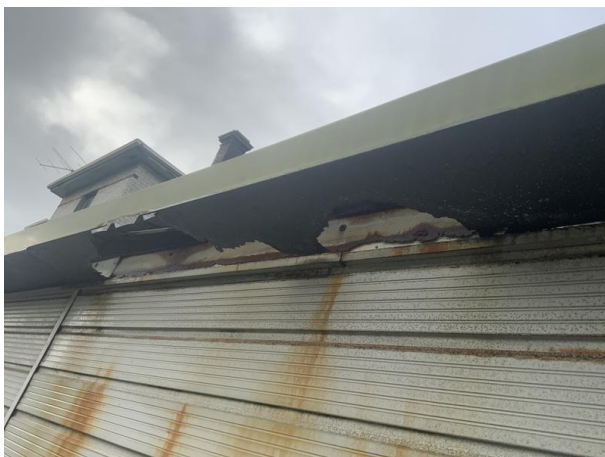
Photo 234

Corrosion detected to garage gutter system. Replacement advised

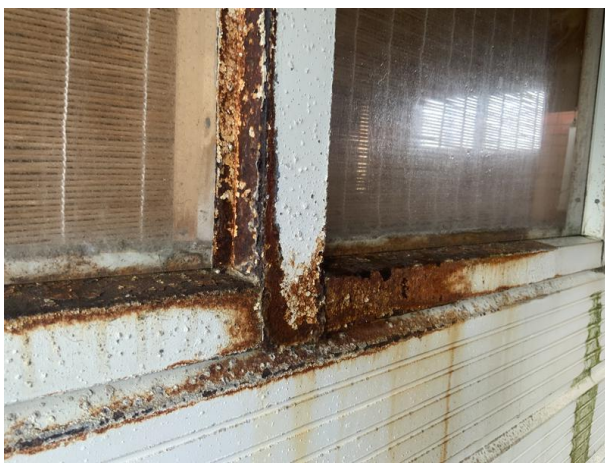
Photo 236

Corrosion detected to garage cladding. Garage requires removal

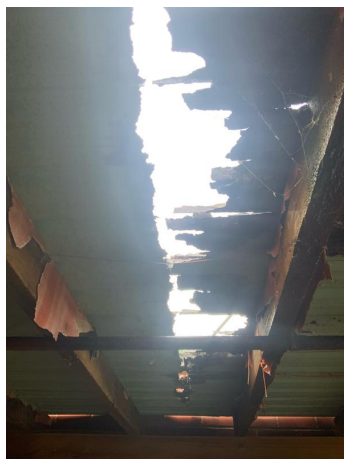
Photo 237

Carport roofing system corroded with damage detected to carport rafters. Removal of carport advised for safety purposes

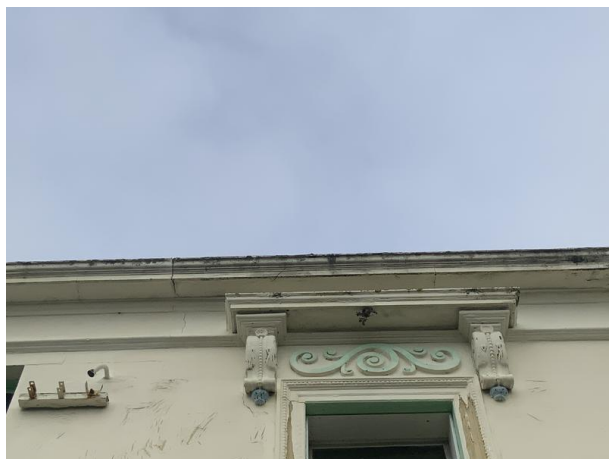
Photo 102

Cracking detected to soffits North aspect. Further investigation is required for safety reasons

Further investigation is required to the roof systems soffits due to cracking detected.

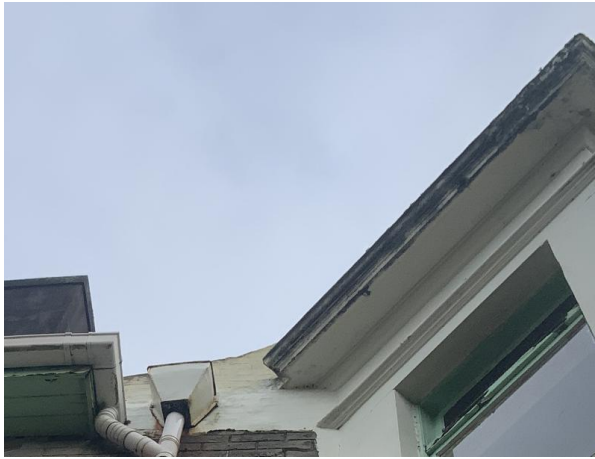
Photo 104

Rot detected to fascia  
Southeast aspect. Replacement  
advised

There are areas of the timber fascia that require repair & replacement, apply a sealer coat then redecoration to prevent further deterioration.

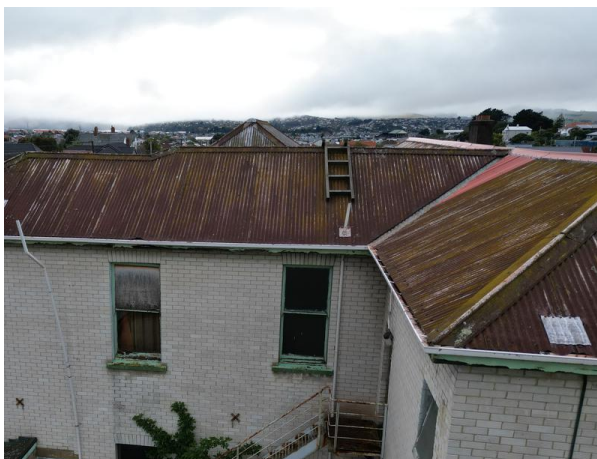
Photo 112

Northwest aspect exterior roofing with patching detected (right)
