**PRESENTATION MATERIAL FOR PLAN CHANGE 1 SUBMISSION**  
**Patersons on behalf of Blue Sky Property 45 Beach Limited**

The DCC Heritage Assessment for the building at 45 Beach Street recommended that the entire external building envelope, excluding the carport and garage on Albert Street, was recommended for protection.

Patersons, on behalf of BlueSky, requests that the Scheduled Heritage Building BX046 feature, referring to the main building at 45 Beach Street be removed from PC1. This includes from the planning maps.

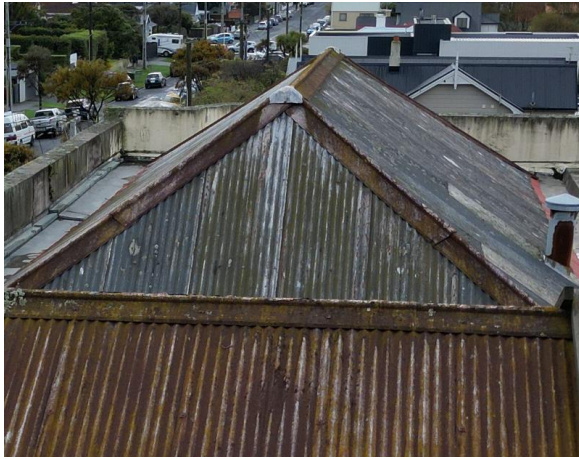
Photo 113

Corrosion detected to all flashings throughout the roofing system. Replacement advised

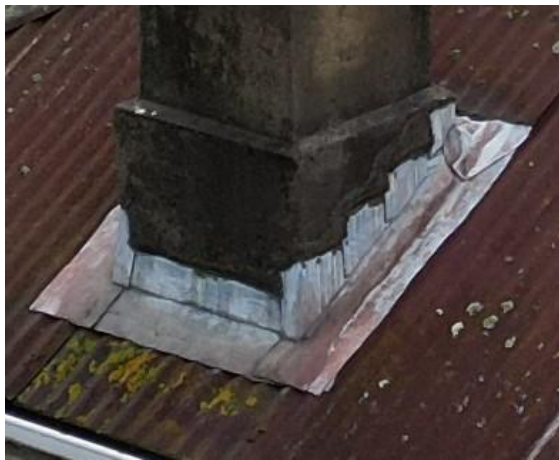
Photo 114

Northwest aspect flue penetration flashing. There is sealant on the roof flashings. This will need to be monitored as it does break down over time

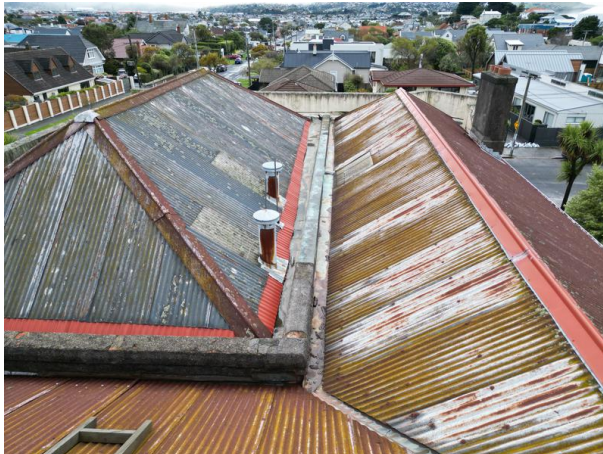
Photo 115

Internal box gutter with deterioration to the surface detected. Advise a roofer for a full inspection of the internal box gutter system

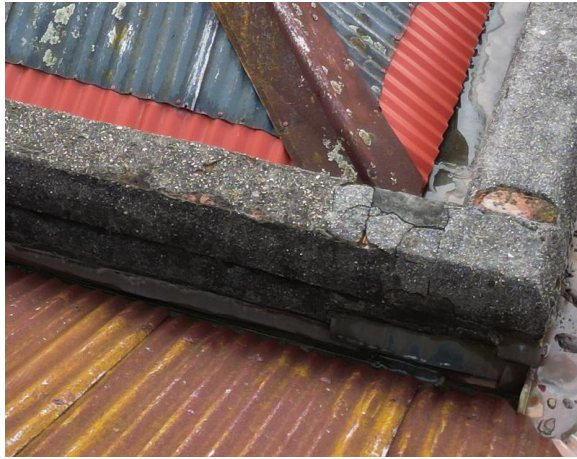
Photo 116

Cracking detected to West aspect parapet. Further investigation is required

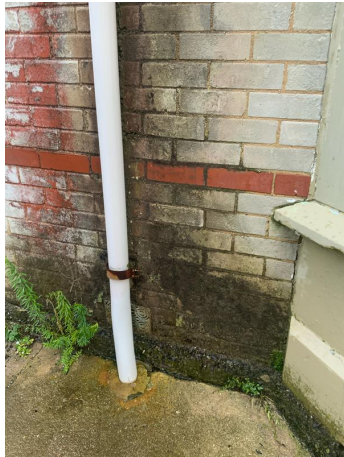
Photo 120

Deterioration of brick, moisture damage and moss detected to South aspect exterior cladding. Further investigation is required

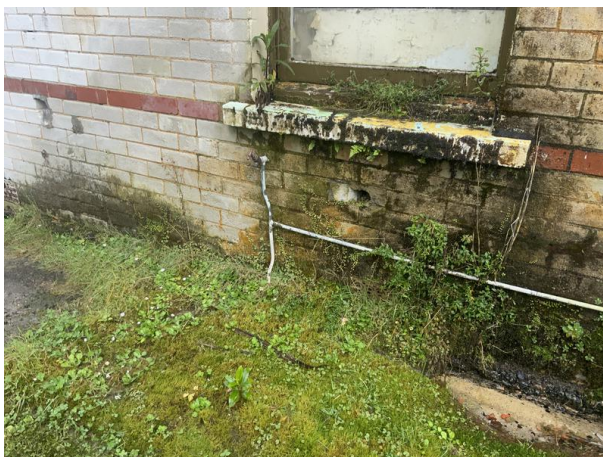
Photo 122

Vegetation growing from South aspect exterior cladding. Further investigation is required

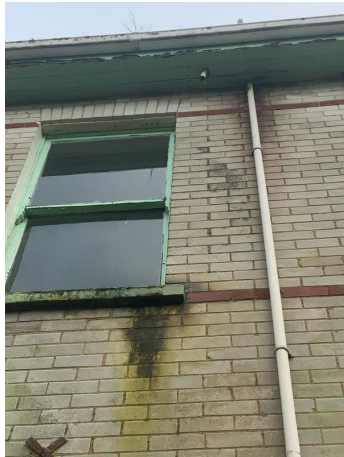
Photo 123

Spoil to brick from water runoff detected to South aspect exterior cladding. Treatment and cleaning advised

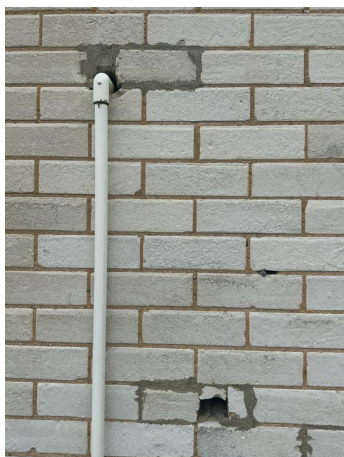
Photo 124

West aspect exterior cladding

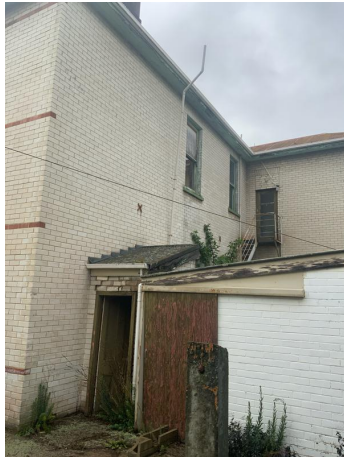
Photo 125

Unfilled penetration holes detected to West aspect exterior cladding. Sealing and re-laying of bricks advised

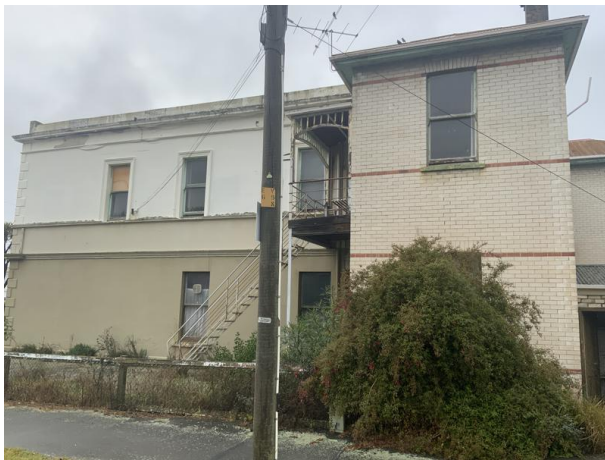
Photo 126

Northwest aspect exterior cladding with vegetation against. Removal advised

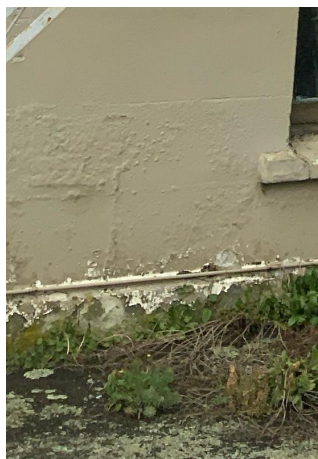
Photo 127

North aspect exterior cladding

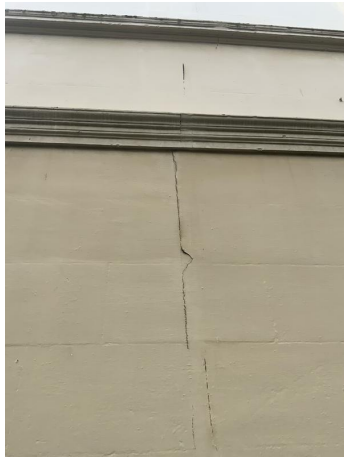
Photo 128

Deterioration of plaster detected throughout North aspect exterior cladding. Advise a plasterer for a full detailed report on the plaster system

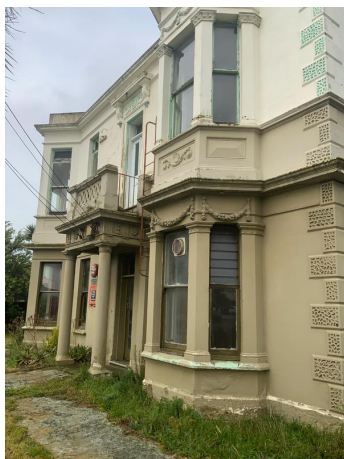
Photo 130

Upper North aspect exterior cladding with cracking detected below soffits. Further investigation is required to the structural integrity below the plaster system

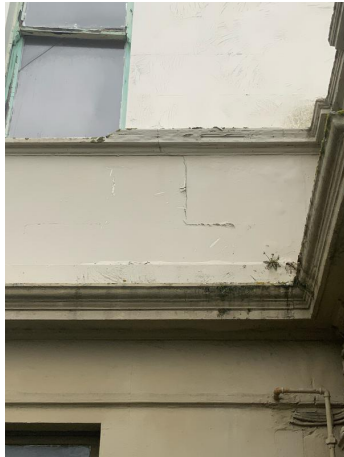
Photo 131

East aspect exterior cladding

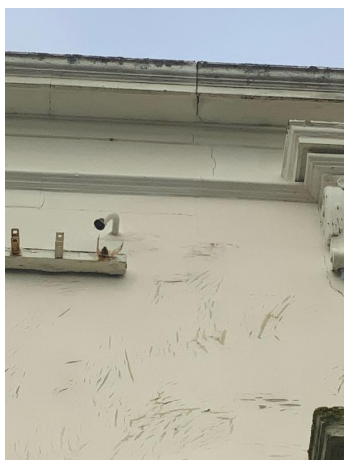
Photo 132

Cracking detected to East aspect exterior cladding. Advise a plasterer for repair

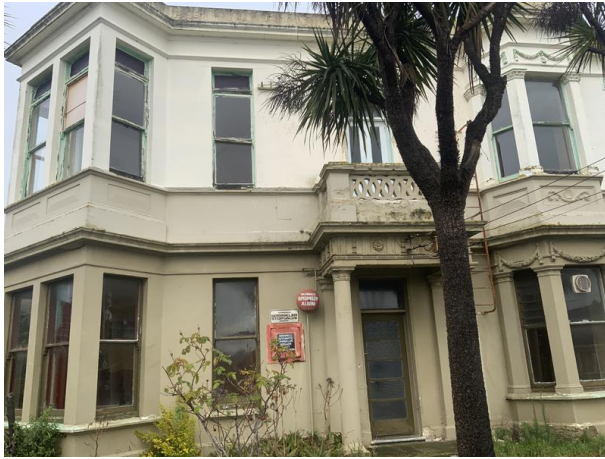
Photo 135

East aspect exterior joinery

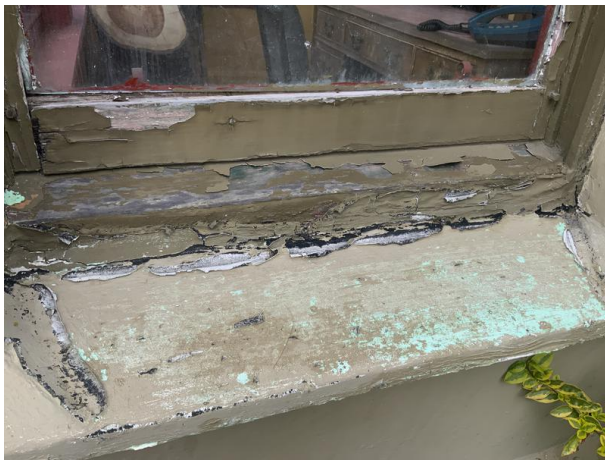
Photo 136

Deterioration of paint & rot detected to all windows throughout dwelling. Replacement of all windows advised

Replacement of all exterior joinery required throughout the dwelling due to broken glass, rot, non opening windows, deterioration and decay.

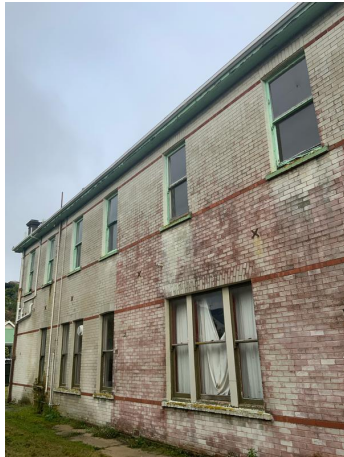
Photo 138

South aspect exterior joinery

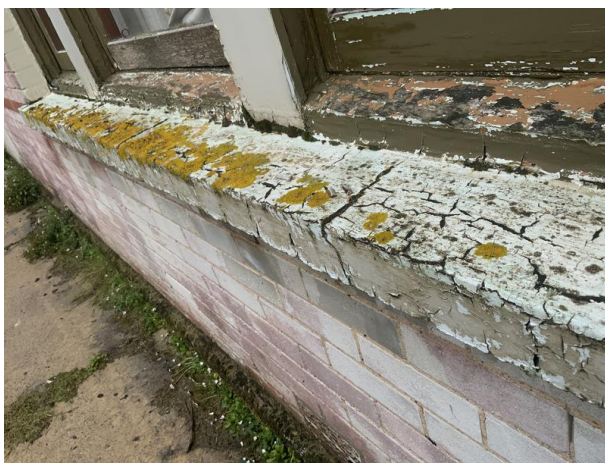
Photo 139

Deterioration of paint, moss & lichen detected to sills throughout dwelling. Treatment, prep and paint required to all sills

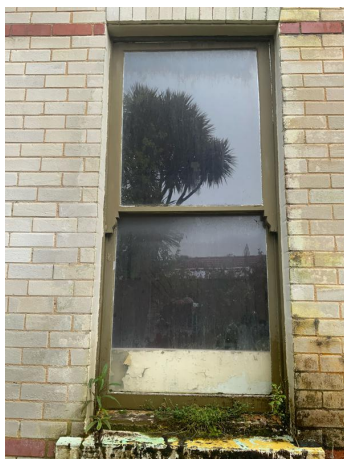
Photo 140

Typical head detail recessed

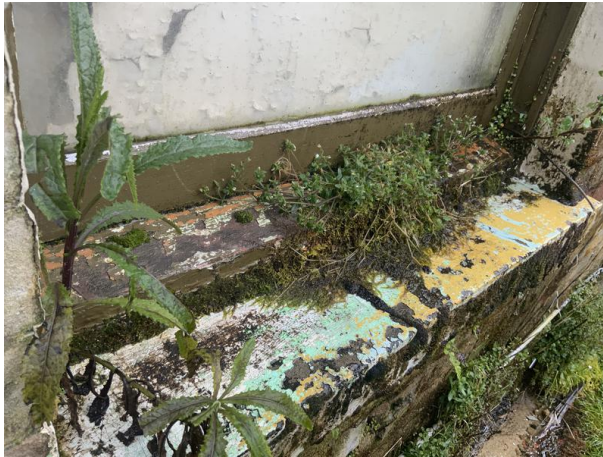
Photo 141

Vegetation detected growing from window & sills Southwest aspect. Further investigation is required

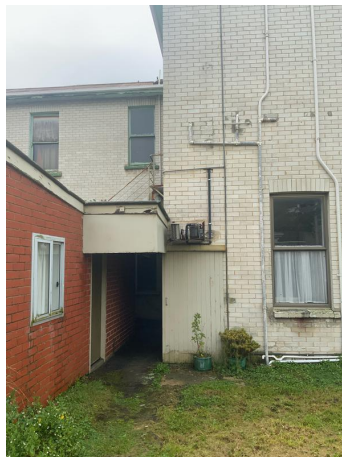
Photo 142

West aspect exterior joinery

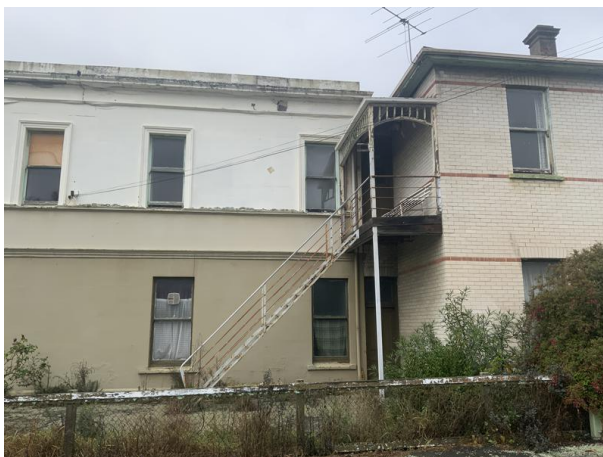
Photo 143

North aspect exterior joinery

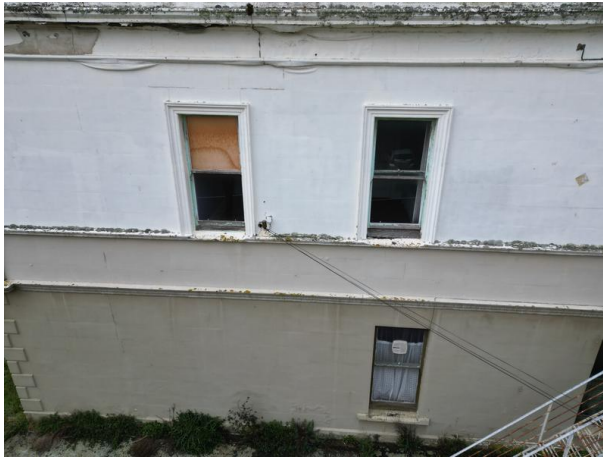
Photo 144

No head flashings viewed throughout exterior joinery. Installation of head flashings with new exterior joinery advised

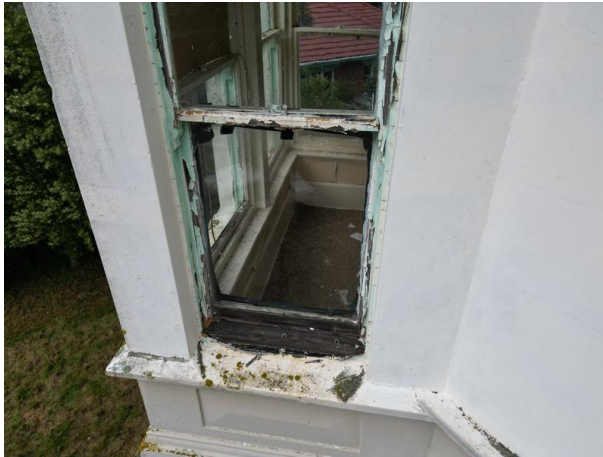
Photo 147

Typical rot and deterioration to upper level exterior joinery. Replacement advised

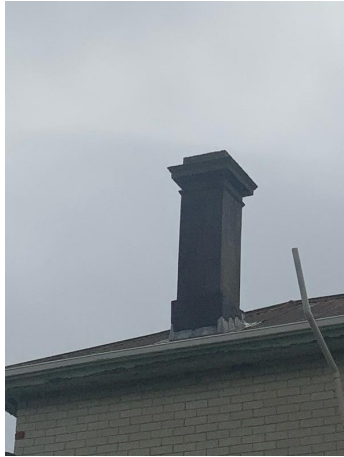
Photo 148

Northwest elevation chimney

Remove any redundant chimneys incase of seismic activity for safety purposes.

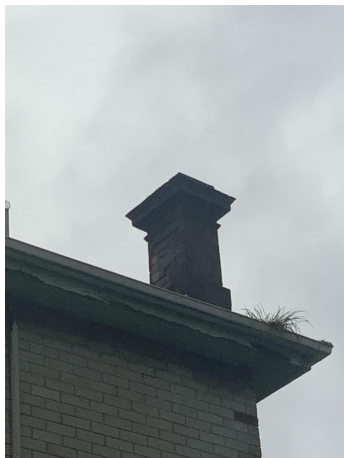
Photo 149

Southwest elevation chimney

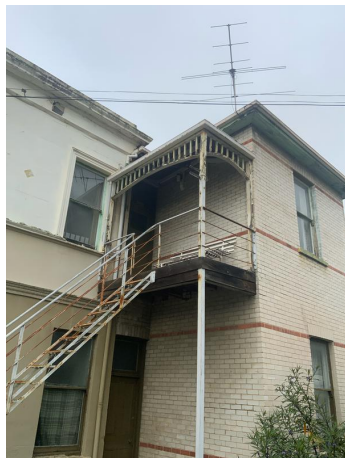
Photo 150

Balcony located Northwest aspect on property

Further investigation is required to the Northwest aspect balcony's structural integrity.  
Although the balustrade would have complied at the time of construction, in the interest of safety, it is recommended to be upgraded/replaced with a current code-compliant version

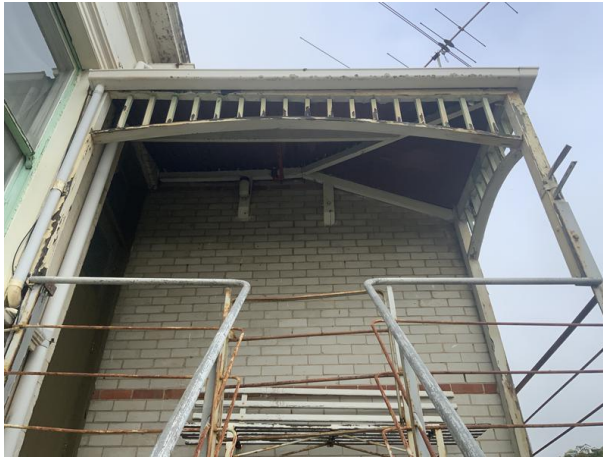
Photo 151

Balcony not visited due to feeling unsafe

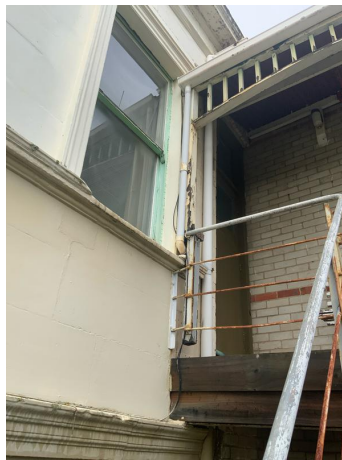
Photo 152

Corrosion detected to balcony handrail. Replacement advised

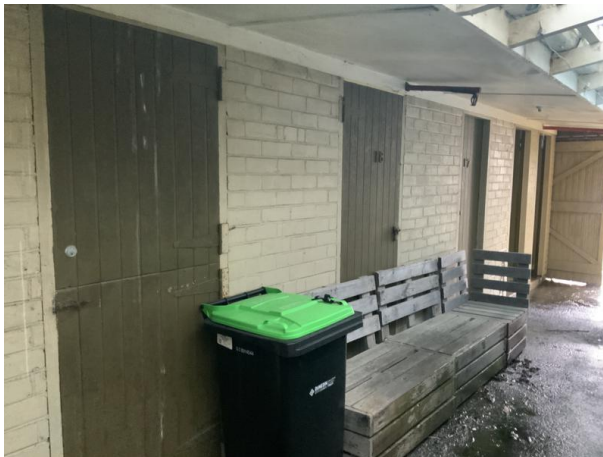
Photo 219

Toilet block located West on property

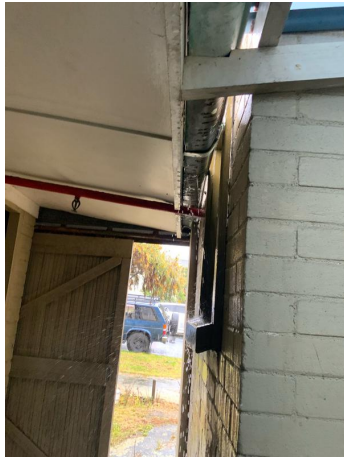
Photo 220

Continuous water leaking through toilet block. Replacement of gutter system advised

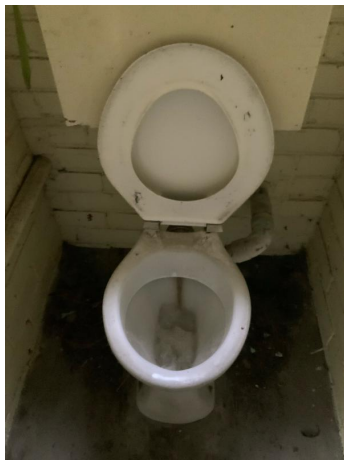
Photo 221

Toilet block toilet one

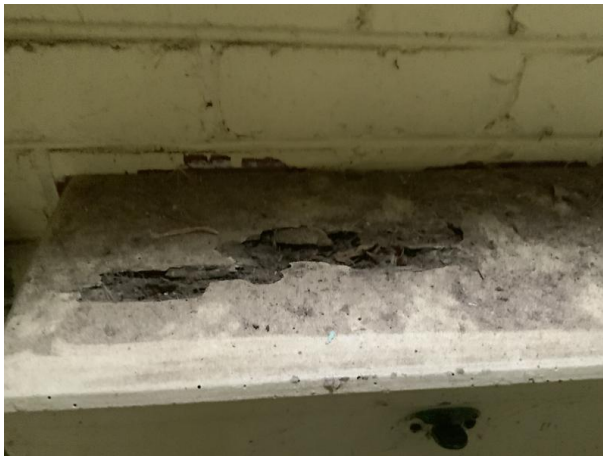
Photo 222

Damage detected to toilet cistern. Replacement of toilet advised

Replace toilet cistern due to damage.

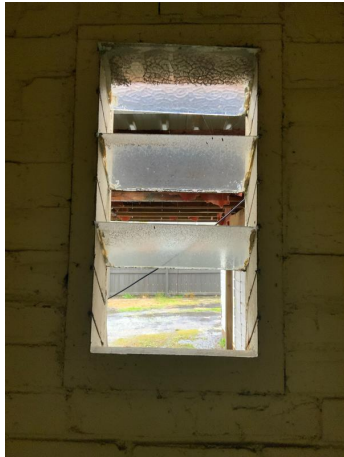
Photo 223

Toilet one window missing glass. Installation of new glass advised

Replace glass to toilet window.

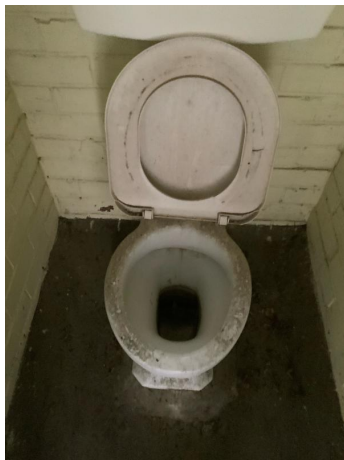
Photo 224

Toilet room 2

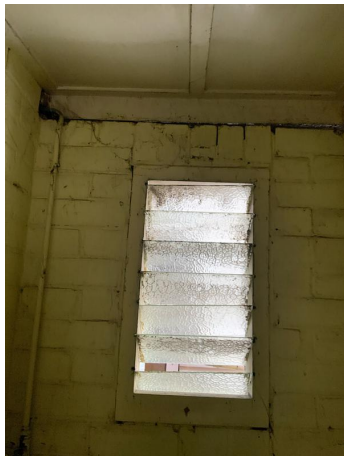
Photo 225

Toilet room 2 window

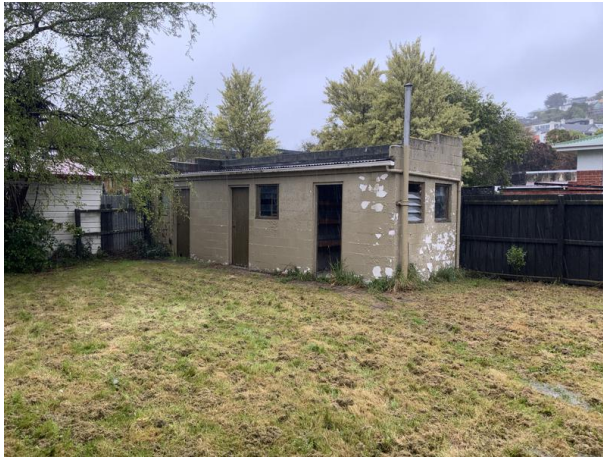
Photo 226

Ablution block & laundry  
located Southwest on property

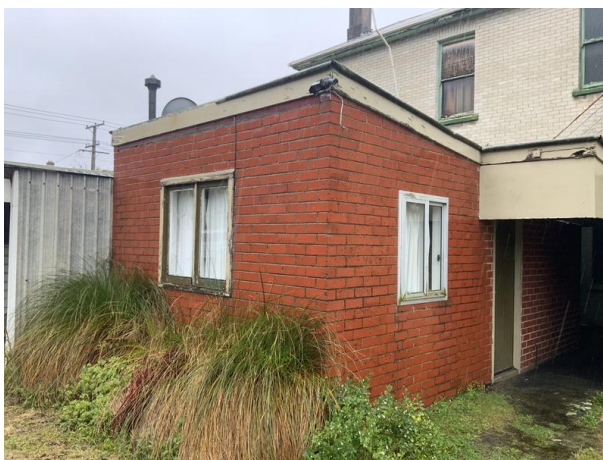
Photo 227

Studio shed located Northwest  
on property

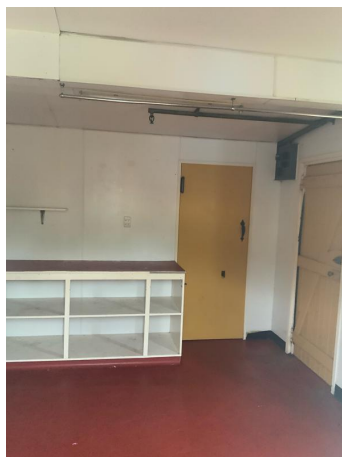
Photo 228

Internal view of studio

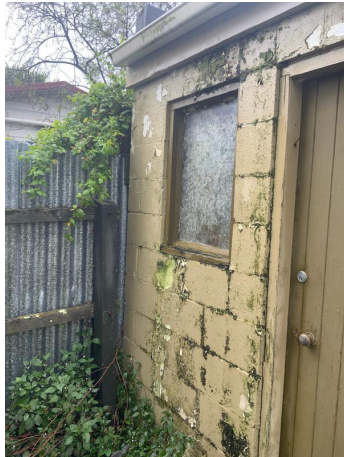
Photo 229

Deterioration detected to ebolution block cladding. Further investigation is required

Further investigation is required to ablution block cladding due to deterioration detected.

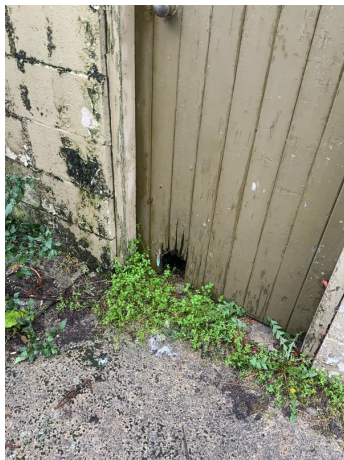
Photo 230

Rot detected to ebolution block door. Replacement advised

Replace ablution block entrance door due to visible signs of rot.

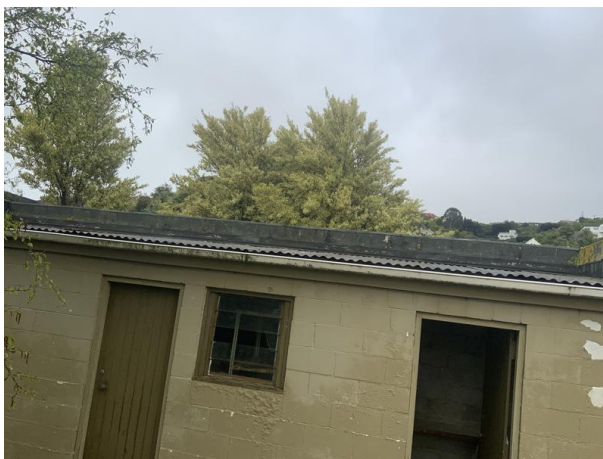
Photo 231

Deterioration of roofing detected to ebolution block. Installation of a new roof advised

Replace ablution block roofing due to deterioration of the roofing system.

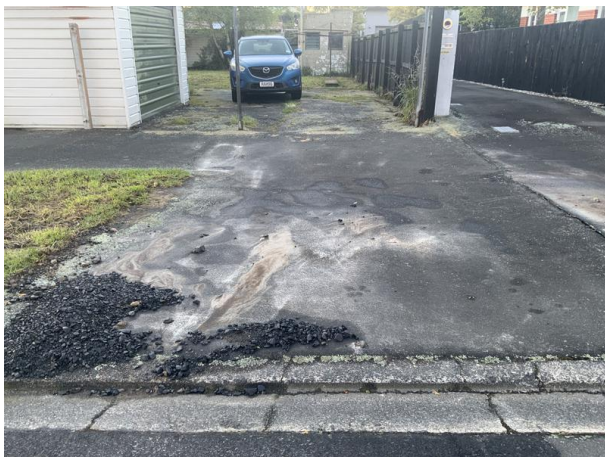
Photo 238

Driveway located Northwest aspect on property

Driveway is cracked which would be expected for the age. Replacement advised.  
Recommend regular water blasting to keep clear of moss & lichen buildup.

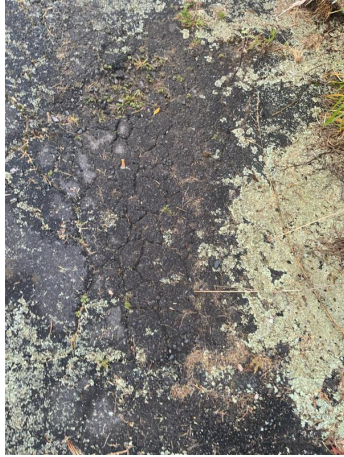
Photo 240

Lichen & moss detected to driveway. Treatment & cleaning advised

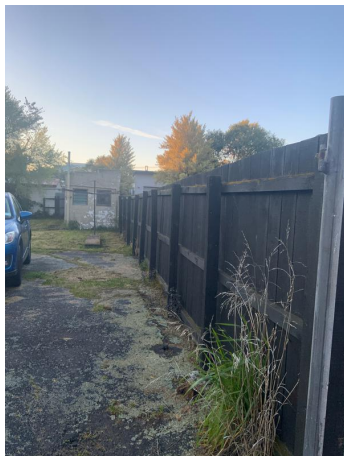
Photo 241

West aspect perimeter fencing

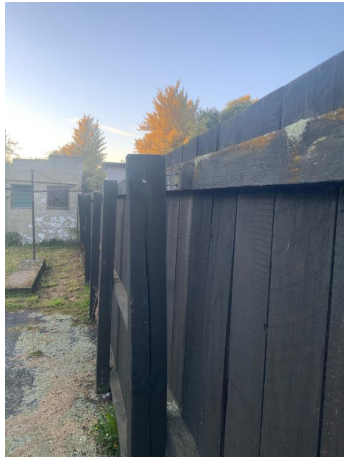
Photo 242

Rail detachment detected to West aspect perimeter fencing. Re-fixing advised

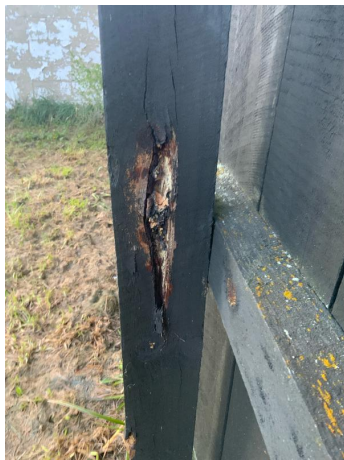
Photo 243

Rot detected to West aspect post. Replacement of post advised

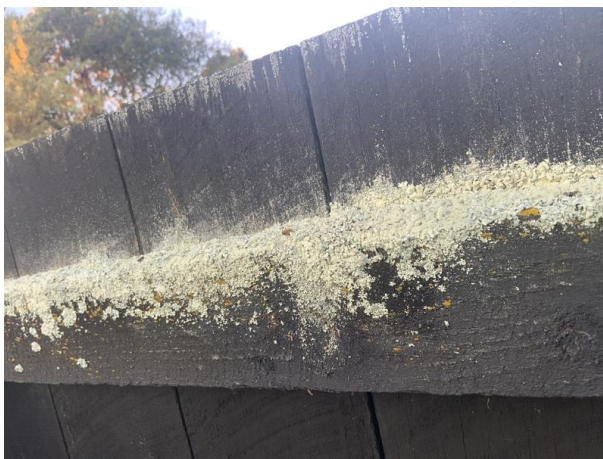
Photo 244

Lichen detected to all aspects of fencing. Treatment and cleaning advised

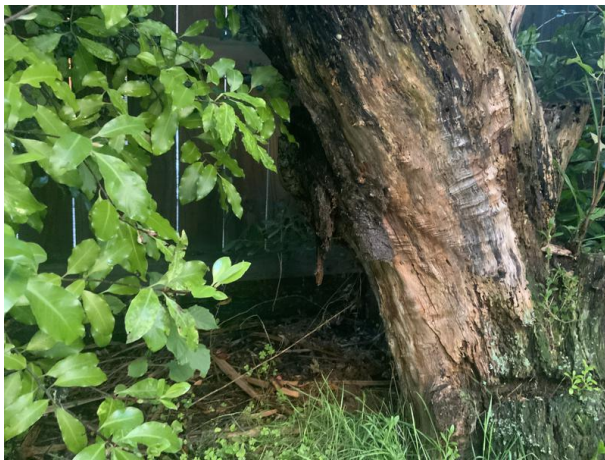
Photo 246

South aspect fencing covered in vegetation. Trimming or removal advised

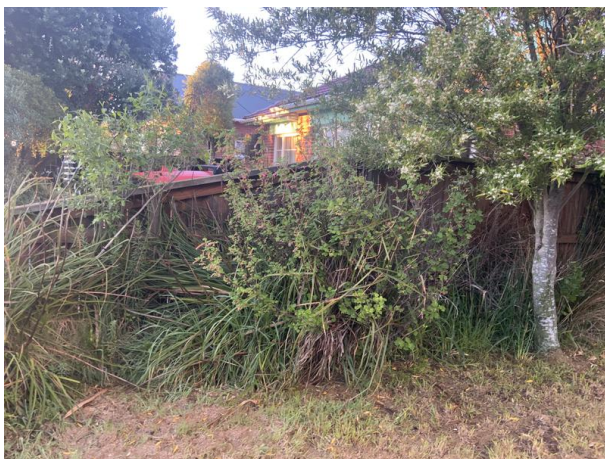
Photo 247

Southeast aspect fencing covered in vegetation. Trimming or removal advised

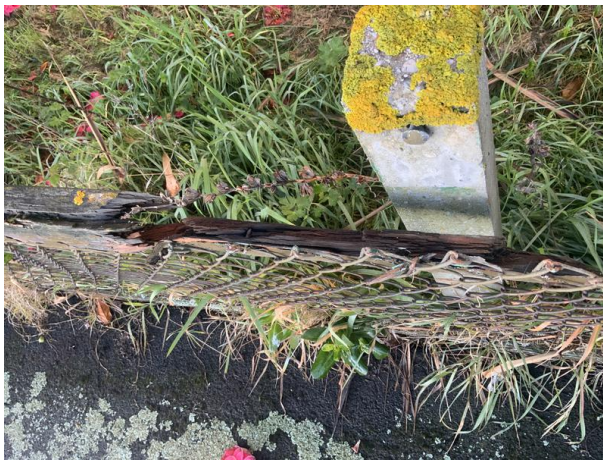
Photo 249

Rot detected to East aspect perimeter fencing.  
Replacement of rail advised

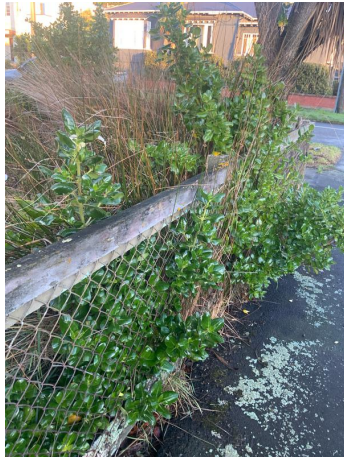
Photo 251

East aspect perimeter fencing covered in vegetation. Removal advised

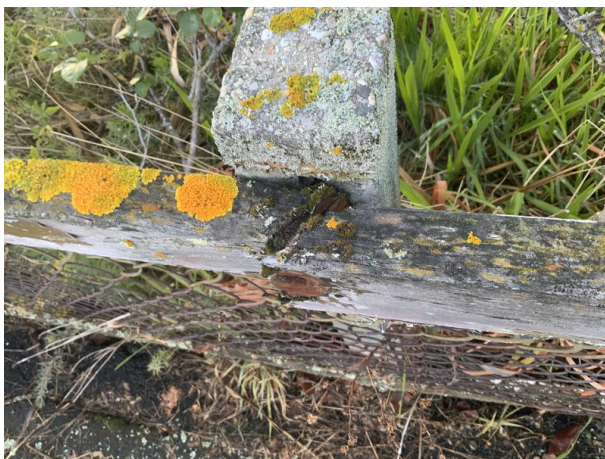
Photo 253

Rot detected to North aspect perimeter fencing. Replacement of rail advised

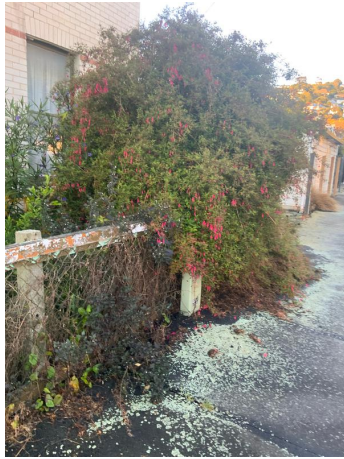
Photo 254

North aspect perimeter fencing covered in vegetation. Removal advised

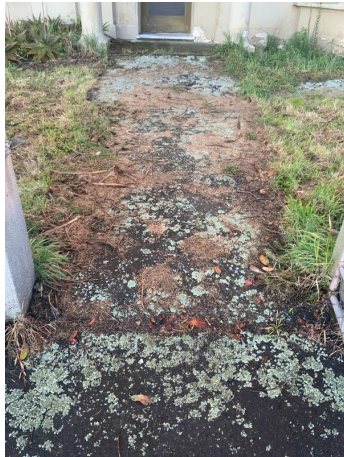
Photo 258

Front entrance path completely covered in moss and lichen. Treatment and cleaning advised

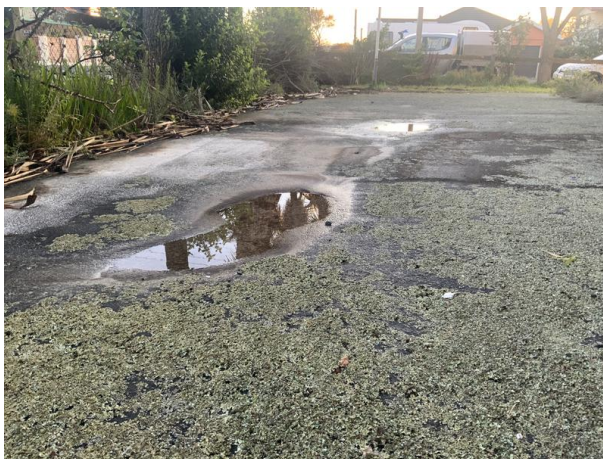
Photo 260

Low areas detected to patio area. Installation of a new patio area advised

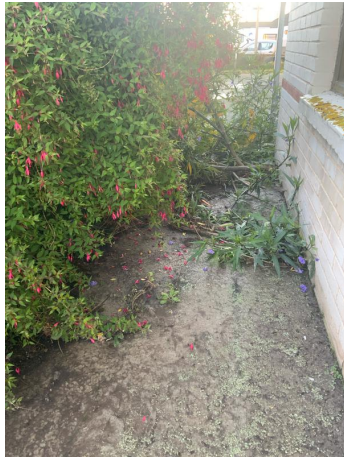
Photo 261

Northwest path covered in vegetation. Trimming and removal advised

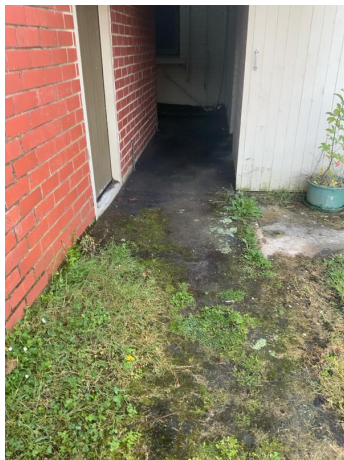
Photo 262

West aspect path covered in vegetation. Removal advised

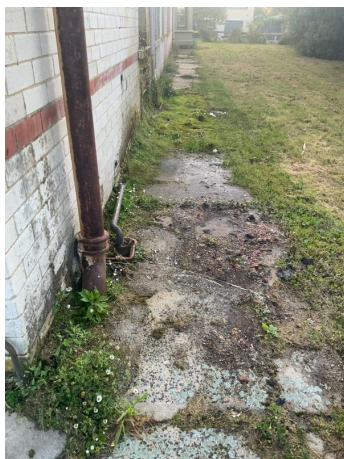
Photo 263

South aspect path damaged. Replacement advised

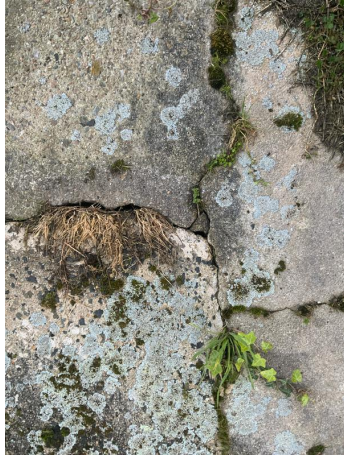
Photo 264

Cracking detected to Southwest aspect path. Installation of a new path advised

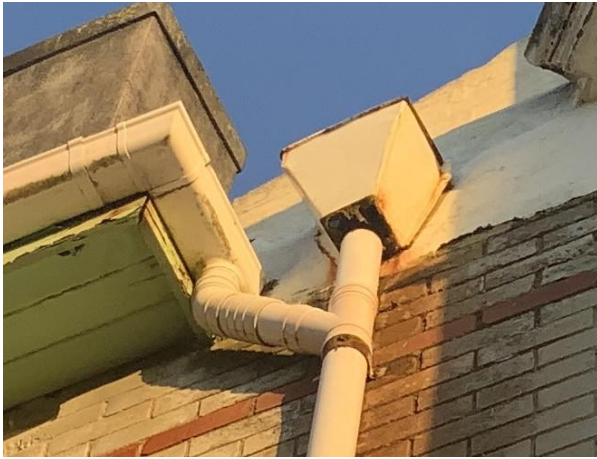
Photo 272

Corrosion detected to rainhead. Replacement advised

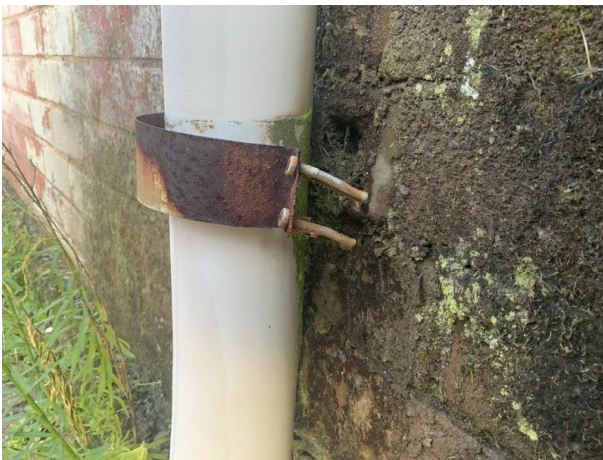
Photo 273

Disconnected brackets detected throughout the stormwater systems. Installation of various stormwater brackets advised

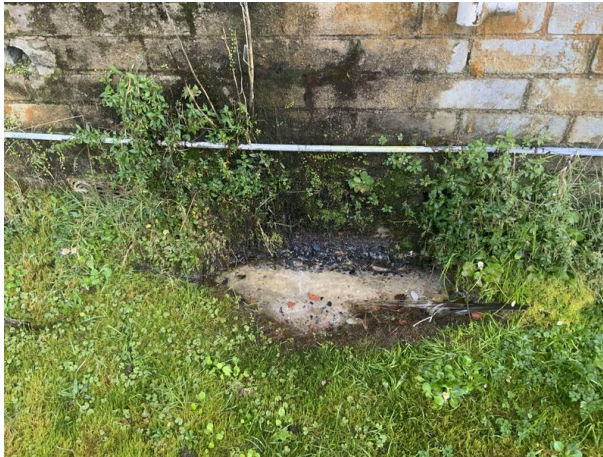
Photo 275

Leakage from stormwater system or overflow detected at Southwest corner of property. Further investigation is required to find the source of the matter

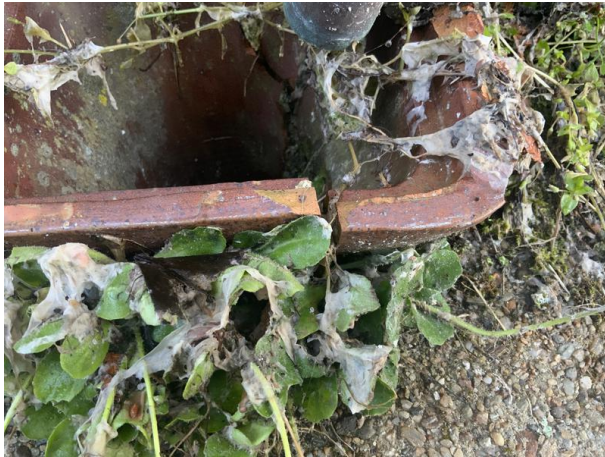
Photo 278

Gully trap located Southwest aspect cracked. Replacement advised

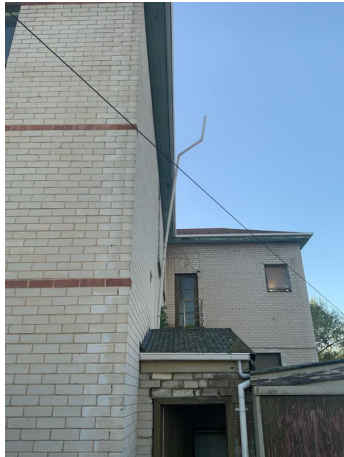
Photo 281

Breather pipe located West aspect disconnected from dwelling. Reinstallation advised promptly for safety purposes

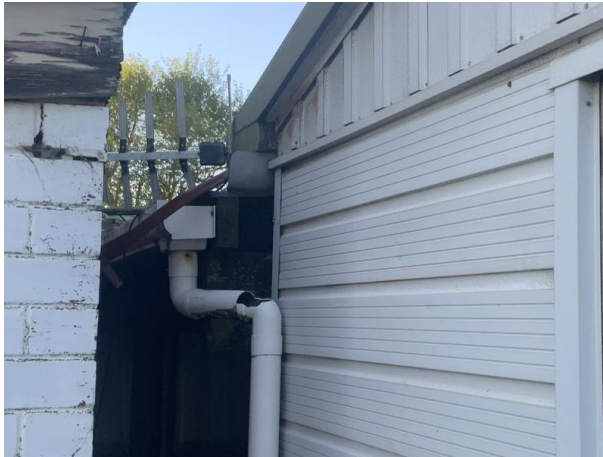
Photo 284

Damage detected to stormwater pipe to garage. Replacement advised

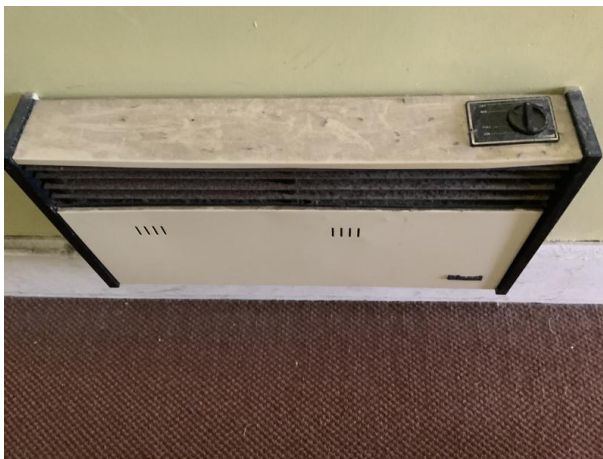
Photo 286

Level two wall heater not tested

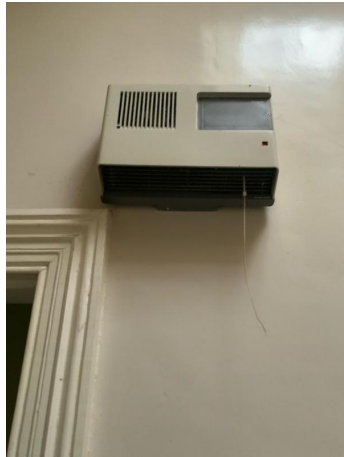
Photo 287

Level two bathroom heater non-operational. Further investigation is required

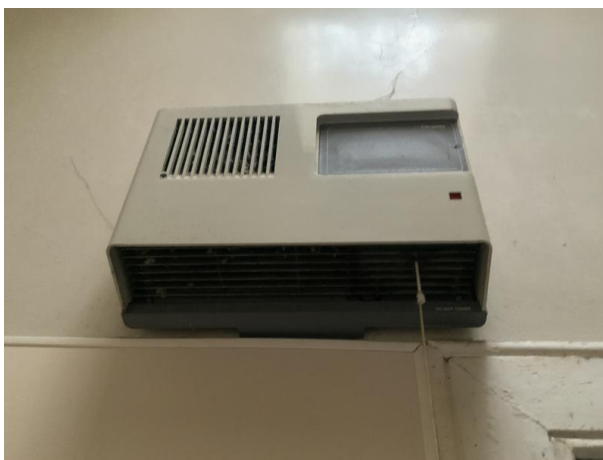
Photo 288

Level two bathroom two bathroom heater non-operational. Further investigation is required

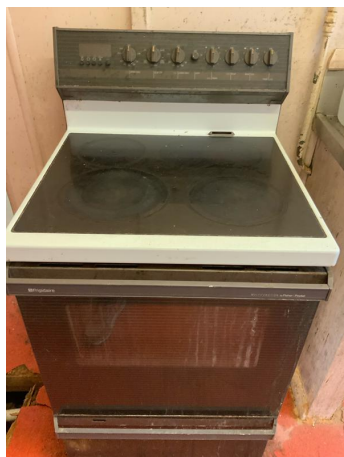
Photo 289

Oven not tested for safety reasons

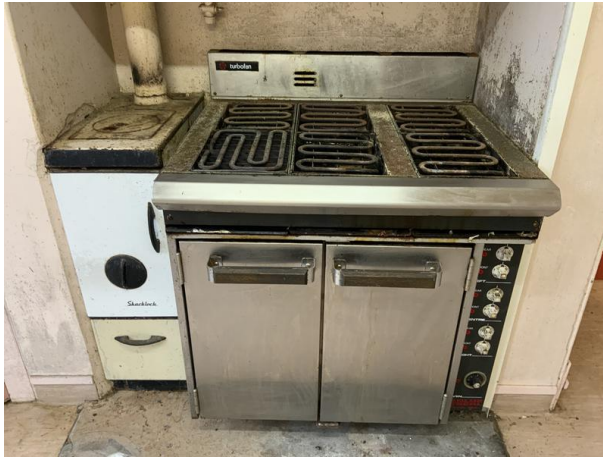
Photo 290

Commercial cooktop and oven  
not tested for safety reasons

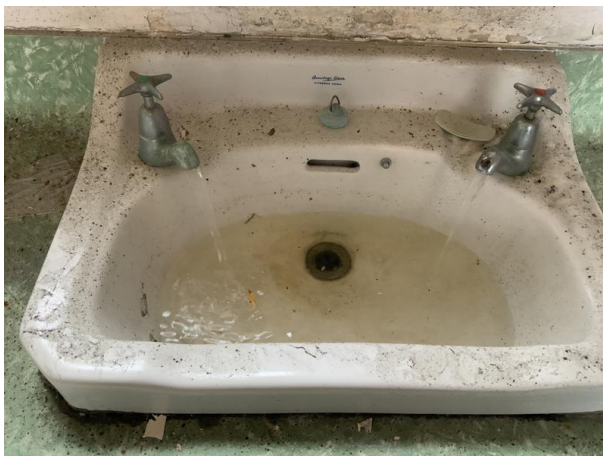
Photo 297

Bathroom vanity basin  
plumbing blocked. Further  
investigation is required by  
registered plumber

Have a registered plumber investigate and report on the work required.  
It appears all plumbing systems will require upgrading, replacing pipes and fittings to modern standards.

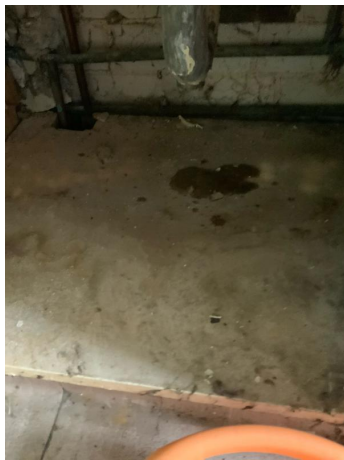
Photo 299

Bathroom vanity basin plumbing leaking. Advise a plumber for repairs

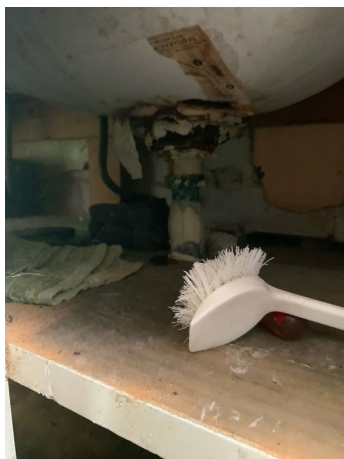
Photo 300

Bathroom vanity basin plumbing 2 leaking. Advise a plumber for repairs

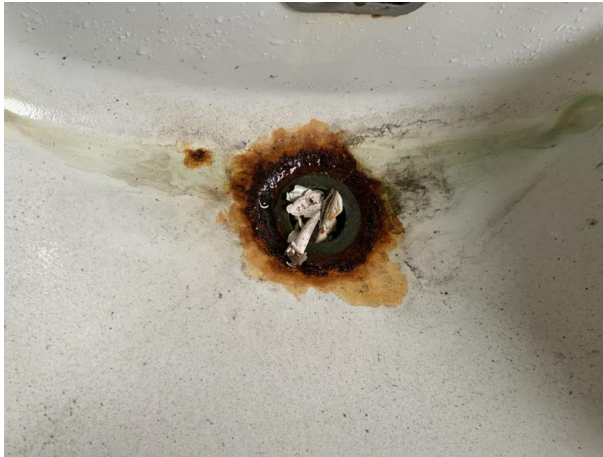
Photo 301

Bathroom vanity basin blocked. Advise a plumber for further investigation

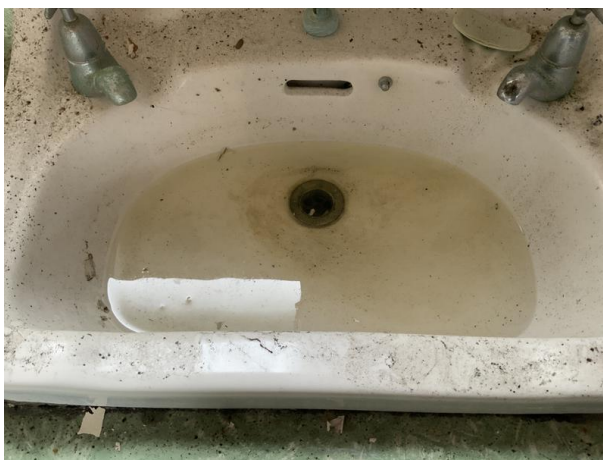
Photo 302

Bathroom vanity basin 2 blocked. Advise a plumber for further investigation

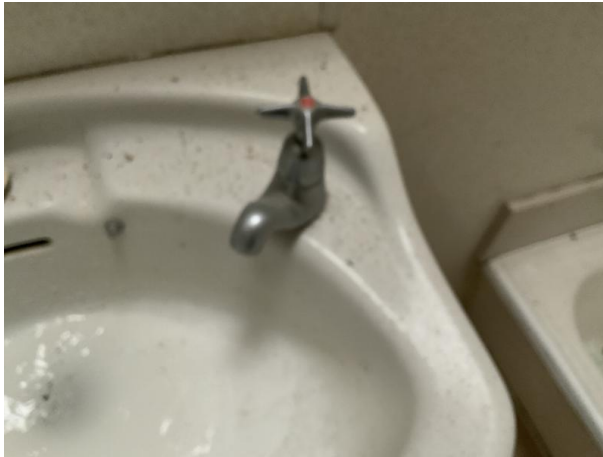
Photo 307

Vanity hot basin hot tap non-functional. Further investigation is required by a registered plumber

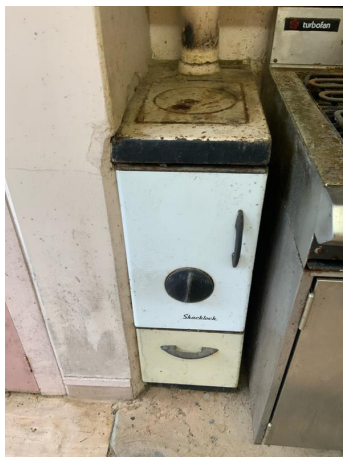
Photo 317

Dining area firebox oven not tested

Have a heating specialist investigate and report on the oven firebox condition.

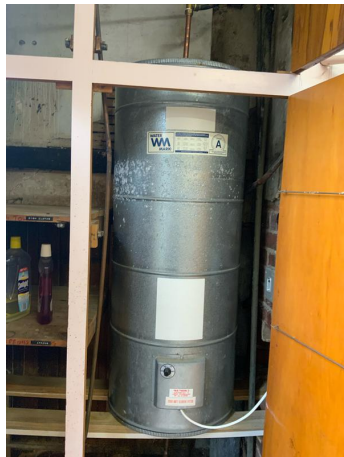
Photo 319

Hot water cylinder located in kitchen cupboard with seismic restraints not viewed. Installation of seismic restraints advised

It is recommended that seismic restraints are fitted correctly to the hot water cylinder. For safety reasons, all hot water cylinders installed after 1 July 1992 should legally have seismic restraints (steel straps) fitted. The restraints should be no more than 100 mm from the top and

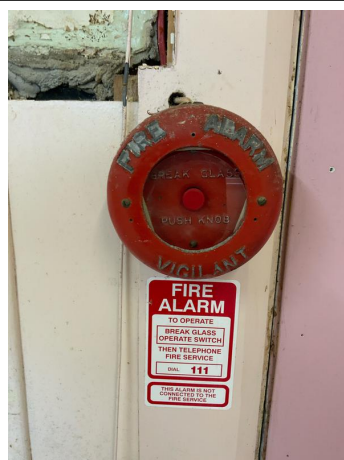
Photo 322

Fire alarm system located in kitchen (Not tested)

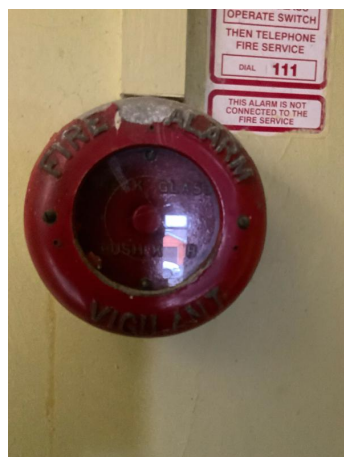
Photo 323

Fire alarm system located in hallway (Not tested)

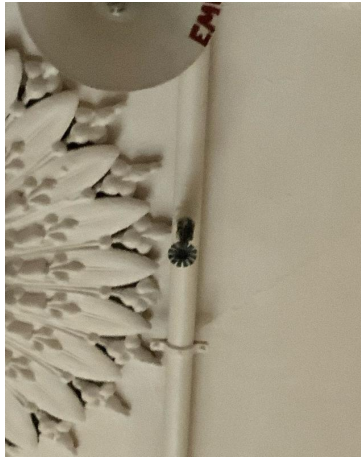
Photo 324

Fire sprinklers located throughout the dwelling. The system should be redesigned to modern standards by a fire engineer.

Updating and replacing all services in the building, including fire systems and means of escape and egress, is strongly recommended.

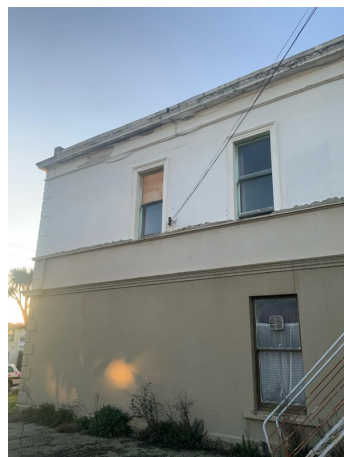
Photo 325

Fire alarm located East aspect

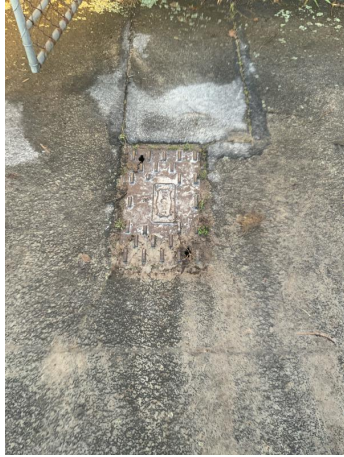
Photo 326

Telecom point of connection located North aspect
